## 2023 - 2024 Ventilation Assessment

## Saint Paul Public Schools Parkway Montessori

Assessment Date:  
Monday, April 17, 2023

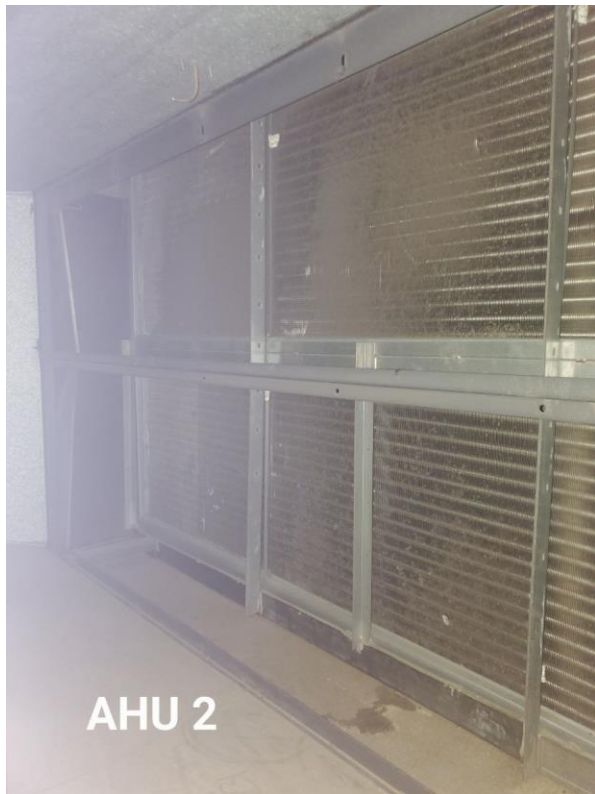
| <b>Filter Type - Mixed</b> <ul style="list-style-type: none"> <li>Pre-filter: None</li> <li>Main filter: Pleated, MERV 11</li> </ul> | <p>Outdoor air intake is in good condition.</p> | <p>Heating coils are dirty.</p> <p>Heat wheels are not present.</p> <p>Exterior ducting is visible. Exterior ducting insulation is in good condition.</p> <p>Interior ducting is not visible. Interior ducting insulation is in an unknown condition. Interior ducting is of unknown cleanliness.</p> <p>Air handling room is free of trash/chemicals.</p> <p>Outside damper is inaccessible, and its condition is not known.</p> <p>Return damper is inaccessible, and its condition is not known.</p> <p>The general condition of the unit is good.</p> |

Dirty Coils were observed on unit AHU 02 during the ventilation inspection.

AHU 02  
Heating Coils

**Recommendation:** Impacted/dirty coils can result in poor ventilation air supply as well as be a source for mold and bacterial growth on the coils. Coils should be cleaned annually, or as needed, as identified in the operations and maintenance program.
