IEA, INC.

2022 - 2023 IAQ Walkthrough

Saint Paul Public Schools Hubbs Lifelong Learning

Walkthrough Date:
Wednesday, January 11, 2023
Retest Date: March 23, 2023

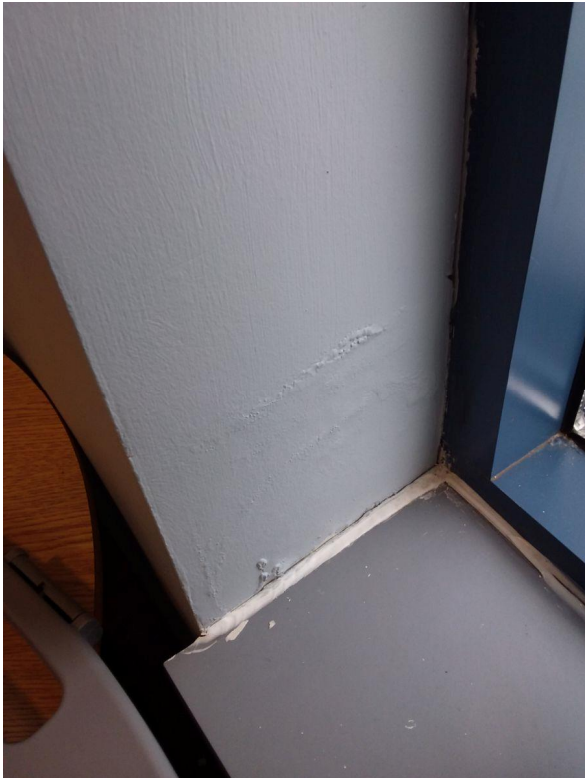
1413

IEA observed bubbling/peeling paint in area(s) within the room(s) listed below. Bubbling/peeling paint can be caused by moisture issues. IEA recommends investigating the cause and repairing the paint. IEA recommends ensuring that the paint is not lead-based prior to disturbance.

Bubbling/Peeling Paint
