IEA, INC.

2023 - 2024 Ventilation Assessment

Saint Paul Public Schools Humboldt Senior High School

Assessment Date:
Monday, April 10, 2023

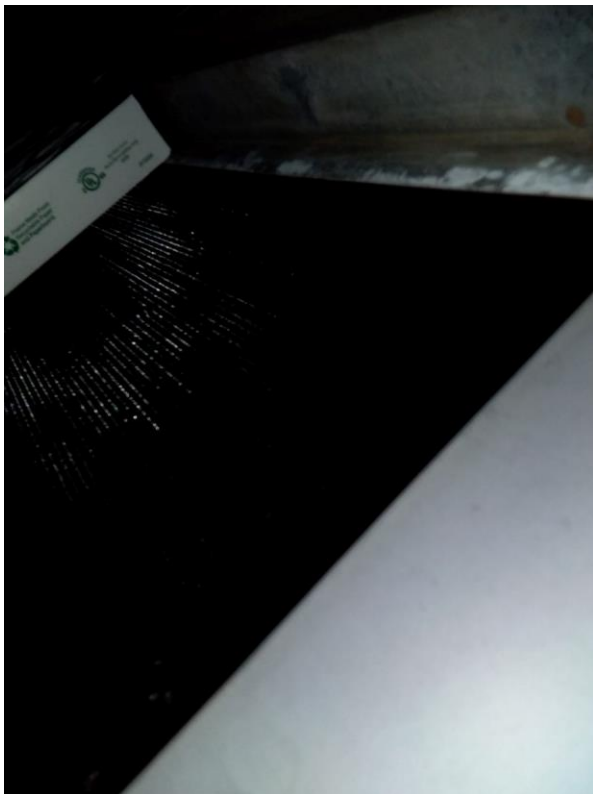
AHU_06
Cooling Coils

Unit Designation:	AHU_06	
Location of Unit:	Mechanical Room stage area	
Areas Served:	See attached map.	
System Enhancements:	None	
Supply System	Outdoor Air	Cleanliness and Observations
Type <ul style="list-style-type: none"> Supply System - Constant Volume Heating - Hot Water Cooling - Chilled Water Energy Recovery Unit (ERU) - None 	Outdoor air intake is inaccessible Outdoor air intake is located on the roof. It is not known if there are nearby pollution sources. Outdoor air intake is in good condition.	Outdoor air filters are not present. Return air filters are not present. Mixed air pre-filters are not present. Mixed air main filters are clean and not in need of replacement (scoring 1 out of 5) and fit well. Mixed air main filters are installed correctly. Drain pans are not plugged. Drain pan condition is good. Heating coils are inaccessible and cooling coils are dirty. Heat wheels are not present. Exterior ducting is visible. Exterior ducting insulation is in good condition. Interior ducting is visible. Interior ducting insulation is not present. Interior ducting is of unknown cleanliness. Air handling room is free of trash/chemicals. Outside damper is open, and its condition is good. Return damper is closed, and its condition is good. The general condition of the unit is good.

Dirty Coils were observed on units AHU_06, AHU_16, HVU_01, HVU_02, HVU_03, HVU_04, HVU_07, HVU_16 and RTU_02 during the ventilation inspection.

Recommendation: Impacted/dirty coils can result in poor ventilation air supply as well as be a source for mold and bacterial growth on the coils. Coils should be cleaned annually, or as needed, as identified in the operations and maintenance program.

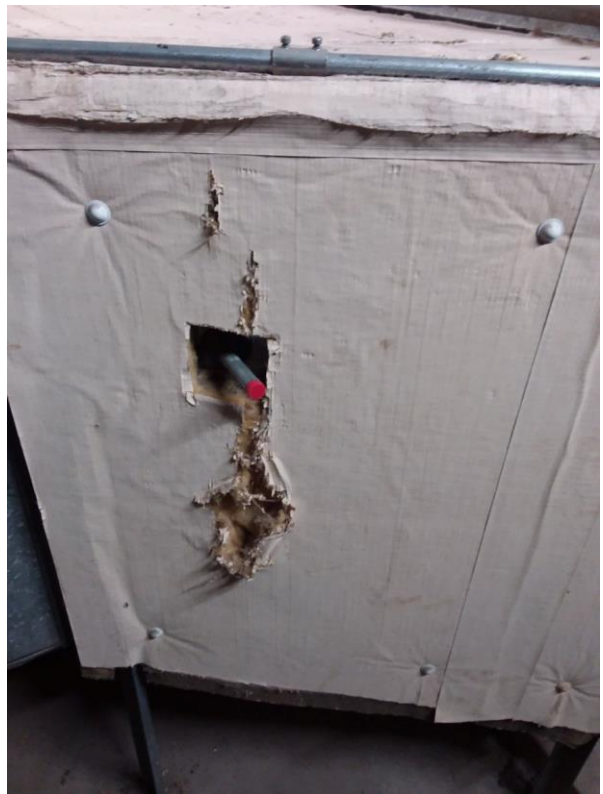
AHU_07
General Condition

Unit Designation:	AHU_07	
Location of Unit:	Mechanical room Stage area	
Areas Served:	Stage See attached map	
System Enhancements:	None	
Supply System	Outdoor Air	Cleanliness and Observations
Type <ul style="list-style-type: none"> Supply System - Constant Volume Heating - Hot Water Cooling - None Energy Recovery Unit (ERU) - None 	<p>Outdoor air intake is inaccessible</p> <p>Outdoor air intake is located on the roof.</p> <p>It is not known if there are nearby pollution sources.</p> <p>Outdoor air intake is in good condition.</p>	<p>Outdoor air filters are not present.</p> <p>Return air filters are not present.</p> <p>Mixed air pre-filters are not present. Mixed air main filters are clean and not in need of replacement (scoring 1 out of 5) and fit well. Mixed air main filters are installed correctly.</p> <p>Drain pan plugged status is not known. Drain pan condition is not known.</p> <p>Heating coils are inaccessible.</p> <p>Heat wheels are not present.</p> <p>Exterior ducting is visible. Exterior ducting insulation is not present.</p> <p>Interior ducting is visible. Interior ducting insulation is in good condition. Interior ducting is clean.</p> <p>Air handling room is free of trash/chemicals.</p> <p>Outside damper is open, and its condition is good.</p> <p>Return damper is open, and its condition is good.</p> <p>The general condition of the unit is poor.</p>

The general condition of unit AHU_07 was poor.

Recommendation: The units should be repaired or cleaned as needed.

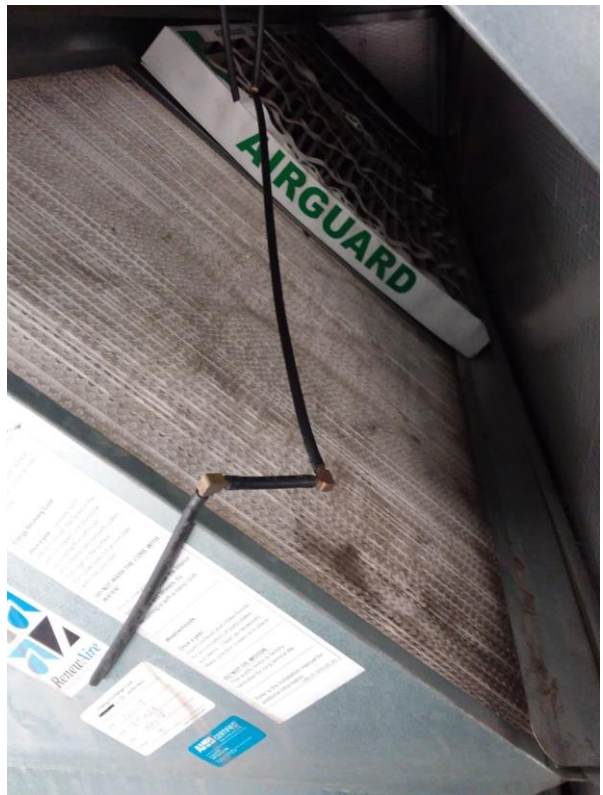
AHU_12
Heat Wheel

Unit Designation:	AHU_12	
Location of Unit:	Mechanical room 2404 (a)	
Areas Served:	1st Flr Area A, NW VAVs See attached map	
System Enhancements:	None	
Supply System	Outdoor Air	Cleanliness and Observations
Type <ul style="list-style-type: none"> Supply System - VAV Heating - Hot Water Cooling - Chilled Water Energy Recovery Unit (ERU) - Fixed Plate 	<p>Outdoor air intake is inaccessible</p> <p>Outdoor air intake is located on the roof.</p> <p>It is not known if there are nearby pollution sources.</p> <p>Outdoor air intake is in good condition.</p>	<p>Outdoor air filters are not present.</p> <p>Return air filters are not present.</p> <p>Mixed air pre-filters are not present. Mixed air main filters are clean and not in need of replacement (scoring 1 out of 5) and fit well. Mixed air main filters are installed correctly.</p> <p>Drain pans are not plugged. Drain pan condition is poor.</p> <p>Heating coils are clean and cooling coils are clean.</p> <p>Heat wheels are dirty.</p> <p>Exterior ducting is visible. Exterior ducting insulation is in good condition.</p> <p>Interior ducting is not visible. Interior ducting insulation is not present. Interior ducting is of unknown cleanliness.</p> <p>Air handling room is free of trash/chemicals.</p> <p>Outside damper is open, and its condition is good.</p> <p>Return damper is open, and its condition is good.</p> <p>The general condition of the unit is good.</p>

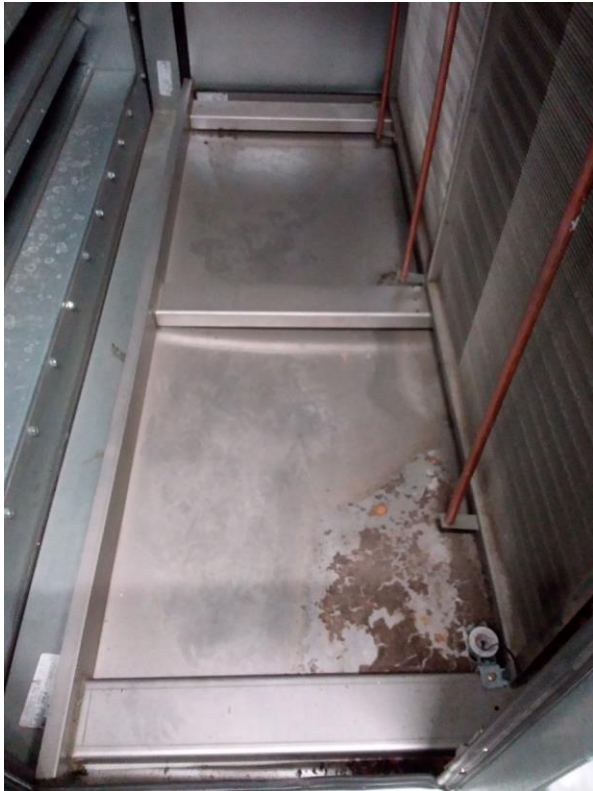
AHU_12
Drain Pans

The drain pan for units AHU_12 , AHU_14 and HVU_17 was plugged or damaged at the time of the site inspection.

Recommendation: Damage to the drain pan should be repaired, or the drain pan should be inspected more frequently to ensure that it does not become plugged.

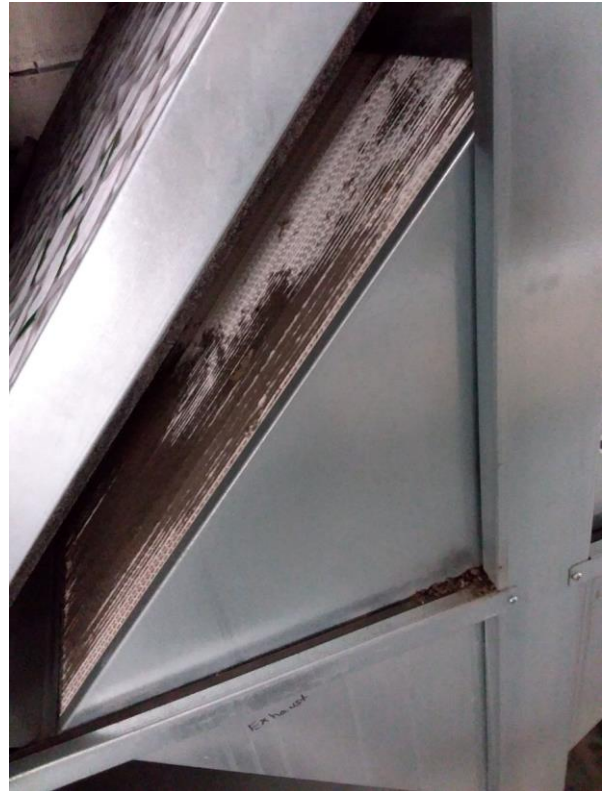
AHU_13
Heat Wheel

Unit Designation:	AHU_13	
Location of Unit:	Mechanical room 2404 (a)	
Areas Served:	1st Flr Area A, NE VAVs See attached map	
System Enhancements:	None	
Supply System	Outdoor Air	Cleanliness and Observations
Type <ul style="list-style-type: none"> Supply System - VAV Heating - Hot Water Cooling - Chilled Water Energy Recovery Unit (ERU) - Fixed Plate 	<p>Outdoor air intake is inaccessible</p> <p>Outdoor air intake is located on the roof.</p> <p>It is not known if there are nearby pollution sources.</p> <p>Outdoor air intake is in good condition.</p>	<p>Outdoor air pre-filters are not present. Outdoor air main filters are clean and not in need of replacement (scoring 1 out of 5) and fit well. Outdoor air main filters are installed correctly.</p> <p>Return air pre-filters are not present. Return air main filters are clean and not in need of replacement (scoring 1 out of 5) and fit well. Return air main filters are installed correctly.</p> <p>Mixed air pre-filters are not present. Mixed air main filters are clean and not in need of replacement (scoring 1 out of 5) and fit well. Mixed air main filters are installed correctly.</p> <p>Drain pans are not plugged. Drain pan condition is good.</p> <p>Heating coils are clean and cooling coils are clean.</p> <p>Heat wheels are dirty.</p> <p>Exterior ducting is visible. Exterior ducting insulation is in good condition.</p> <p>Interior ducting is not visible. Interior ducting insulation is in an unknown condition. Interior ducting is of unknown cleanliness.</p> <p>Air handling room is free of trash/chemicals.</p> <p>Outside damper is closed, and its condition is good.</p> <p>Return damper is open, and its condition is good.</p> <p>The general condition of the unit is good.</p>

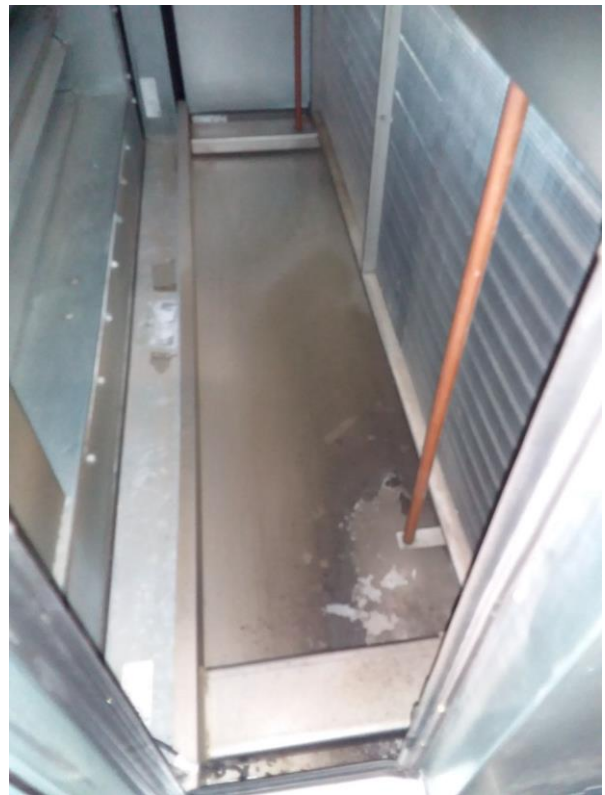
AHU_14
Drain Pans

Unit Designation:	AHU_14	
Location of Unit:	Mechanical Room 2504	
Areas Served:	See attached map.	
System Enhancements:	None	
Supply System	Outdoor Air	Cleanliness and Observations
Type <ul style="list-style-type: none"> Supply System - Unknown Heating - Steam Cooling - Chilled Water Energy Recovery Unit (ERU) - Fixed Plate 	<p>Outdoor air intake is inaccessible</p> <p>Outdoor air intake is located on the roof.</p> <p>It is not known if there are nearby pollution sources.</p>	<p>Outdoor air pre-filters are not present. Outdoor air main filters are clean and not in need of replacement (scoring 1 out of 5) and fit well. Outdoor air main filters are installed correctly.</p> <p>Return air pre-filters are not present. Return air main filters are clean and not in need of replacement (scoring 1 out of 5) and fit well. Return air main filters are installed correctly.</p>
Filter Type - Outdoor <ul style="list-style-type: none"> Pre-filter: None Main filter: Pleated, MERV 11 	Outdoor air intake is in good condition.	<p>Mixed air pre-filters are not present. Mixed air main filters are clean and not in need of replacement (scoring 1 out of 5) and fit well. Mixed air main filters are installed correctly.</p> <p>Drain pans are not plugged. Drain pan condition is poor.</p> <p>Heating coils are clean and cooling coils are clean.</p> <p>Heat wheels are clean.</p> <p>Exterior ducting is visible. Exterior ducting insulation is in good condition.</p> <p>Interior ducting is not visible. Interior ducting insulation is in an unknown condition. Interior ducting is of unknown cleanliness.</p> <p>Air handling room is free of trash/chemicals.</p> <p>Outside damper is open, and its condition is good.</p> <p>Return damper is open, and its condition is good.</p> <p>The general condition of the unit is good.</p>

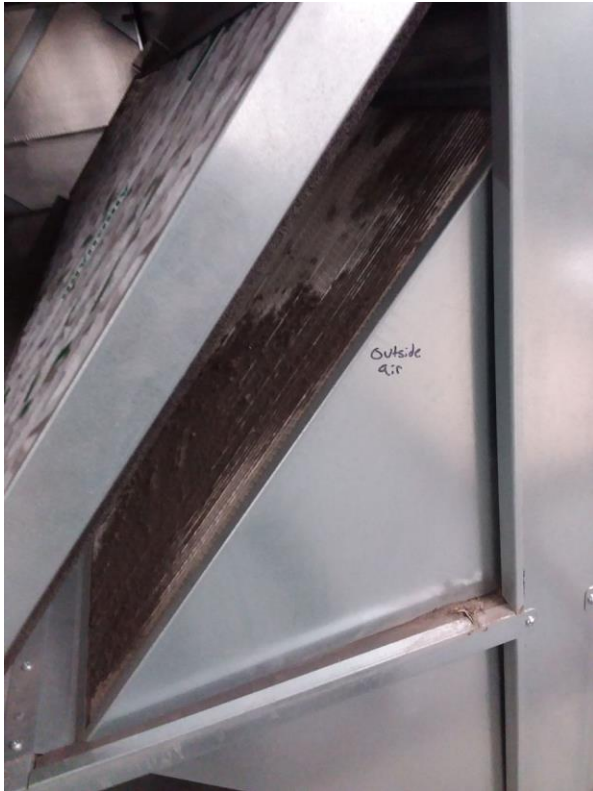
AHU_15
Heat Wheel

Unit Designation:	AHU_15	
Location of Unit:	Mechanical Room 2504	
Areas Served:	See attached map.	
System Enhancements:	None	
Supply System	Outdoor Air	Cleanliness and Observations
Type <ul style="list-style-type: none"> Supply System - VAV Heating - Steam Cooling - Chilled Water Energy Recovery Unit (ERU) - Fixed Plate 	<p>Outdoor air intake is inaccessible</p> <p>Outdoor air intake is located on an exterior wall.</p> <p>It is not known if there are nearby pollution sources.</p>	<p>Outdoor air pre-filters are not present. Outdoor air main filters are clean and not in need of replacement (scoring 1 out of 5) and fit well. Outdoor air main filters are installed correctly.</p> <p>Return air pre-filters are not present. Return air main filters are clean and not in need of replacement (scoring 1 out of 5) and fit well. Return air main filters are installed correctly.</p>
Filter Type - Outdoor <ul style="list-style-type: none"> Pre-filter: None Main filter: Pleated, MERV 8 	<p>Outdoor air intake is in good condition.</p>	<p>Mixed air pre-filters are not present. Mixed air main filters are clean and not in need of replacement (scoring 1 out of 5) and fit well. Mixed air main filters are installed correctly.</p>

Filter Type - Return <ul style="list-style-type: none"> Pre-filter: None Main filter: Pleated, MERV 8 		<p>Drain pans are not plugged. Drain pan condition is good.</p> <p>Heating coils are clean and cooling coils are clean.</p> <p>Heat wheels are dirty.</p>
Filter Type - Mixed <ul style="list-style-type: none"> Pre-filter: None Main filter: Pleated, MERV 13 		<p>Exterior ducting is visible. Exterior ducting insulation is in good condition.</p> <p>Interior ducting is not visible. Interior ducting insulation is in an unknown condition. Interior ducting is of unknown cleanliness.</p> <p>Air handling room is free of trash/chemicals.</p> <p>Outside damper is closed, and its condition is good.</p> <p>Return damper is open, and its condition is good.</p> <p>The general condition of the unit is good.</p>

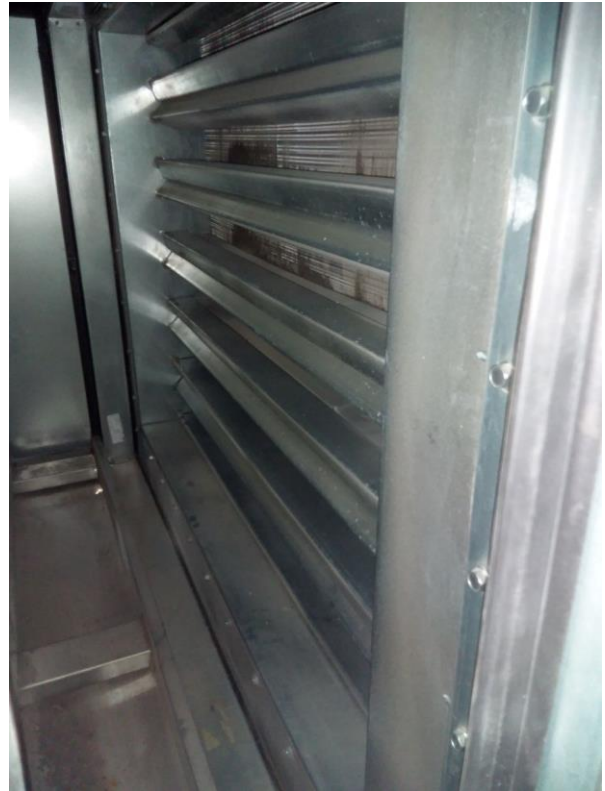
AHU_16
Heating Coils

Unit Designation:	AHU_16	
Location of Unit:	Mechanical room 2503(a)	
Areas Served:	1st Flr Area A, NE VAVs See attached map	
System Enhancements:	None	
Supply System	Outdoor Air	Cleanliness and Observations
Type <ul style="list-style-type: none"> Supply System - VAV Heating - Hot Water Cooling - Chilled Water Energy Recovery Unit (ERU) - None 	<p>Outdoor air intake is inaccessible</p> <p>Outdoor air intake is located on an exterior wall.</p> <p>It is not known if there are nearby pollution sources.</p>	<p>Outdoor air filters are not present.</p> <p>Return air filters are not present.</p> <p>Mixed air pre-filters are not present. Mixed air main filters are clean and not in need of replacement (scoring 1 out of 5) and fit well. Mixed air main filters are installed correctly.</p> <p>Drain pans are not plugged. Drain pan condition is good.</p>
Filter Type - Mixed <ul style="list-style-type: none"> Pre-filter: None Main filter: Pleated, MERV 13 	<p>Outdoor air intake is in good condition.</p>	<p>Heating coils are dirty and cooling coils are clean.</p> <p>Heat wheels are not present.</p> <p>Exterior ducting is visible. Exterior ducting insulation is in good condition.</p> <p>Interior ducting is not visible. Interior ducting insulation is in an unknown condition. Interior ducting is of unknown cleanliness.</p> <p>Air handling room is free of trash/chemicals.</p> <p>Outside damper is inaccessible, and its condition is not known.</p> <p>Return damper is open, and its condition is good.</p> <p>The general condition of the unit is good.</p>

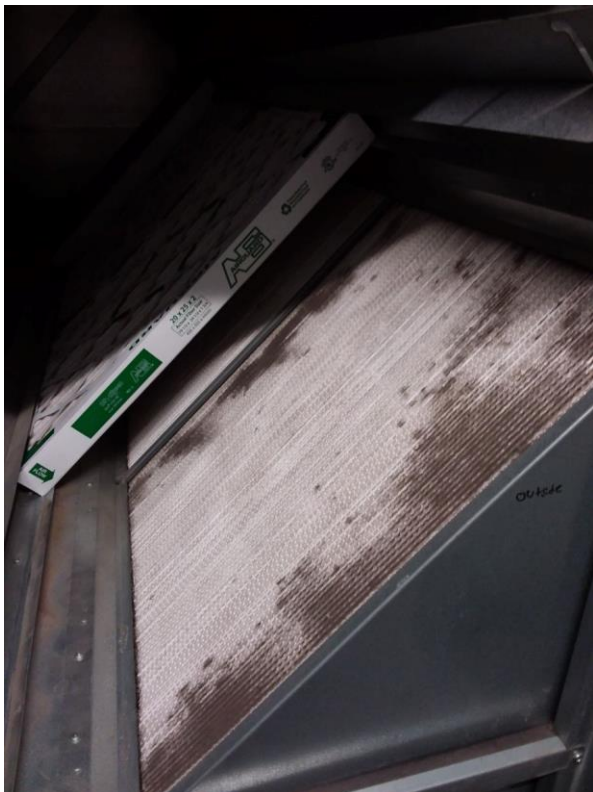
AHU_17
Heat Wheel

Unit Designation:	AHU_17	
Location of Unit:	Mechanical room w.penthouse (Stairwell C Penthouse)	
Areas Served:	All Flrs Area B, SW VAVs See attached map	
System Enhancements:	None	
Supply System	Outdoor Air	Cleanliness and Observations
Type <ul style="list-style-type: none"> Supply System - VAV Heating - Hot Water Cooling - Chilled Water Energy Recovery Unit (ERU) - Fixed Plate 	<p>Outdoor air intake is accessible</p> <p>Outdoor air intake is located on an exterior wall.</p> <p>No nearby pollution sources were found.</p>	<p>Outdoor air pre-filters are not present. Outdoor air main filters are clean and not in need of replacement (scoring 1 out of 5) and fit well. Outdoor air main filters are installed correctly.</p> <p>Return air pre-filters are not present. Return air main filters are clean and not in need of replacement (scoring 1 out of 5) and fit well. Return air main filters are installed correctly.</p> <p>Mixed air pre-filters are not present. Mixed air main filters are clean and not in need of replacement (scoring 1 out of 5) and fit well. Mixed air main filters are installed correctly.</p>

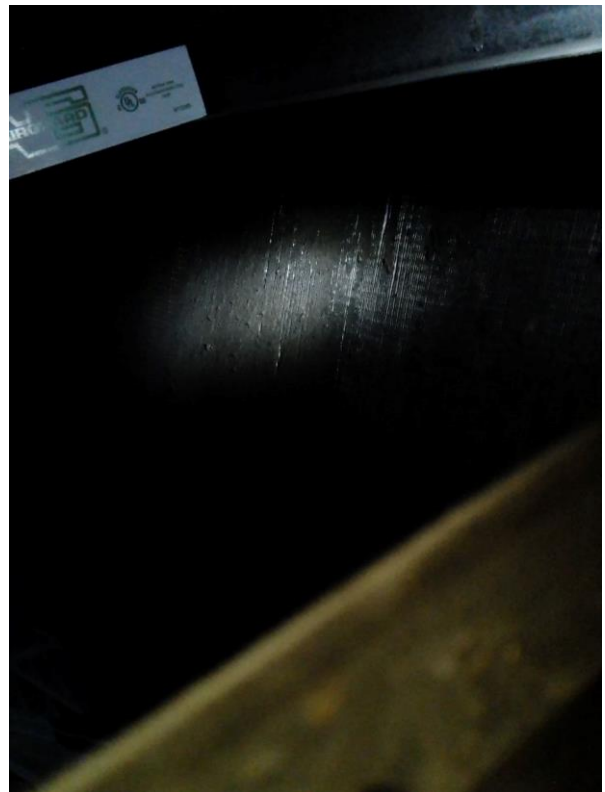
HVU_01
Heating Coils

Unit Designation:	HVU_01	
Location of Unit:	Mechanical Room Stage Area	
Areas Served:	See attached map.	
System Enhancements:	None	
Supply System	Outdoor Air	Cleanliness and Observations
Type <ul style="list-style-type: none"> Supply System - Unknown Heating - Hot Water Cooling - None Energy Recovery Unit (ERU) - None 	<p>Outdoor air intake is accessible</p> <p>Outdoor air intake is located on an exterior wall.</p> <p>No nearby pollution sources were found.</p>	<p>Outdoor air filters are not present.</p> <p>Return air filters are not present.</p> <p>Mixed air pre-filters are not present. Mixed air main filters are clean and not in need of replacement (scoring 2 out of 5) and fit well. Mixed air main filters are installed correctly.</p> <p>Drain pans are not applicable or not present. Drain pan condition is not known.</p>
Filter Type - Mixed <ul style="list-style-type: none"> Pre-filter: None Main filter: Pleated, MERV 11 	<p>Outdoor air intake is in poor condition.</p>	<p>Heating coils are dirty.</p> <p>Heat wheels are not present.</p> <p>Exterior ducting is visible. Exterior ducting insulation is not present.</p> <p>Interior ducting is visible. Interior ducting insulation is in an unknown condition. Interior ducting is of unknown cleanliness.</p> <p>Air handling room is free of trash/chemicals.</p> <p>Outside damper is open, and its condition is good.</p> <p>Return damper is inaccessible, and its condition is not known.</p> <p>The general condition of the unit is good.</p>

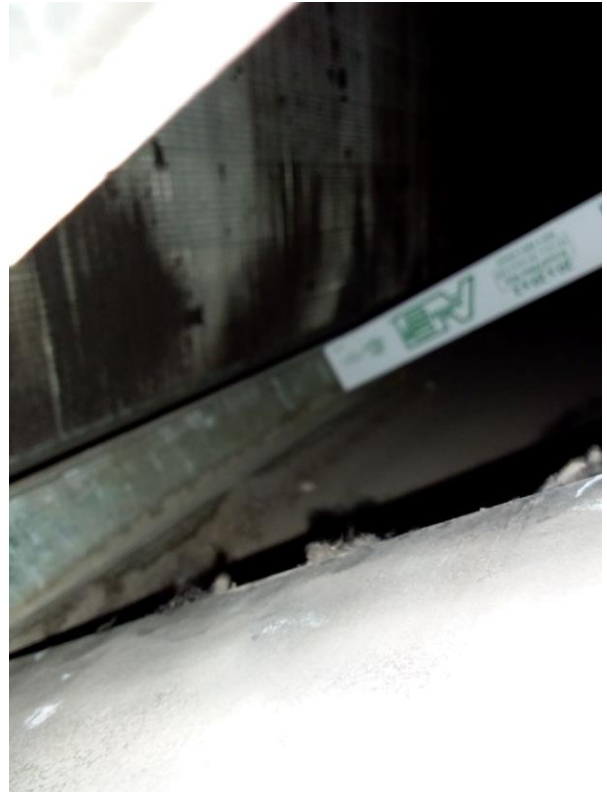
HVU_02
Heating Coils

Unit Designation:	HVU_02	
Location of Unit:	Mechanical room stage area	
Areas Served:	North Gym See attached map	
System Enhancements:	None	
Supply System	Outdoor Air	Cleanliness and Observations
Type <ul style="list-style-type: none"> Supply System - Constant Volume Heating - Hot Water Cooling - None Energy Recovery Unit (ERU) - None 	<p>Outdoor air intake is inaccessible</p> <p>Outdoor air intake is located on an exterior wall.</p> <p>It is not known if there are nearby pollution sources.</p>	<p>Outdoor air filters are not present.</p> <p>Return air filters are not present.</p> <p>Mixed air pre-filters are not present. Mixed air main filters are clean and not in need of replacement (scoring 1 out of 5) and fit well. Mixed air main filters are installed correctly.</p> <p>Drain pans are not applicable or not present. Drain pan condition is not known.</p>
Filter Type - Mixed <ul style="list-style-type: none"> Pre-filter: None Main filter: Pleated, MERV 11 	<p>Outdoor air intake is in good condition.</p>	<p>Heating coils are dirty.</p> <p>Heat wheels are not present.</p> <p>Exterior ducting is visible. Exterior ducting insulation is not present.</p> <p>Interior ducting is not visible. Interior ducting insulation is in an unknown condition. Interior ducting is of unknown cleanliness.</p> <p>Air handling room is free of trash/chemicals.</p> <p>Outside damper is open, and its condition is good.</p> <p>Return damper is open, and its condition is good.</p> <p>The general condition of the unit is good.</p>

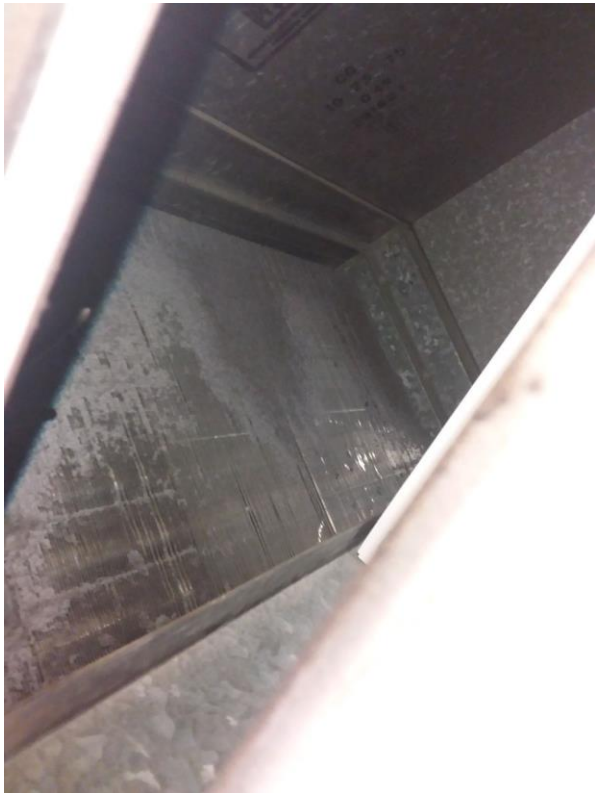
HVU_03
Heating Coils

Unit Designation:	HVU_03	
Location of Unit:	Wrestling Room 3112	
Areas Served:	See attached map.	
System Enhancements:	None	
Supply System	Outdoor Air	Cleanliness and Observations
Type <ul style="list-style-type: none"> Supply System - Unknown Heating - Hot Water Cooling - None Energy Recovery Unit (ERU) - None 	<p>Outdoor air intake is inaccessible</p> <p>Outdoor air intake is located in an unknown location.</p> <p>It is not known if there are nearby pollution sources.</p>	<p>Outdoor air filters are not present.</p> <p>Return air pre-filters are not present. Return air main filters are clean and not in need of replacement (scoring 1 out of 5) and fit well. Return air main filters are installed correctly.</p> <p>Drain pans are not applicable or not present. Drain pan condition is not known.</p> <p>Heating coils are dirty.</p>
Filter Type - Return <ul style="list-style-type: none"> Pre-filter: None Main filter: Pleated, MERV 11 	<p>Outdoor air intake is in good condition.</p>	<p>Heat wheels are not present.</p> <p>Exterior ducting is visible. Exterior ducting insulation is not present.</p> <p>Interior ducting is not visible. Interior ducting insulation is in an unknown condition. Interior ducting is of unknown cleanliness.</p> <p>Air handling room is free of trash/chemicals.</p> <p>Outside damper is inaccessible, and its condition is not known.</p> <p>Return damper is inaccessible, and its condition is not known.</p> <p>The general condition of the unit is good.</p>

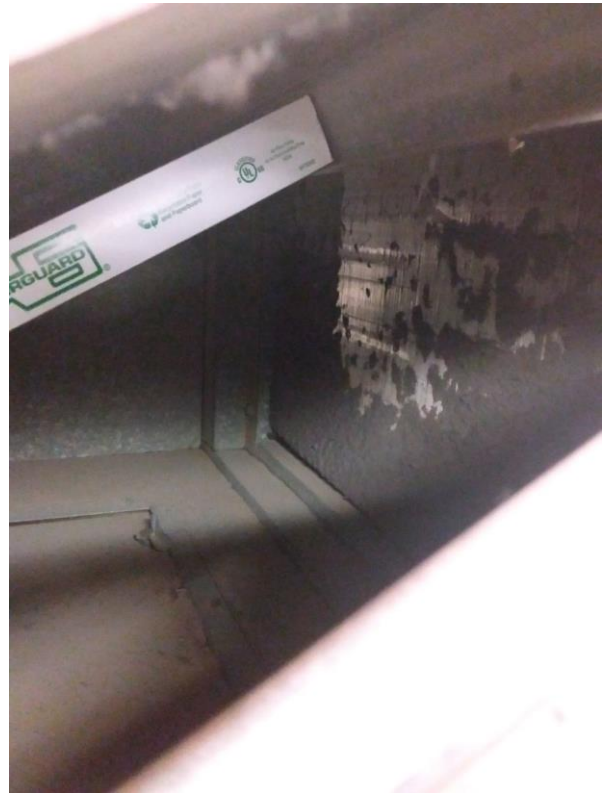
HVU_04
Heating Coils

Unit Designation:	HVU_04	
Location of Unit:	Wrestling Room 3112	
Areas Served:	See attached map.	
System Enhancements:	None	
Supply System	Outdoor Air	Cleanliness and Observations
Type <ul style="list-style-type: none"> Supply System - Unknown Heating - Hot Water Cooling - None Energy Recovery Unit (ERU) - None 	<p>Outdoor air intake is inaccessible</p> <p>Outdoor air intake is located in an unknown location.</p> <p>It is not known if there are nearby pollution sources.</p>	<p>Outdoor air filters are not present.</p> <p>Return air pre-filters are not present. Return air main filters are of unknown cleanliness and fit well. Return air main filters are installed correctly.</p> <p>Drain pans are not applicable or not present. Drain pan condition is not known.</p> <p>Heating coils are dirty.</p>
Filter Type - Return <ul style="list-style-type: none"> Pre-filter: None Main filter: Pleated, MERV 11 	<p>Outdoor air intake is in good condition.</p>	<p>Heat wheels are not present.</p> <p>Exterior ducting is visible. Exterior ducting insulation is not present.</p> <p>Interior ducting is not visible. Interior ducting insulation is in an unknown condition. Interior ducting is of unknown cleanliness.</p> <p>Air handling room is free of trash/chemicals.</p> <p>Outside damper is inaccessible, and its condition is not known.</p> <p>Return damper is inaccessible, and its condition is not known.</p> <p>The general condition of the unit is good.</p>

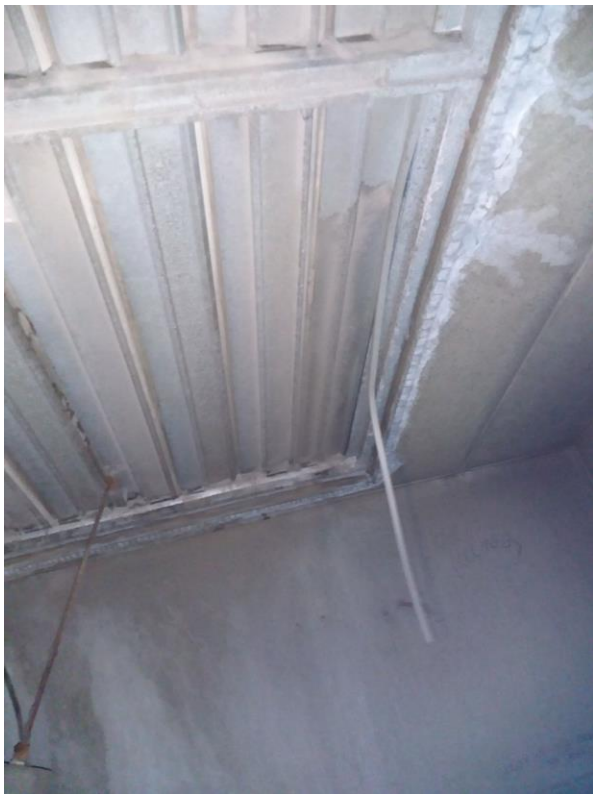
HVU_07
Outside Damper

Unit Designation:	HVU_07	
Location of Unit:	Mechanical Room above pool deck	
Areas Served:	Jr High Gym See attached map	
System Enhancements:	None	
Supply System	Outdoor Air	Cleanliness and Observations
Type <ul style="list-style-type: none"> Supply System - Unknown Heating - Hot Water Cooling - None Energy Recovery Unit (ERU) - None 	<p>Outdoor air intake is inaccessible</p> <p>Outdoor air intake is located on the roof.</p> <p>It is not known if there are nearby pollution sources.</p>	<p>Outdoor air filters are not present.</p> <p>Return air filters are not present.</p> <p>Mixed air pre-filters are not present. Mixed air main filters are clean and not in need of replacement (scoring 1 out of 5) and fit well. Mixed air main filters are installed correctly.</p> <p>Drain pans are not applicable or not present. Drain pan condition is not known.</p> <p>Heating coils are dirty.</p> <p>Heat wheels are not present.</p> <p>Exterior ducting is visible. Exterior ducting insulation is not present.</p> <p>Interior ducting is visible. Interior ducting insulation is not present. Interior ducting is of unknown cleanliness.</p> <p>Air handling room is free of trash/chemicals.</p> <p>Outside damper is closed, and its condition is poor. The seal is damaged.</p> <p>Return damper is open, and its condition is good.</p> <p>The general condition of the unit is good.</p>

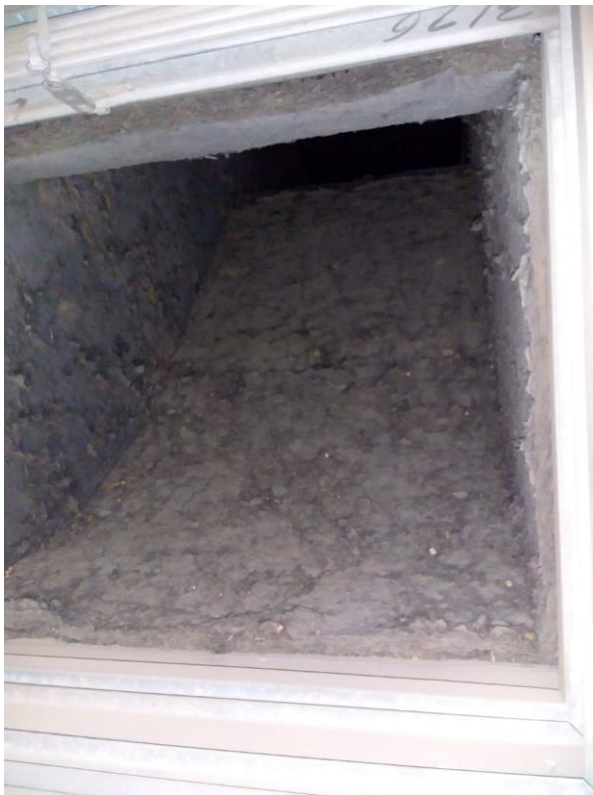
HVU_11
Interior Ducting

The accessible ductwork for unit HVU_11 was visibly dirty, damaged, or had evidence of moisture at the time of the site inspection.

Recommendation: IEA recommends further inspection into the overall condition of the interior ductwork and level of dirt/debris quantified. If deemed a concern, it is recommended that the interior ducting be cleaned by a professional contractor to improve the impact on the IAQ for the supply spaces.

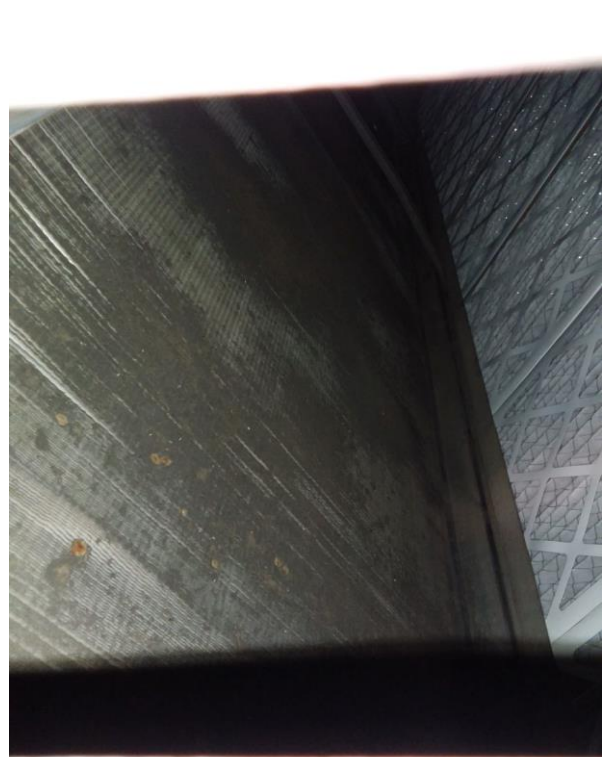
HVU_16
Heating Coils

Unit Designation:	HVU_16	
Location of Unit:	Mechanical room stage area	
Areas Served:	Auditorium Lobby See attached map	
System Enhancements:	None	
Supply System	Outdoor Air	Cleanliness and Observations
Type <ul style="list-style-type: none"> Supply System - Constant Volume Heating - Hot Water Cooling - None Energy Recovery Unit (ERU) - None 	Outdoor air intake is accessible Outdoor air intake is located on an exterior wall. No nearby pollution sources were found. Outdoor air intake is in good condition.	Outdoor air filters are not present. Return air filters are not present. Mixed air pre-filters are not present. Mixed air main filters are clean and not in need of replacement (scoring 1 out of 5) and fit well. Mixed air main filters are installed correctly. Drain pans are not applicable or not present. Drain pan condition is not known. Heating coils are dirty. Heat wheels are not present. Exterior ducting is not visible. Exterior ducting insulation is not present. Interior ducting is not visible. Interior ducting insulation is in an unknown condition. Interior ducting is of unknown cleanliness. Air handling room is free of trash/chemicals. Outside damper is open, and its condition is good. Return damper is inaccessible, and its condition is not known. The general condition of the unit is good.

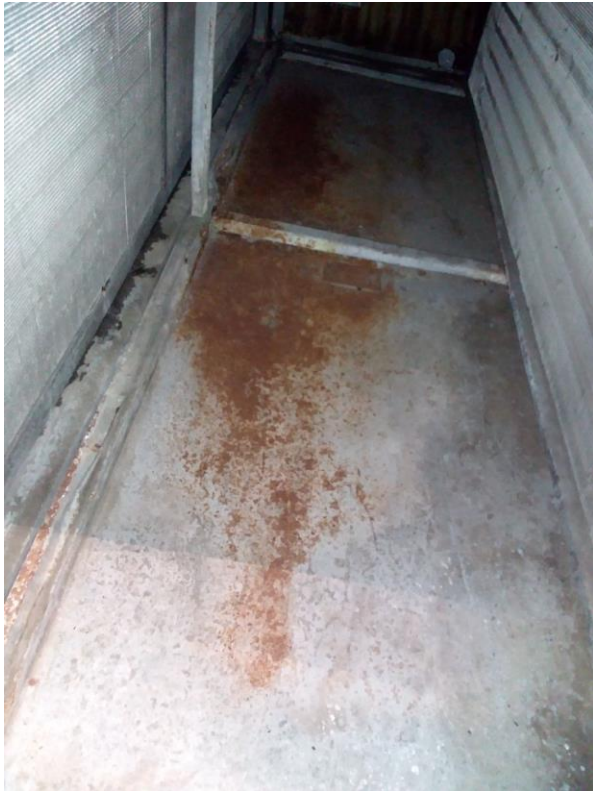
HVU_17
Drain Pans

Unit Designation:	HVU_17	
Location of Unit:	Mechanical Room above pool deck	
Areas Served:	Pool See attached map	
System Enhancements:	None	
Supply System	Outdoor Air	Cleanliness and Observations
Type <ul style="list-style-type: none"> Supply System - Constant Volume Heating - Steam Cooling - Chilled Water Energy Recovery Unit (ERU) - None 	<p>Outdoor air intake is inaccessible</p> <p>Outdoor air intake is located on an exterior wall.</p> <p>It is not known if there are nearby pollution sources.</p> <p>Outdoor air intake is in good condition.</p>	<p>Outdoor air filters are not present.</p> <p>Return air filters are not present.</p> <p>Mixed air pre-filters are not present. Mixed air main filters are clean and not in need of replacement (scoring 1 out of 5) and fit well. Mixed air main filters are installed correctly.</p> <p>Drain pans are not plugged. Drain pan condition is poor.</p> <p>Heating coils are clean and cooling coils are clean.</p> <p>Heat wheels are not present.</p> <p>Exterior ducting is visible. Exterior ducting insulation is not present.</p> <p>Interior ducting is visible. Interior ducting insulation is not present. Interior ducting is of unknown cleanliness.</p> <p>Air handling room is free of trash/chemicals.</p> <p>Outside damper is open, and its condition is good.</p> <p>Return damper is open, and its condition is good.</p> <p>The general condition of the unit is good.</p>

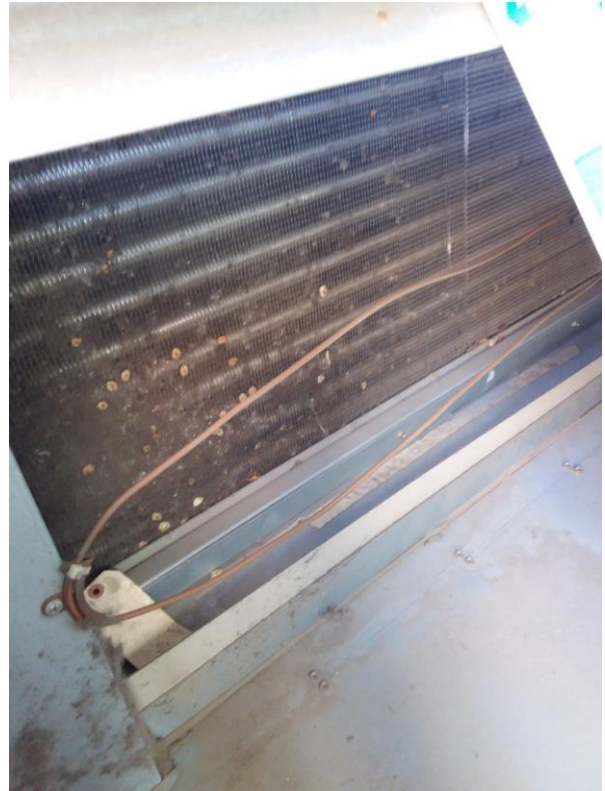
RTU_02
Heating Coils

Unit Designation:	RTU_02	
Location of Unit:	Mechanical room rooftop	
Areas Served:	Fitness Center See attached map	
System Enhancements:	None	
Supply System	Outdoor Air	Cleanliness and Observations
Type <ul style="list-style-type: none"> Supply System - Constant Volume Heating - Hot Water Cooling - None Energy Recovery Unit (ERU) - None 	Outdoor air intake is accessible Outdoor air intake is located on the roof. No nearby pollution sources were found.	Outdoor air pre-filters are not present. Outdoor air main filters are clean and not in need of replacement (scoring 2 out of 5) and fit well. Outdoor air main filters are installed correctly. Return air filters are not present. Drain pans are not plugged. Drain pan condition is good. Heating coils are dirty.
Filter Type - Outdoor <ul style="list-style-type: none"> Pre-filter: None Main filter: Pleated, MERV 8 	Outdoor air intake is in good condition.	Heat wheels are not present. Exterior ducting is not visible. Exterior ducting insulation is not present. Interior ducting is visible. Interior ducting insulation is in good condition. Interior ducting is clean. Air handling room is free of trash/chemicals. Outside damper is open, and its condition is good. Return damper is not present. The general condition of the unit is good.

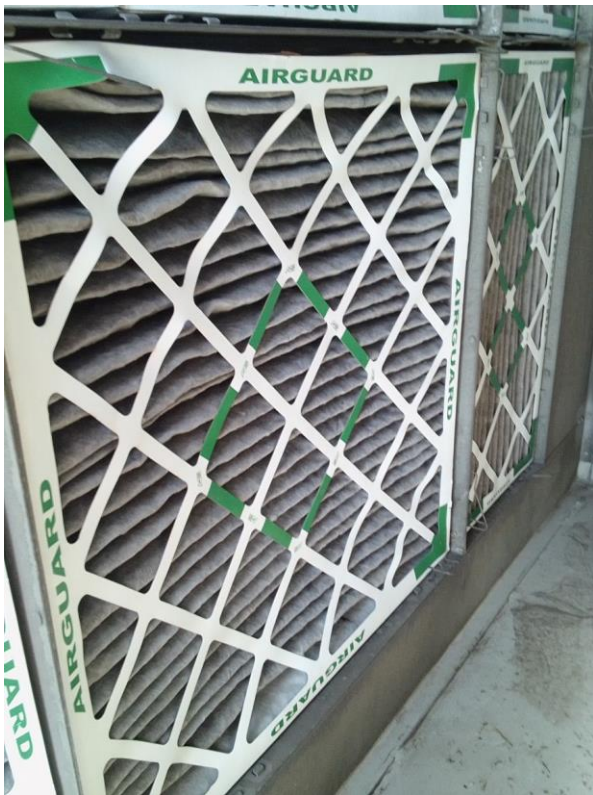
RTU_03
Mixed Main Filter Cleanliness

Unit Designation:	RTU_03	
Location of Unit:	Rooftop near baseball field	
Areas Served:	See attached map.	
System Enhancements:	None	
Supply System	Outdoor Air	Cleanliness and Observations
Type <ul style="list-style-type: none"> Supply System - Unknown Heating - Hot Water Cooling - None Energy Recovery Unit (ERU) - None 	Outdoor air intake is accessible Outdoor air intake is located on the roof. No nearby pollution sources were found.	Outdoor air filters are not present. Return air filters are not present. Mixed air pre-filters are not present. Mixed air main filters are somewhat dirty and on the border of needing replacement (scoring 3 out of 5) and fit well. Mixed air main filters are installed correctly. Drain pans are not plugged. Drain pan condition is good. Heating coils are clean. Heat wheels are not present. Exterior ducting is not visible. Exterior ducting insulation is in an unknown condition. Interior ducting is not visible. Interior ducting insulation is in an unknown condition. Interior ducting is of unknown cleanliness. Air handling room is free of trash/chemicals. Outside damper is open, and its condition is good. Return damper is open, and its condition is good. The general condition of the unit is good.
