2023 - 2024 Ventilation Assessment

Saint Paul Public Schools Open World Learning

Assessment Date: Thursday, April 6, 2023

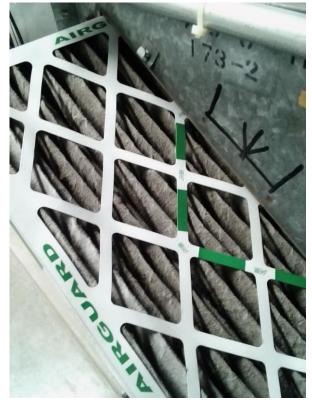
HVU 9 Return Pre-Filter Cleanliness

Unit Designation:	HVU 9	
Location of Unit:	Gym Storage	
Areas Served:	See attached map	
System Enhancements:		
Supply System	Outdoor Air	Cleanliness and Observations
Type Supply System - Constant Volume Heating - Hot Water Cooling - None Energy Recovery Unit (ERU) - None Filter Type - Return		Outdoor air filters are not present. Return air pre-filters are not present. Return air main filters are somewhat dirty and on the border of needing replacement (scoring 3 out of 5) and fit well. Return air main filters are installed correctly. Drain pans are not applicable or not present. Drain pan condition is not known. Heat wheels are not present. Exterior ducting is not visible. Exterior ducting insulation is not present. Interior ducting is not visible. Interior ducting insulation is not present. Interior ducting is of unknown cleanliness. Air handling room is free of trash/chemicals. Outside damper is not present. Return damper is inaccessible, and its condition is good.

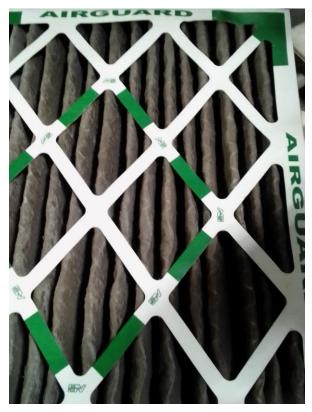
HVU 19 Mixed Main Filter Cleanliness

Unit Designation:	HVU 19	
Location of Unit:	Mechanical room 3208 A	
Areas Served:	See attached map	
System Enhancements:	None	
Supply System	Outdoor Air	Cleanliness and Observations
 Constant Volume Heating - Hot Water Cooling - None Energy Recovery Unit 	Outdoor air intake is accessible Outdoor air intake is located on an exterior wall. No nearby pollution sources	Outdoor air filters are not present. Return air filters are not present. Mixed air pre-filters are not present. Mixed air main filters are somewhat dirty and on the border of needing replacement (scoring 3 out of 5) and fit well. Mixed air main filters are installed correctly.
Pre-filter: None	were found. Outdoor air intake is in good condition.	Drain pans are not applicable or not present. Drain pan condition is not known. Heating coils are clean. Heat wheels are not present. Exterior ducting is visible. Exterior ducting insulation is not present. Interior ducting is not visible. Interior ducting insulation is in good condition. Interior ducting is clean. Air handling room is free of trash/chemicals. Outside damper is open, and its condition is good. Return damper is open, and its condition is good. The general condition of the unit is good.

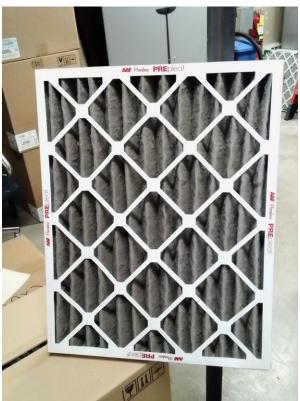
AHU 10 Mixed Main Filter Cleanliness

Unit Designation:	AHU 10	
Location of Unit:	Mechanical Room 2604	
Areas Served:	See attached map.	
	None	
Enhancements:		
Supply System	Outdoor Air	Cleanliness and Observations
 Supply System Constant Volume Heating - Steam Cooling - None Energy Recovery Unit (ERU) - None 	Outdoor air intake is inaccessible Outdoor air intake is located on the roof. It is not known if there are nearby pollution sources. Outdoor air intake is in good condition.	Outdoor air filters are not present. Return air filters are not present. Mixed air pre-filters are not present. Mixed air main filters are somewhat dirty and on the border of needing replacement (scoring 4 out of 5) and fit well. Mixed air main filters are installed correctly. Drain pans are not applicable or not present. Drain pan condition is not known. Heating coils are inaccessible. Heat wheels are not present. Exterior ducting is visible. Exterior ducting insulation is not present. Interior ducting is not visible. Interior ducting insulation is in an unknown condition. Interior ducting is of unknown cleanliness. Air handling room is free of trash/chemicals. Outside damper is inaccessible, and its condition is not known. Return damper is open, and its condition is good. The general condition of the unit is good.

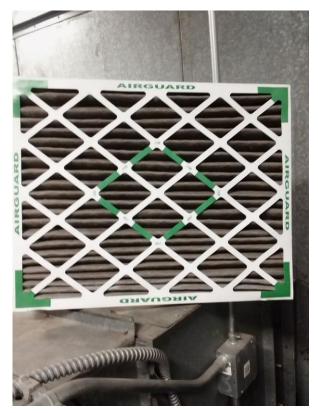
AHU 9 Mixed Main Filter Cleanliness

• • Filter Ty •	Supply System - Unknown Heating - Steam Cooling - None Energy Recovery Unit (ERU) - None pe - Mixed Pre-filter: None Main filter:	Outdoor air intake is accessible Outdoor air intake is located on an exterior wall. No nearby pollution sources were found. Outdoor air intake is in good condition.	Outdoor air filters are not present. Return air filters are not present. Mixed air pre-filters are not present. Mixed air main filters are somewhat dirty and on the border of needing replacement (scoring 4 out of 5) and fit well. Mixed air main filters are installed correctly. Drain pans are not applicable or not present. Drain pan condition is not known. Heating coils are inaccessible. Heat wheels are not present. Exterior ducting is visible. Exterior ducting insulation is not present. Interior ducting is not visible. Interior ducting insulation is in poor condition. Interior ducting is of unknown cleanliness. Air handling room is free of trash/chemicals. Outside damper is open, and its condition is good. Return damper is open, and its condition is good.

The accessible ductwork for unit AHU 9 was visibly dirty, damaged, or had evidence of moisture at the time of the site inspection.

Recommendation: IEA recommends further inspection into the overall condition of the interior ductwork and level of dirt/debris quantified. If deemed a concern, it is recommended that the interior ducting be cleaned by a professional contractor to improve the impact on the IAQ for the supply spaces.

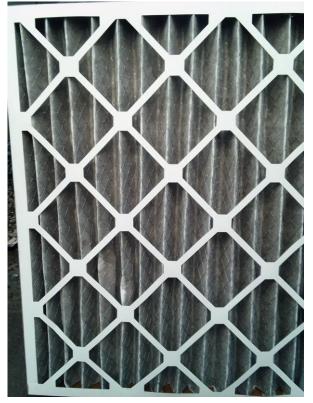
AHU 11 (RTU_11) Mixed Main Filter Cleanliness

Unit Designatio	n:	AHU 11 (RTU_11)	
Location of Unit	t:	Roof via stage access	
Areas Served:		Roof top on the stag See attached map	e
System Enhance	ements:	None	
Supply Syst	em	Outdoor Air	Cleanliness and Observations
Constar Volume • Heating Water	- Hot - None ry Unit Wheel xed er: None ter:	accessible Outdoor air intake is located on the roof. It is not known if there are nearby pollution sources. Outdoor air intake is in good condition.	Outdoor air filters are not present. Return air filters are not present. Mixed air pre-filters are not present. Mixed air main filters are somewhat dirty and on the border of needing replacement (scoring 3 out of 5) and fit well. Mixed air main filters are installed correctly. Drain pans are not applicable or not present. Drain pan condition is not known. Heating coils are inaccessible. Heat wheels are clean. Exterior ducting is visible. Exterior ducting insulation is not present. Interior ducting is visible. Interior ducting insulation is in good condition. Interior ducting is clean. Air handling room is free of trash/chemicals. Outside damper is inaccessible, and its condition is not known. Return damper is open, and its condition is good. The general condition of the unit is good.

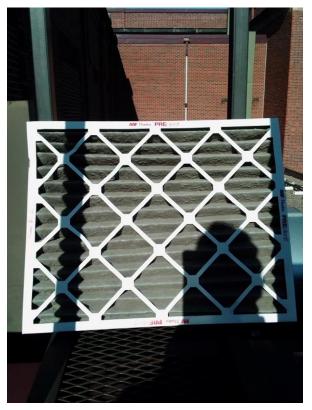
AHU 12 (RTU_12) Mixed Main Filter Cleanliness

•	Water Cooling - None Energy	Outdoor air intake is located on the roof. No nearby	Mixed air pre-filters are not present. Mixed air main filters are somewhat dirty and on the border of needing replacement (scoring 4 out of 5) and fit well. Mixed air main filters are installed correctly.	
	(ERU) - None		Drain pan plugged status is not known. Drain pan condition is not known.	
	ype - Mixed

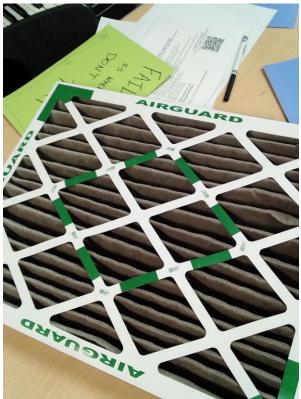
2116 CEILING Return Pre-Filter Cleanliness

Location of Unit: Room 2116 above Ceiling Areas Served: See attached map. System None Enhancements: Control of the state of		ion: 2116 CEILING			
System None Enhancements:	cation of Unit:	nit: Room 2116 above Ce	Room 2116 above Ceiling		
Enhancements:	reas Served:	See attached map.	See attached map.		
	Supply System		Cleanliness and Observations		
Volume • Heating - None • Cooling - None • Energy Recovery Unit (ERU) - NoneOutdoor air intake is in good condition.are somewhat dirty and on the border of needing replacement (scoring 3 out of 5) and fit well. Return air main filters are installed correctly.Filter Type - Return • Pre-filter: • Main filter: • Pleated, MERVIt is not known if there are nearby pollution sources.Drain pans are not applicable or not present. Drain pan condition is not known.• Pre-filter: • Pre-filter: • Pleated, MERVOutdoor air intake is in good condition.Heat wheels are not present.	 Supply System Constant Volume Heating - None Cooling - None Energy Recovery Unit (ERU) - None Iter Type - Return Pre-filter: None Main filter: Pleated, MERV 	y System inaccessible itant be Outdoor air intake is located in an located in an located in an located in an unknown location. y ery Unit It is not known if - None there are nearby pollution sources. <u>eturn</u> ter: Outdoor air intake is in good condition.	Return air pre-filters are not present. Return air main filters are somewhat dirty and on the border of needing replacement (scoring 3 out of 5) and fit well. Return air main filters are installed correctly. Drain pans are not applicable or not present. Drain pan condition is not known. Heat wheels are not present. Exterior ducting is not visible. Exterior ducting insulation is in an unknown condition. Interior ducting is visible. Interior ducting insulation is not present. Interior ducting is clean. Air handling room is free of trash/chemicals. Outside damper is not present. Return damper is open, and its condition is good.

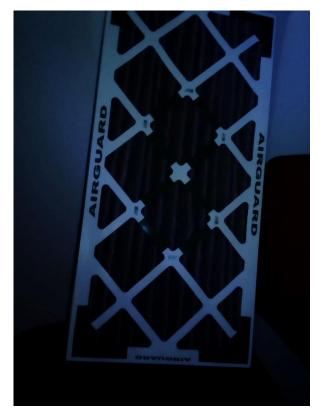
AHU 13 Outdoor Main Filter Cleanliness

Unit Designation:	AHU 13		
	Unlabeled Mechanical Room on mezzanine between floors 1 and 2 (Theater Area)		
Areas Served:	OWL Gym		
System Enhancements:	None		
Supply System	Outdoor Air Cleanliness and Observations		
 Supply System - Constant Volume Heating - Steam Cooling - Dx Energy Recovery Unit (ERU) - Fixed 	inaccessible Outdoor air intake is	Outdoor air pre-filters are not present. Outdoor air main filters are somewhat dirty and on the border of needing replacement (scoring 3 out of 5) and fit well. Outdoor air main filters are installed correctly. Return air pre-filters are not present. Return air main filters are clean and not in need of replacement (scoring 2 out of 5) and fit well. Return air main filters are installed correctly. Drain pans are not plugged. Drain pan condition is good.	
	Outdoor air intake is in good condition.	 Heating coils are clean and cooling coils are clean. Heat wheels are inaccessible. Exterior ducting is visible. Exterior ducting insulation is in good condition. Interior ducting is not visible. Interior ducting insulation is in an unknown condition. Interior ducting is of unknown cleanliness. Air handling room is free of trash/chemicals. Outside damper is open, and its condition is good. Return damper is open, and its condition is good. The general condition of the unit is good.
