## 2022 - 2023 IAQ Walkthrough

## Saint Paul Public Schools Jie Ming Mandarin Immersion Academy

Walkthrough Date:  
Wednesday, January 18, 2023

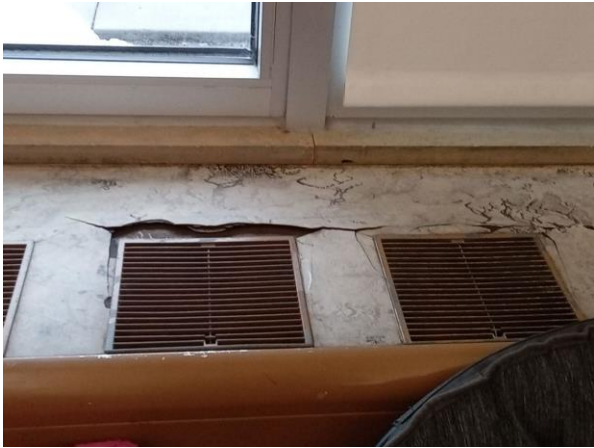
| Room / Location | Number of Occupants | Odor Present | Observations | Dust Accumulation | CO <sub>2</sub> (ppm) | CO (ppm) | RH (%) | Temp (°F) |
|---|---|---|---|---|---|---|---|---|
| 1205 | 8 | No | <ul style="list-style-type: none"> <li>Moisture Impacted Materials: See Appendix A</li> <li>Plants</li> </ul> | No | 886 | 0.5 | 27.2 | 71.4 |

Moisture Impacted Materials

Moisture-impacted building materials should be repaired or replaced when discoloration or water staining is observed. Moisture-impacted building materials can be a source for microbial growth. The source for the moisture infiltration should be investigated and repaired if not easily identified.
