IEA, INC.

2023 - 2024 Ventilation Assessment

Saint Paul Public Schools Johnson Senior High School

Assessment Date:
Thursday, April 6, 2023

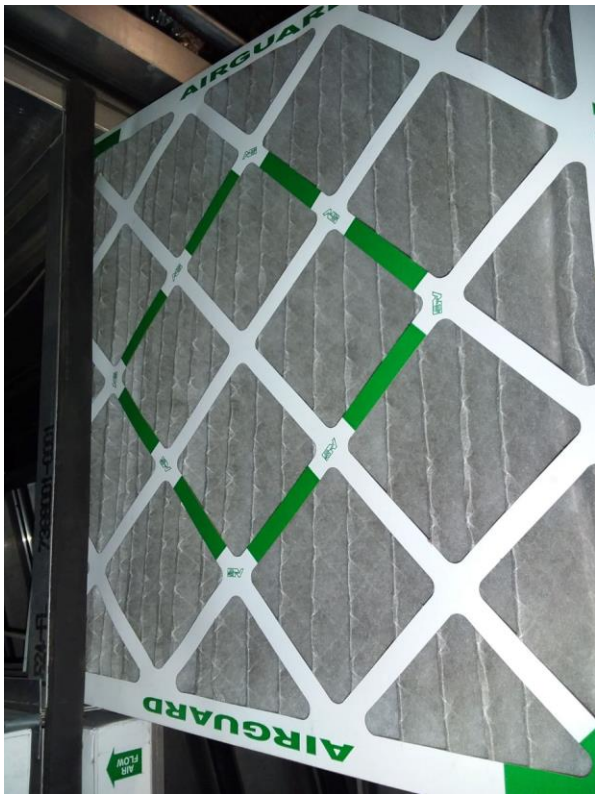
Unit Designation:	AHU-01	
Location of Unit:	Pool mechanical room 211 outside stairwell/206 locker room	
Areas Served:	See attached map.	
System Enhancements:	None	
Supply System	Outdoor Air	Cleanliness and Observations
Type <ul style="list-style-type: none"> Supply System - Unknown Heating - Hot Water Cooling - Chilled Water Energy Recovery Unit (ERU) - None 	<p>Outdoor air intake is inaccessible</p> <p>Outdoor air intake is located on an exterior wall.</p> <p>It is not known if there are nearby pollution sources.</p>	<p>Outdoor air filters are not present.</p> <p>Return air filters are not present.</p> <p>Mixed air filters are somewhat dirty and on the border of needing replacement (scoring 4 out of 5) and fit well. Mixed air filters are installed correctly.</p> <p>Drain pans are not plugged. Drain pan condition is poor.</p>
Filter Type - Mixed <ul style="list-style-type: none"> Pre-filter: Pleated, MERV 8 Main filter: Pleated, MERV 13 	<p>Outdoor air intake is in good condition.</p>	<p>Heating coils are clean and cooling coils are clean.</p> <p>Heat wheels are not present.</p> <p>Exterior ducting is visible. Exterior ducting insulation is in good condition.</p> <p>Interior ducting is not visible. Interior ducting insulation is in an unknown condition. Interior ducting is of unknown cleanliness.</p> <p>Air handling room is free of trash/chemicals.</p> <p>Outside damper is inaccessible, and its condition is good.</p> <p>Return damper is inaccessible, and its condition is good.</p> <p>The general condition of the unit is good.</p>

Mixed Pre-Filter Cleanliness

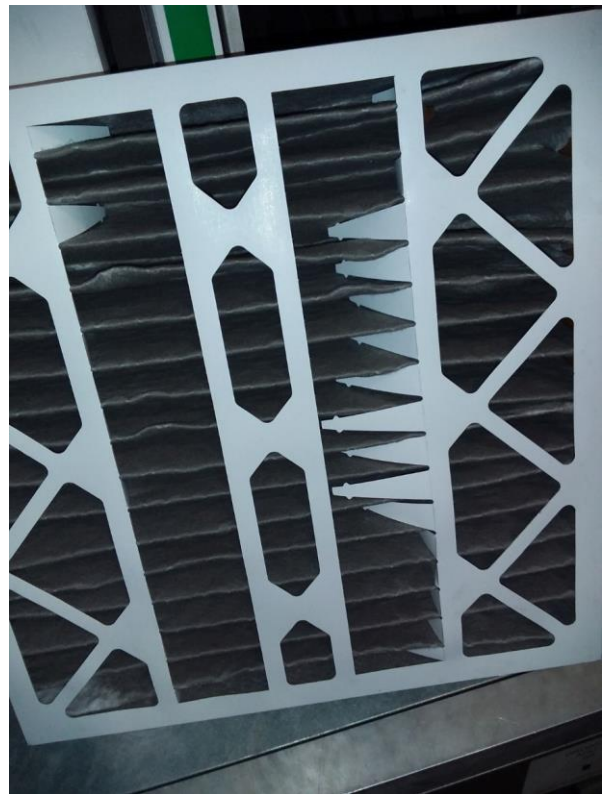
AHU-01

Mixed Main Filter Cleanliness

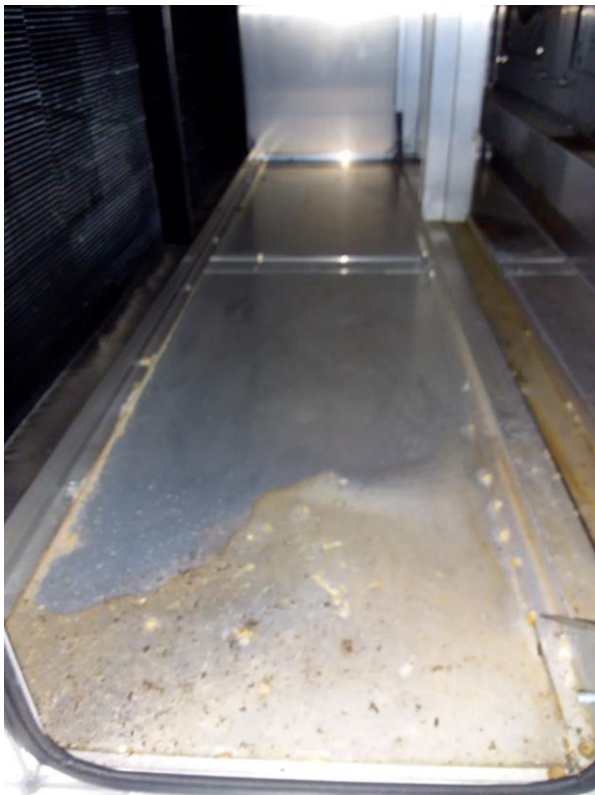
AHU-01

The drain pan for units AHU-01, AHU-09, AHU-10, AHU-13, UV 2107, UV 2112, UV 2114, UV 2203 and UV 2207 was plugged or damaged at the time of the site inspection.

Drain Pans

Recommendation: Damage to the drain pan should be repaired, or the drain pan should be inspected more frequently to ensure that it does not become plugged.

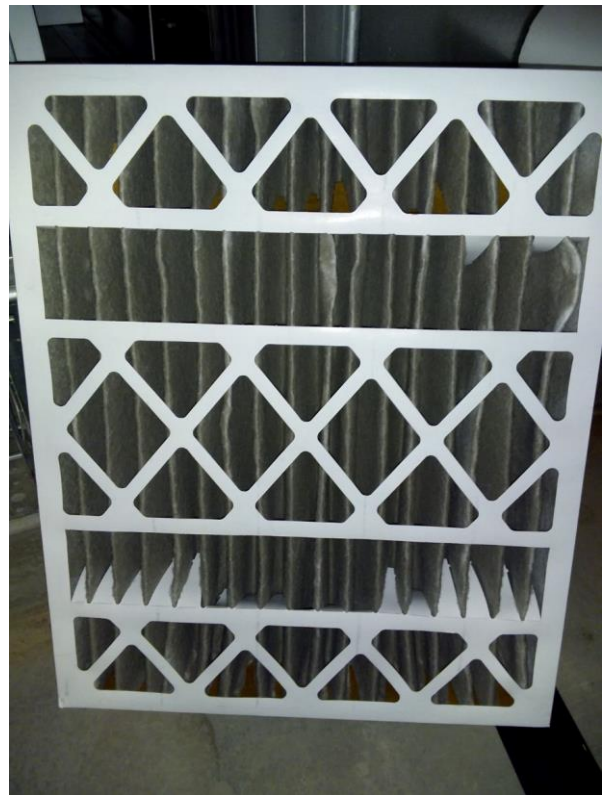
Unit Designation:	AHU-02	
Location of Unit:	Electrical room 0405	
Areas Served:	See attached map Boys Varsity Locker Room	
System Enhancements:	None	
Supply System	Outdoor Air	Cleanliness and Observations
Type <ul style="list-style-type: none"> Supply System - VAV Heating - Hot Water Cooling - Chilled Water Energy Recovery Unit (ERU) - None 	Outdoor air intake is inaccessible Outdoor air intake is located on an exterior wall. It is not known if there are nearby pollution sources. Outdoor air intake is in good condition.	Outdoor air filters are not present. Return air filters are not present. Mixed air pre-filters are clean and not in need of replacement (scoring 2 out of 5) and fit well. Mixed air pre-filters are installed correctly. Mixed air main filters are somewhat dirty and on the border of needing replacement (scoring 3 out of 5) and fit well. Mixed air main filters are installed correctly. Drain pans are not plugged. Drain pan condition is good. Heating coils are clean and cooling coils are clean. Heat wheels are not present. Exterior ducting is visible. Exterior ducting insulation is in good condition. Interior ducting is not visible. Interior ducting insulation is in an unknown condition. Interior ducting is of unknown cleanliness. Air handling room is free of trash/chemicals. Outside damper is open, and its condition is good. Return damper is open, and its condition is good. The general condition of the unit is good.

Mixed Main Filter Cleanliness

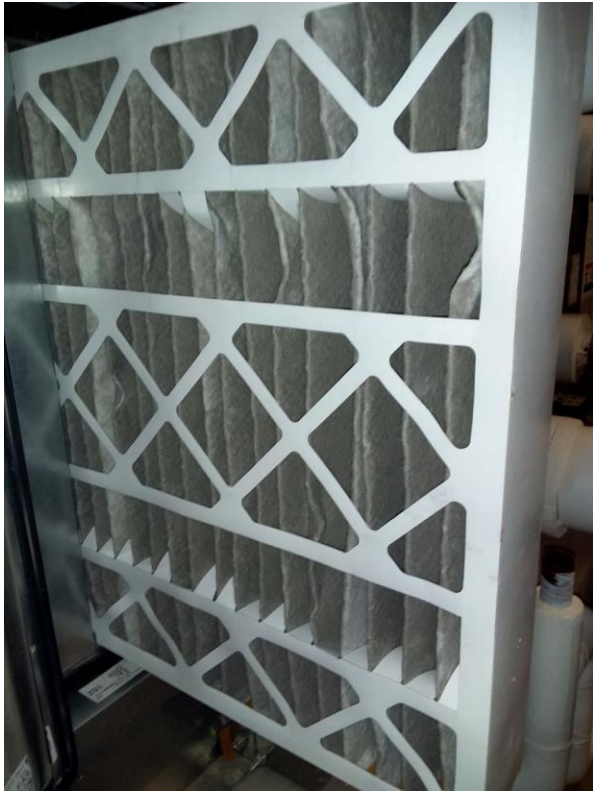
Unit Designation:	AHU-04	
Location of Unit:	Mechanical 0403 inside wrestling	
Areas Served:	See attached map Girls Locker Room	
System Enhancements:	None	
Supply System	Outdoor Air	Cleanliness and Observations
Type <ul style="list-style-type: none"> • Supply System - VAV • Heating - Hot Water • Cooling - Chilled Water • Energy Recovery Unit (ERU) - None 	<p>Outdoor air intake is inaccessible</p> <p>Outdoor air intake is located on an exterior wall.</p> <p>It is not known if there are nearby pollution sources.</p> <p>Outdoor air intake is in good condition.</p>	<p>Outdoor air filters are not present.</p> <p>Return air filters are not present.</p> <p>Mixed air pre-filters are clean and not in need of replacement (scoring 2 out of 5) and fit well. Mixed air pre-filters are installed correctly. Mixed air main filters are somewhat dirty and on the border of needing replacement (scoring 3 out of 5) and fit well. Mixed air main filters are installed correctly.</p> <p>Drain pans are not plugged. Drain pan condition is good.</p> <p>Heating coils are clean and cooling coils are dirty.</p> <p>Heat wheels are not present.</p> <p>Exterior ducting is visible. Exterior ducting insulation is in good condition.</p> <p>Interior ducting is not visible. Interior ducting insulation is in an unknown condition. Interior ducting is of unknown cleanliness.</p> <p>Air handling room is free of trash/chemicals.</p> <p>Outside damper is open, and its condition is good.</p> <p>Return damper is open, and its condition is good.</p> <p>The general condition of the unit is good.</p>

Mixed Main Filter Cleanliness

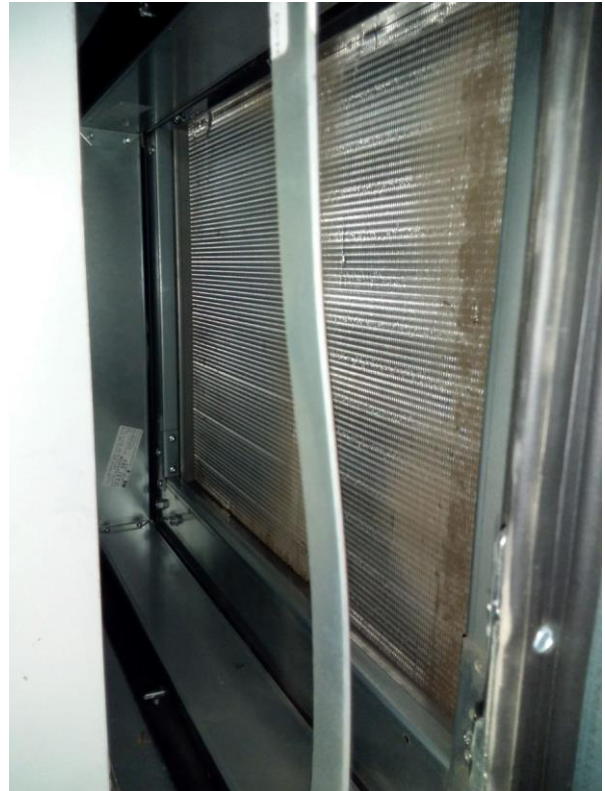
AHU-04

Dirty Coils were observed on units AHU-04, AHU-09 and AHU-20 during the ventilation inspection.

Cooling Coils

Recommendation: Impacted/dirty coils can result in poor ventilation air supply as well as be a source for mold and bacterial growth on the coils. Coils should be cleaned annually, or as needed, as identified in the operations and maintenance program.

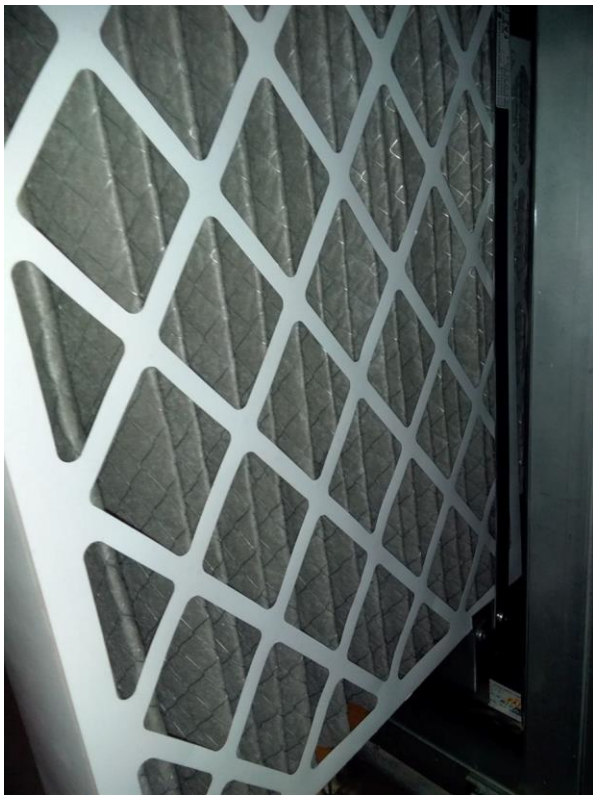
Unit Designation:	AHU-4A	
Location of Unit:	Tunnel near wrestling	
Areas Served:	See attached map Locker Rooms	
System Enhancements:	None	
Supply System	Outdoor Air	Cleanliness and Observations
Type <ul style="list-style-type: none"> Supply System - VAV Heating - Hot Water Cooling - Chilled Water Energy Recovery Unit (ERU) - None 	<p>Outdoor air intake is inaccessible</p> <p>Outdoor air intake is located in an unknown location.</p> <p>It is not known if there are nearby pollution sources.</p> <p>Outdoor air intake is in good condition.</p>	<p>Outdoor air filters are not present.</p> <p>Return air filters are not present.</p> <p>Mixed air pre-filters are clean and not in need of replacement (scoring 2 out of 5) and fit well. Mixed air pre-filters are installed correctly. Mixed air main filters are somewhat dirty and on the border of needing replacement (scoring 3 out of 5) and fit well. Mixed air main filters are installed correctly.</p> <p>Drain pans are not plugged. Drain pan condition is good.</p> <p>Heating coils are clean and cooling coils are clean.</p> <p>Heat wheels are not present.</p> <p>Exterior ducting is visible. Exterior ducting insulation is in good condition.</p> <p>Interior ducting is not visible. Interior ducting insulation is in an unknown condition. Interior ducting is of unknown cleanliness.</p> <p>Air handling room is free of trash/chemicals.</p> <p>Outside damper is open, and its condition is good.</p> <p>Return damper is open, and its condition is good.</p> <p>The general condition of the unit is good.</p>

Mixed Main Filter Cleanliness

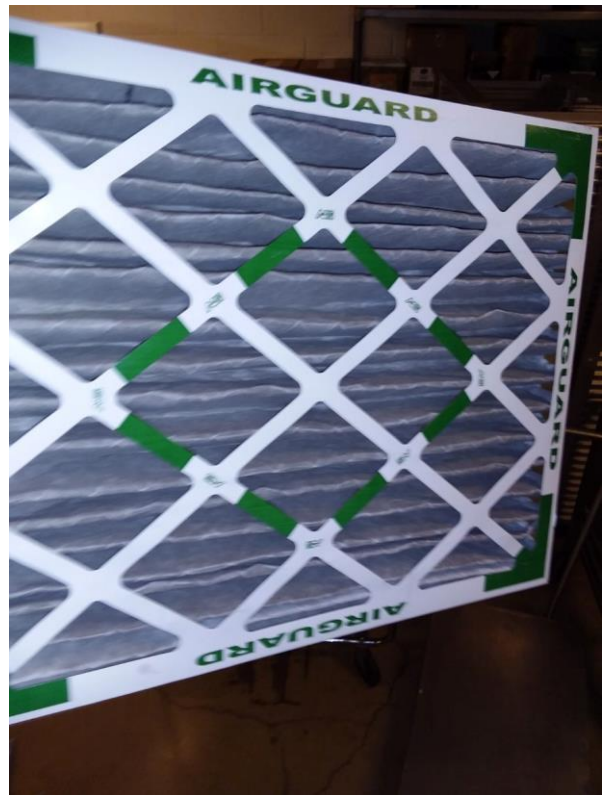
Unit Designation:	AHU-05	
Location of Unit:	Kitchen Storage 1412	
Areas Served:	See attached map Kitchen & Hood Exhaust Fan	
System Enhancements:	None	
Supply System	Outdoor Air	Cleanliness and Observations
Type <ul style="list-style-type: none"> Supply System - Constant Volume Heating - Hot Water Cooling - None Energy Recovery Unit (ERU) - None 	<p>Outdoor air intake is inaccessible</p> <p>Outdoor air intake is located on an exterior wall.</p> <p>It is not known if there are nearby pollution sources.</p>	<p>Outdoor air filters are not present.</p> <p>Return air filters are not present.</p> <p>Mixed air pre-filters are not present. Mixed air main filters are somewhat dirty and on the border of needing replacement (scoring 4 out of 5) and fit well. Mixed air main filters are installed correctly.</p> <p>Drain pan plugged status is not known. Drain pan condition is good.</p>
Filter Type - Mixed <ul style="list-style-type: none"> Pre-filter: None Main filter: Pleated, MERV 11 	<p>Outdoor air intake is in good condition.</p>	<p>Heating coils are clean.</p> <p>Heat wheels are not present.</p> <p>Exterior ducting is visible. Exterior ducting insulation is in good condition.</p> <p>Interior ducting is not visible. Interior ducting insulation is in an unknown condition. Interior ducting is of unknown cleanliness.</p> <p>Air handling room is free of trash/chemicals.</p> <p>Outside damper is inaccessible, and its condition is good.</p> <p>Return damper is inaccessible, and its condition is good.</p> <p>The general condition of the unit is good.</p>

Mixed Main Filter Cleanliness

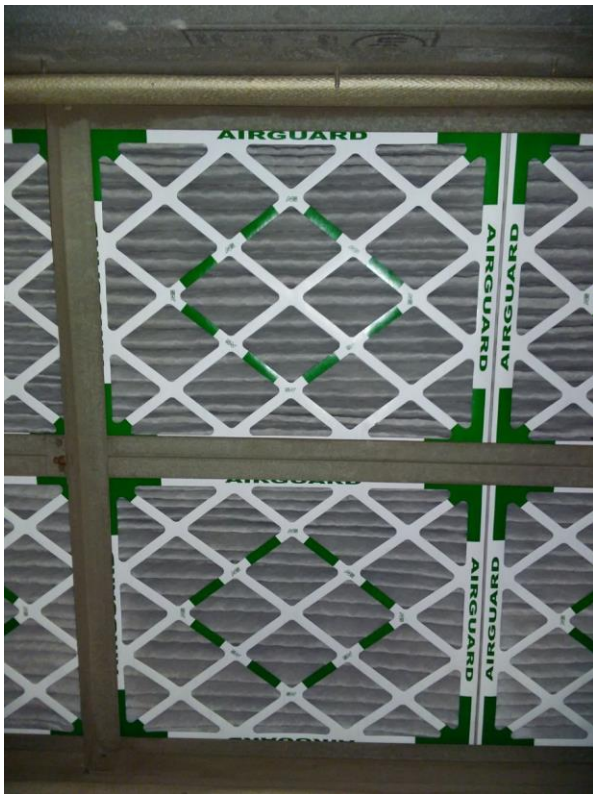
Unit Designation:	AHU-09	
Location of Unit:	W Penthouse	
Areas Served:	See attached map Band room	
System Enhancements:	None	
Supply System	Outdoor Air	Cleanliness and Observations
Type <ul style="list-style-type: none"> Supply System - Constant Volume Heating - Hot Water Cooling - None Energy Recovery Unit (ERU) - None 	<p>Outdoor air intake is inaccessible</p> <p>Outdoor air intake is located on an exterior wall.</p> <p>It is not known if there are nearby pollution sources.</p>	<p>Outdoor air filters are not present.</p> <p>Return air filters are not present.</p> <p>Mixed air pre-filters are not present. Mixed air main filters are somewhat dirty and on the border of needing replacement (scoring 3 out of 5) and fit well. Mixed air main filters are installed correctly.</p> <p>Drain pans are not plugged. Drain pan condition is poor.</p>
Filter Type - Mixed <ul style="list-style-type: none"> Pre-filter: None Main filter: Pleated, MERV 11 	<p>Outdoor air intake is in good condition.</p>	<p>Heating coils are dirty.</p> <p>Heat wheels are not present.</p> <p>Exterior ducting is visible. Exterior ducting insulation is in an unknown condition.</p> <p>Interior ducting is not visible. Interior ducting insulation is in good condition. Interior ducting is of unknown cleanliness.</p> <p>Air handling room is free of trash/chemicals.</p> <p>Outside damper is open, and its condition is good.</p> <p>Return damper is inaccessible, and its condition is not known.</p> <p>The general condition of the unit is good.</p>

Mixed Main Filter Cleanliness

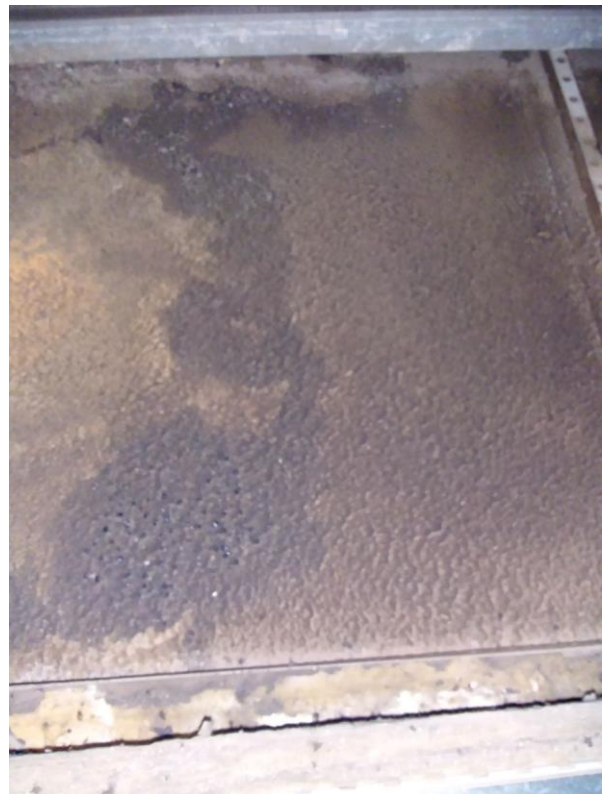
AHU-09

Drain Pans

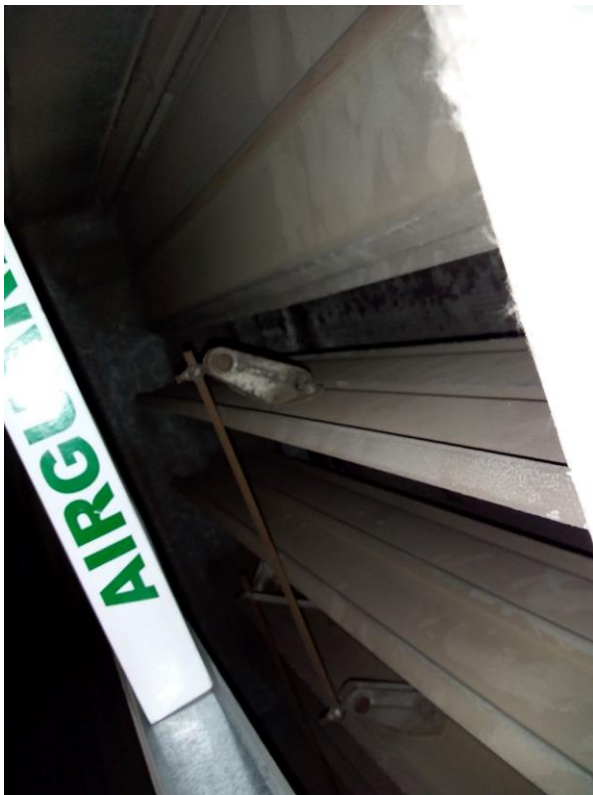
AHU-09

Heating Coils

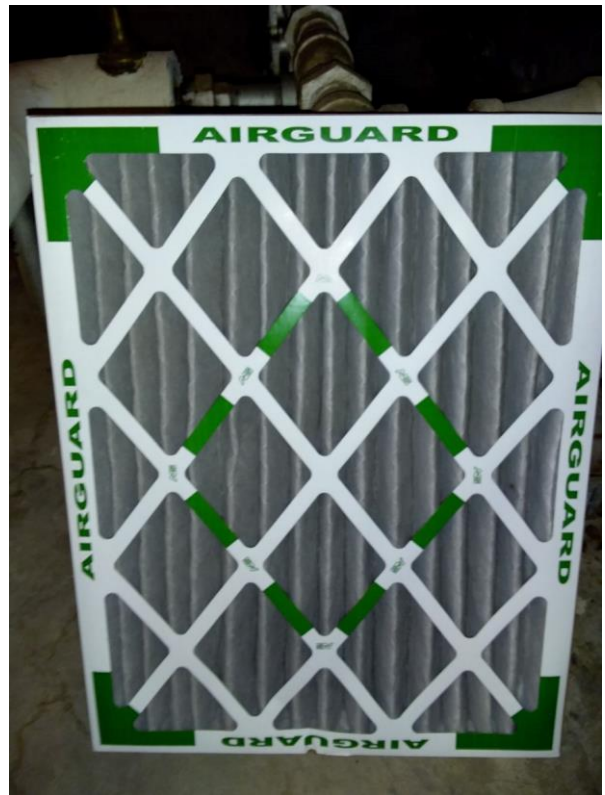
Unit Designation:	AHU-10	
Location of Unit:	E Penthouse	
Areas Served:	See attached map Room 2402 / Choir	
System Enhancements:	None	
Supply System	Outdoor Air	Cleanliness and Observations
Type <ul style="list-style-type: none"> Supply System - Constant Volume Heating - Hot Water Cooling - None Energy Recovery Unit (ERU) - None 	<p>Outdoor air intake is inaccessible</p> <p>Outdoor air intake is located on the roof.</p> <p>It is not known if there are nearby pollution sources.</p> <p>Outdoor air intake is in good condition.</p>	<p>Outdoor air filters are not present.</p> <p>Return air filters are not present.</p> <p>Mixed air pre-filters are not present. Mixed air main filters are somewhat dirty and on the border of needing replacement (scoring 3 out of 5) and fit well. Mixed air main filters are installed correctly.</p> <p>Drain pans are plugged. Drain pan condition is good.</p> <p>Heating coils are clean.</p> <p>Heat wheels are not present.</p> <p>Exterior ducting is visible. Exterior ducting insulation is not present.</p> <p>Interior ducting is not visible. Interior ducting insulation is in an unknown condition. Interior ducting is of unknown cleanliness.</p> <p>Air handling room is free of trash/chemicals.</p> <p>Outside damper is open, and its condition is good.</p> <p>Return damper is open, and its condition is good.</p> <p>The general condition of the unit is poor.</p>

The general condition of units AHU-10, RTU-02, UV 2107, UV 2114 and UV 2203 was poor.

Mixed Main Filter Cleanliness

Recommendation: The units should be repaired or cleaned as needed.

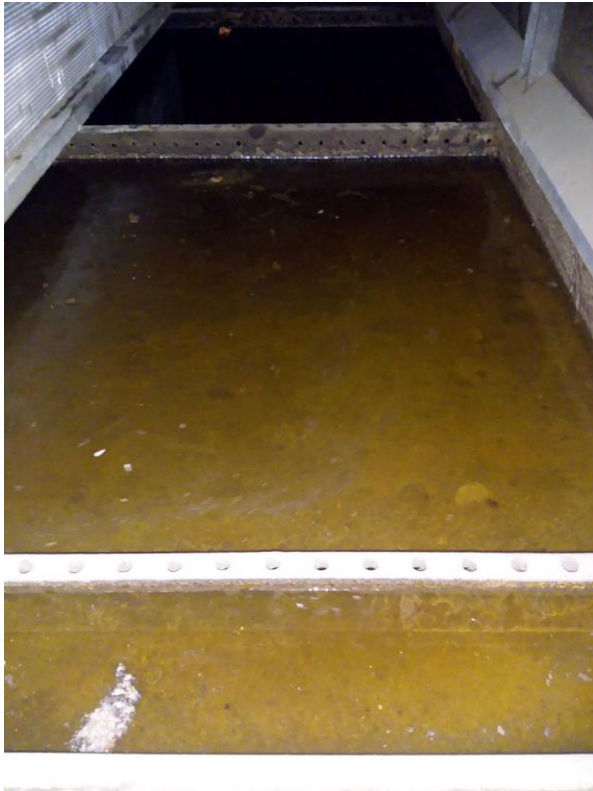
AHU-10
Drain Pans

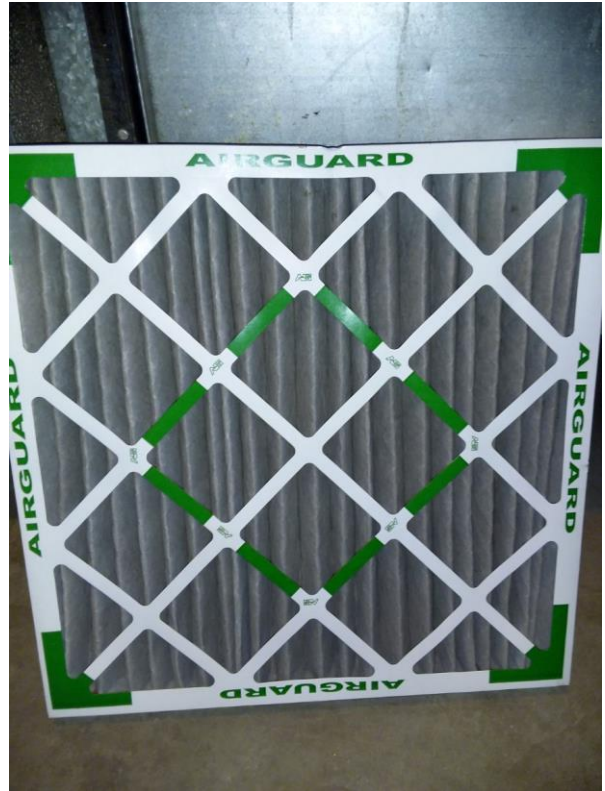
Unit Designation:	AHU-11	
Location of Unit:	E Penthouse	
Areas Served:	Auditorium and Dressing Rooms	
System Enhancements:	None	
Supply System	Outdoor Air	Cleanliness and Observations
Type <ul style="list-style-type: none"> Supply System - Constant Volume Heating - Hot Water Cooling - None Energy Recovery Unit (ERU) - None 	<p>Outdoor air intake is inaccessible</p> <p>Outdoor air intake is located on the roof.</p> <p>It is not known if there are nearby pollution sources.</p> <p>Outdoor air intake is in good condition.</p>	<p>Outdoor air filters are not present.</p> <p>Return air filters are not present.</p> <p>Mixed air pre-filters are not present. Mixed air main filters are somewhat dirty and on the border of needing replacement (scoring 3 out of 5) and fit well. Mixed air main filters are installed correctly.</p> <p>Drain pans are not applicable or not present. Drain pan condition is not known.</p> <p>Heating coils are clean.</p> <p>Heat wheels are not present.</p> <p>Exterior ducting is visible. Exterior ducting insulation is not present.</p> <p>Interior ducting is not visible. Interior ducting insulation is in an unknown condition. Interior ducting is of unknown cleanliness.</p> <p>Air handling room is free of trash/chemicals.</p> <p>Outside damper is open, and its condition is good.</p> <p>Return damper is open, and its condition is good.</p> <p>The general condition of the unit is good.</p>

AHU-11
Mixed Main Filter Cleanliness

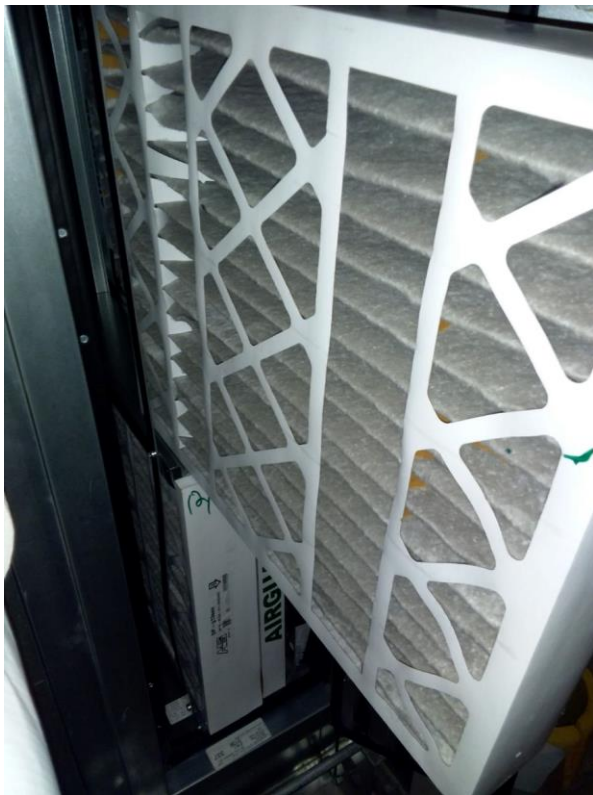
Unit Designation:	AHU-12	
Location of Unit:	0215C	
Areas Served:	See attached map Ground Floor Classrooms	
System Enhancements:	None	
Supply System	Outdoor Air	Cleanliness and Observations
Type <ul style="list-style-type: none"> • Supply System - VAV • Heating - Hot Water • Cooling - Chilled Water • Energy Recovery Unit (ERU) - None 	<p>Outdoor air intake is inaccessible</p> <p>Outdoor air intake is located in an unknown location.</p> <p>It is not known if there are nearby pollution sources.</p> <p>Outdoor air intake is in good condition.</p>	<p>Outdoor air filters are not present.</p> <p>Return air filters are not present.</p> <p>Mixed air pre-filters are clean and not in need of replacement (scoring 2 out of 5) and fit well. Mixed air pre-filters are installed correctly. Mixed air main filters are somewhat dirty and on the border of needing replacement (scoring 3 out of 5) and fit well. Mixed air main filters are installed correctly.</p> <p>Drain pans are not plugged. Drain pan condition is good.</p> <p>Heating coils are clean and cooling coils are clean.</p> <p>Heat wheels are not present.</p> <p>Exterior ducting is visible. Exterior ducting insulation is in good condition.</p> <p>Interior ducting is not visible. Interior ducting insulation is in an unknown condition. Interior ducting is of unknown cleanliness.</p> <p>Air handling room is free of trash/chemicals.</p> <p>Outside damper is open, and its condition is good.</p> <p>Return damper is inaccessible, and its condition is not known.</p> <p>The general condition of the unit is good.</p>

AHU-12
Mixed Main Filter Cleanliness

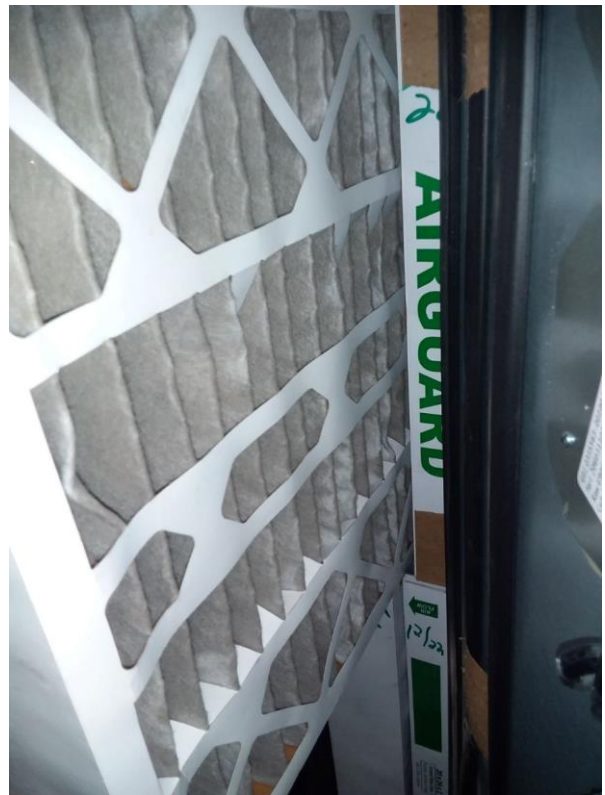
Unit Designation:	AHU-13	
Location of Unit:	0215C	
Areas Served:	See attached map classrooms to west & south of north courtyard	
System Enhancements:	None	
Supply System	Outdoor Air	Cleanliness and Observations
Type <ul style="list-style-type: none"> Supply System - VAV Heating - Hot Water Cooling - Chilled Water Energy Recovery Unit (ERU) - None 	Outdoor air intake is inaccessible Outdoor air intake is located in an unknown location. It is not known if there are nearby pollution sources. Outdoor air intake is in good condition.	Outdoor air filters are not present. Return air filters are not present. Mixed air pre-filters are clean and not in need of replacement (scoring 2 out of 5) and fit well. Mixed air pre-filters are installed correctly. Mixed air main filters are somewhat dirty and on the border of needing replacement (scoring 3 out of 5) and fit well. Mixed air main filters are installed correctly. Drain pans are not plugged. Drain pan condition is poor. Heating coils are clean and cooling coils are clean. Heat wheels are not present. Exterior ducting is visible. Exterior ducting insulation is in good condition. Interior ducting is not visible. Interior ducting insulation is in an unknown condition. Interior ducting is of unknown cleanliness. Air handling room is free of trash/chemicals. Outside damper is inaccessible, and its condition is not known. Return damper is inaccessible, and its condition is not known. The general condition of the unit is good.

AHU-13
Mixed Main Filter Cleanliness

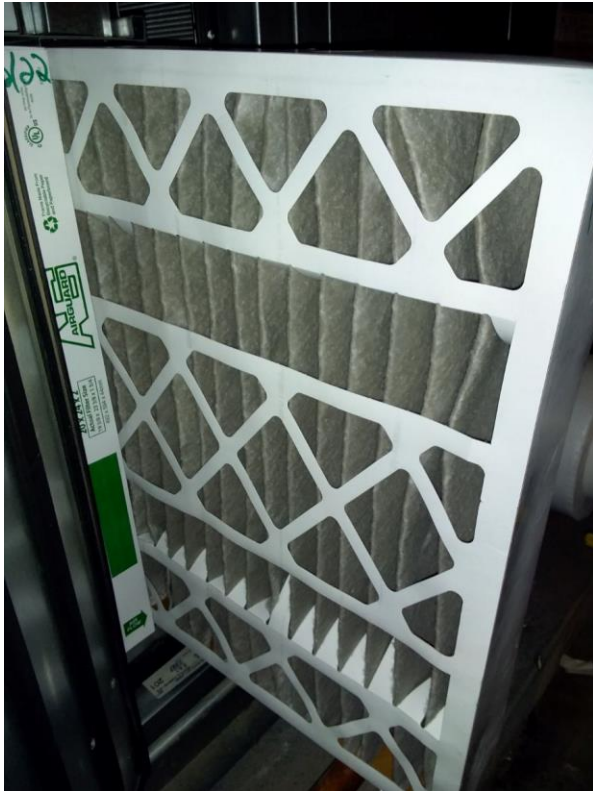
Unit Designation:	AHU-13A	
Location of Unit:	0215C	
Areas Served:	See attached map classrooms around south courtyard	
System Enhancements:	None	
Supply System	Outdoor Air	Cleanliness and Observations
Type <ul style="list-style-type: none"> Supply System - VAV Heating - Hot Water Cooling - Chilled Water Energy Recovery Unit (ERU) - None 	Outdoor air intake is inaccessible Outdoor air intake is located in an unknown location. It is not known if there are nearby pollution sources. Outdoor air intake is in good condition.	Outdoor air filters are not present. Return air filters are not present. Mixed air pre-filters are clean and not in need of replacement (scoring 2 out of 5) and fit well. Mixed air pre-filters are installed correctly. Mixed air main filters are somewhat dirty and on the border of needing replacement (scoring 3 out of 5) and fit well. Mixed air main filters are installed correctly. Drain pans are not plugged. Drain pan condition is good. Heating coils are clean and cooling coils are clean. Heat wheels are not present. Exterior ducting is visible. Exterior ducting insulation is in good condition. Interior ducting is not visible. Interior ducting insulation is in an unknown condition. Interior ducting is of unknown cleanliness. Air handling room is free of trash/chemicals. Outside damper is open, and its condition is good. Return damper is open, and its condition is good. The general condition of the unit is good.

Mixed Main Filter Cleanliness

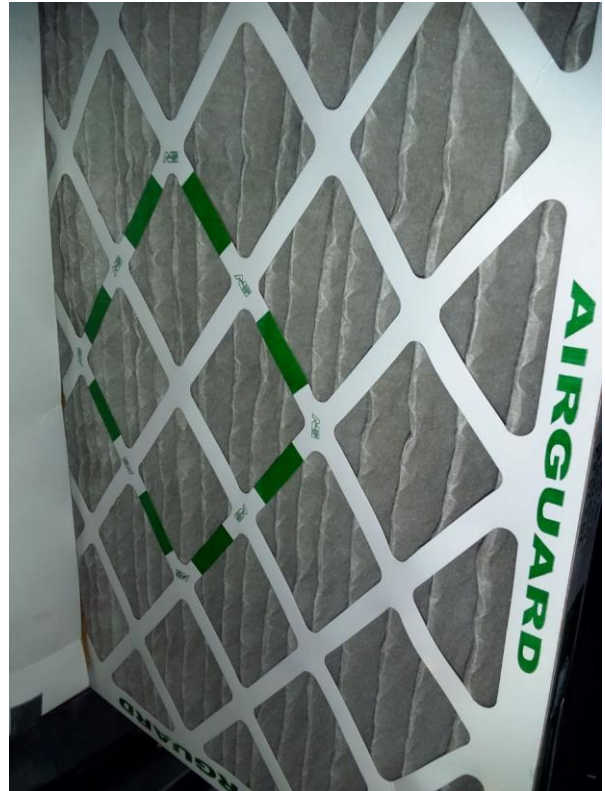
Unit Designation:	AHU-13B	
Location of Unit:	Crawl space SE	
Areas Served:	See attached map 1st Floor Classrooms	
System Enhancements:	None	
Supply System	Outdoor Air	Cleanliness and Observations
Type <ul style="list-style-type: none"> Supply System - VAV Heating - Hot Water Cooling - Chilled Water Energy Recovery Unit (ERU) - None 	<p>Outdoor air intake is inaccessible</p> <p>Outdoor air intake is located in an unknown location.</p> <p>It is not known if there are nearby pollution sources.</p>	<p>Outdoor air filters are not present.</p> <p>Return air filters are not present.</p> <p>Mixed air filters are somewhat dirty and on the border of needing replacement (scoring 3 out of 5) and fit well. Mixed air filters are installed correctly.</p> <p>Drain pans are not plugged. Drain pan condition is good.</p>
Filter Type - Mixed <ul style="list-style-type: none"> Pre-filter: Pleated, MERV 8 Main filter: Pleated, MERV 13 	<p>Outdoor air intake is in good condition.</p>	<p>Heating coils are clean and cooling coils are clean.</p> <p>Heat wheels are not present.</p> <p>Exterior ducting is visible. Exterior ducting insulation is in good condition.</p> <p>Interior ducting is not visible. Interior ducting insulation is in an unknown condition. Interior ducting is of unknown cleanliness.</p> <p>Air handling room is free of trash/chemicals.</p> <p>Outside damper is open, and its condition is good.</p> <p>Return damper is open, and its condition is good.</p> <p>The general condition of the unit is good.</p>

Mixed Pre-Filter Cleanliness

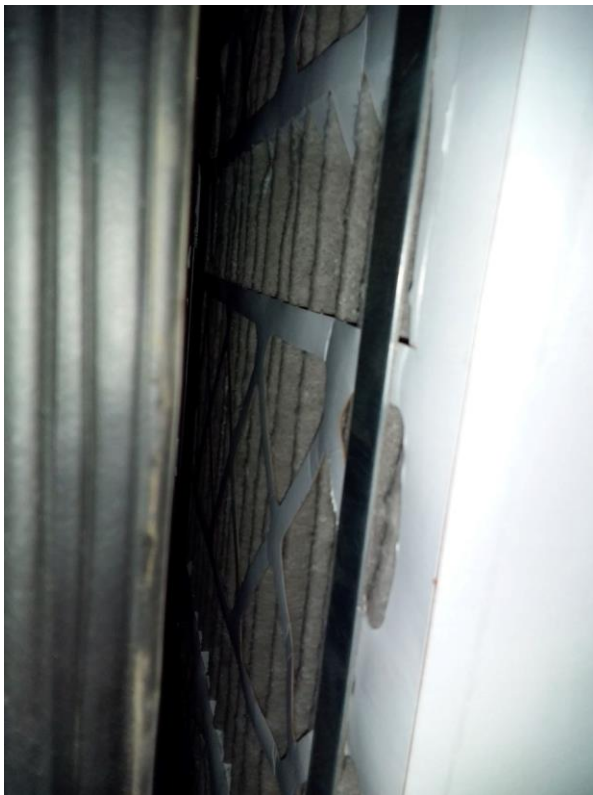
AHU-13B

Mixed Main Filter Cleanliness

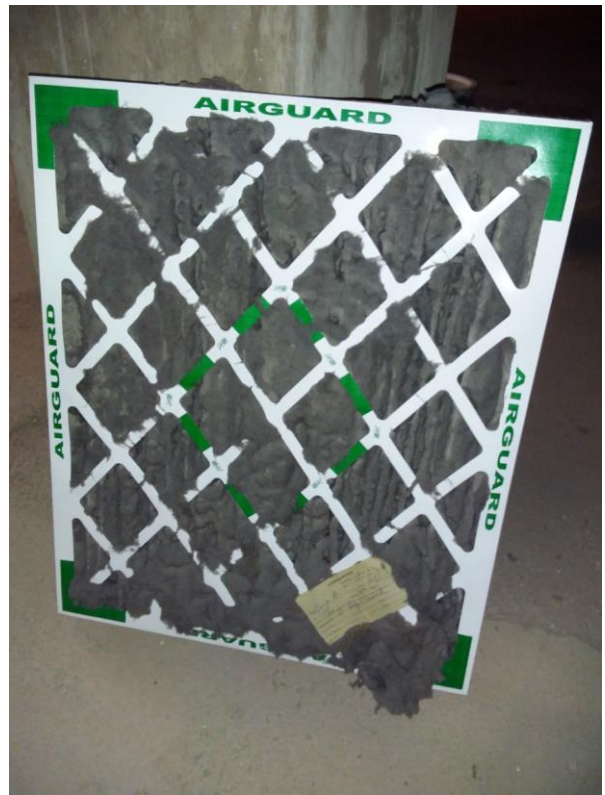
Dirty or poorly fitting filters were observed in units AHU-14 and UV 2203 during the ventilation inspection.

Return Pre-Filter Cleanliness

Recommendation: The operations and maintenance program for filter changes should be reviewed and revised to ensure proper filter changes to optimize filtration capacity.

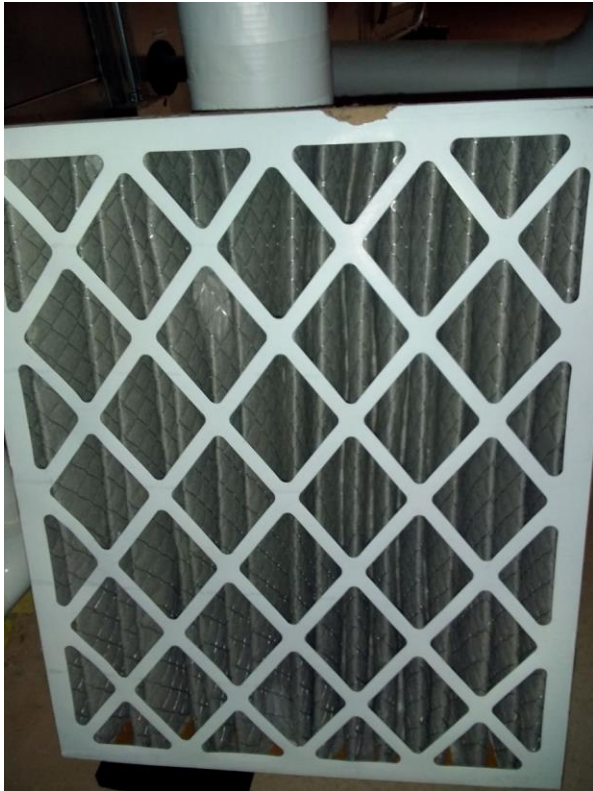
AHU-14

Return Main Filter Cleanliness

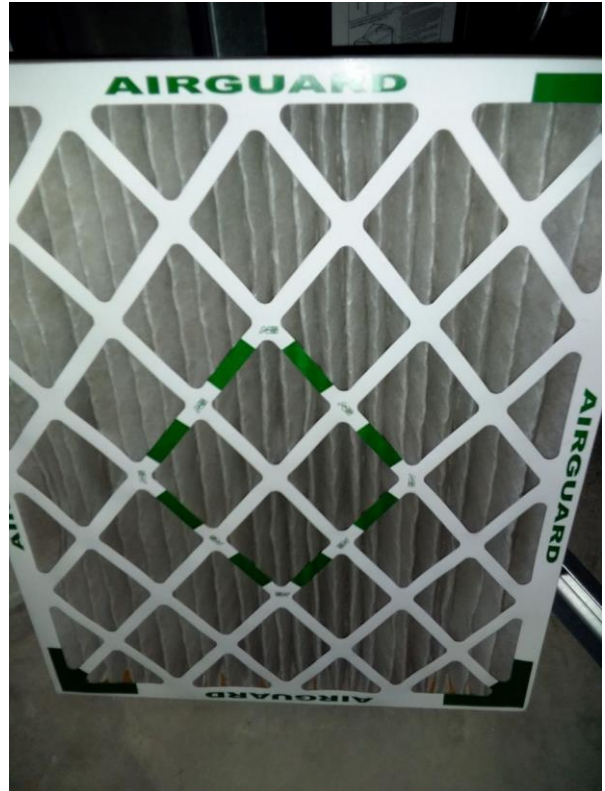
Unit Designation:	AHU-15	
Location of Unit:	2216 Mechanical	
Areas Served:	See attached map 2nd Floor Aerospace	
System Enhancements:	None	
Supply System	Outdoor Air	Cleanliness and Observations
Type <ul style="list-style-type: none"> • Supply System - VAV • Heating - Hot Water • Cooling - Chilled Water • Energy Recovery Unit (ERU) - None 	<p>Outdoor air intake is inaccessible</p> <p>Outdoor air intake is located on the roof.</p> <p>It is not known if there are nearby pollution sources.</p> <p>Outdoor air intake is in good condition.</p>	<p>Outdoor air filters are not present.</p> <p>Return air filters are not present.</p> <p>Mixed air pre-filters are somewhat dirty and on the border of needing replacement (scoring 3 out of 5) and fit well. Mixed air pre-filters are installed correctly. Mixed air main filters are somewhat dirty and on the border of needing replacement (scoring 4 out of 5) and fit well. Mixed air main filters are installed correctly.</p> <p>Drain pans are not plugged. Drain pan condition is good.</p> <p>Heating coils are clean and cooling coils are clean.</p> <p>Heat wheels are not present.</p> <p>Exterior ducting is visible. Exterior ducting insulation is in good condition.</p> <p>Interior ducting is not visible. Interior ducting insulation is in an unknown condition. Interior ducting is of unknown cleanliness.</p> <p>Air handling room is free of trash/chemicals.</p> <p>Outside damper is open, and its condition is good.</p> <p>Return damper is open, and its condition is good.</p> <p>The general condition of the unit is good.</p>

Mixed Pre-Filter Cleanliness

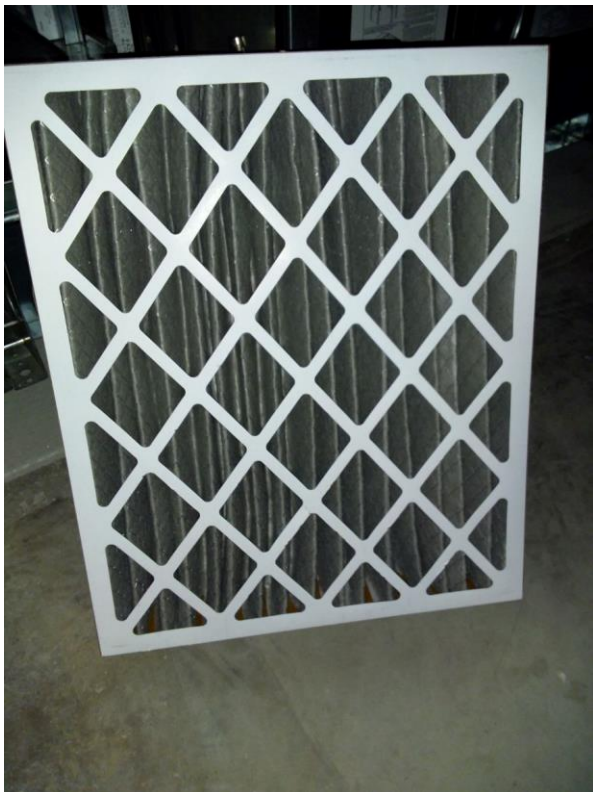
AHU-15

Mixed Main Filter Cleanliness

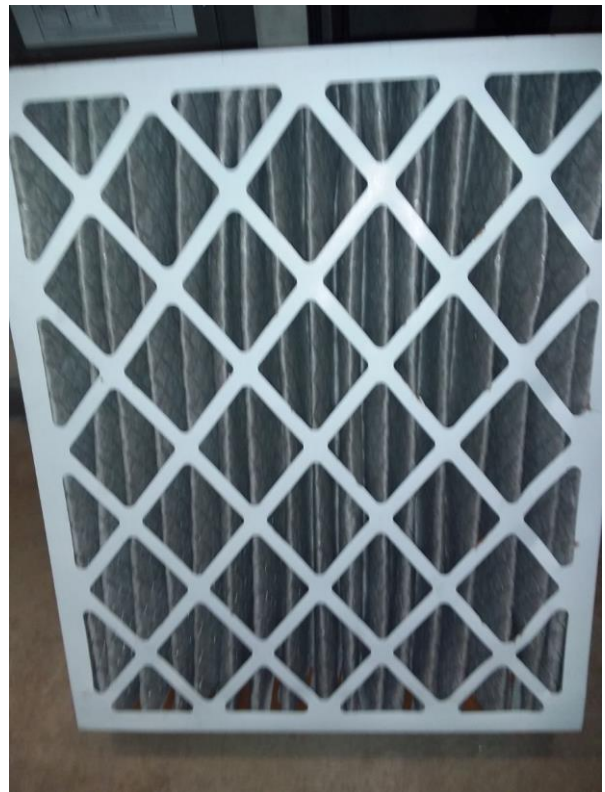
Unit Designation:	AHU-16	
Location of Unit:	2214 Mechanical	
Areas Served:	See attached map ROTC and 2110	
System Enhancements:	None	
Supply System	Outdoor Air	Cleanliness and Observations
Type <ul style="list-style-type: none"> Supply System - VAV Heating - Hot Water Cooling - Chilled Water Energy Recovery Unit (ERU) - None 	Outdoor air intake is inaccessible Outdoor air intake is located on the roof. It is not known if there are nearby pollution sources. Outdoor air intake is in good condition.	Outdoor air filters are not present. Return air filters are not present. Mixed air pre-filters are clean and not in need of replacement (scoring 2 out of 5) and fit well. Mixed air pre-filters are installed correctly. Mixed air main filters are somewhat dirty and on the border of needing replacement (scoring 3 out of 5) and fit well. Mixed air main filters are installed correctly. Drain pans are not plugged. Drain pan condition is good. Heating coils are clean and cooling coils are clean. Heat wheels are not present. Exterior ducting is visible. Exterior ducting insulation is in good condition. Interior ducting is not visible. Interior ducting insulation is in an unknown condition. Interior ducting is of unknown cleanliness. Air handling room is free of trash/chemicals. Outside damper is open, and its condition is good. Return damper is open, and its condition is good. The general condition of the unit is good.

Mixed Main Filter Cleanliness

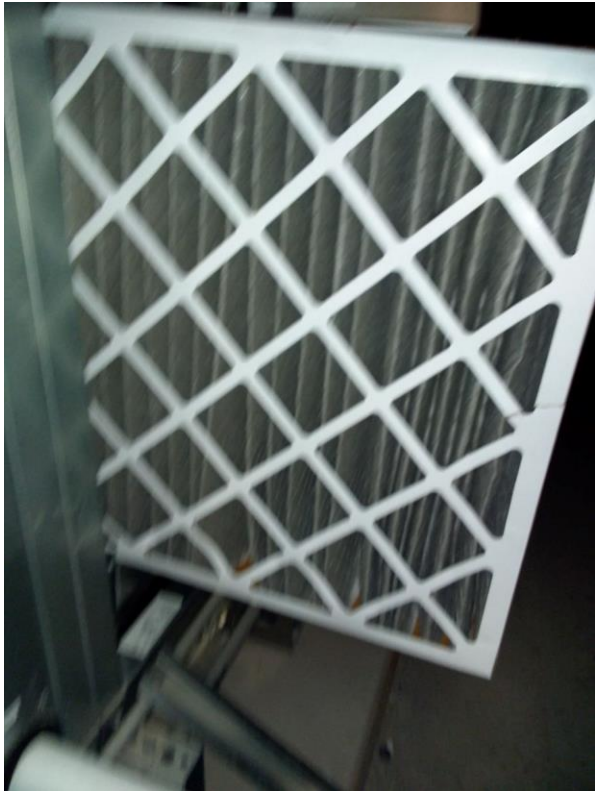
Unit Designation:	AHU-17	
Location of Unit:	Crawl space south	
Areas Served:	See attached map Room 0212 / Weight Room	
System Enhancements:	None	
Supply System	Outdoor Air	Cleanliness and Observations
Type <ul style="list-style-type: none"> Supply System - VAV Heating - Hot Water Cooling - Chilled Water Energy Recovery Unit (ERU) - None 	Outdoor air intake is inaccessible Outdoor air intake is located in an unknown location. It is not known if there are nearby pollution sources. Outdoor air intake is in good condition.	Outdoor air filters are not present. Return air filters are not present. Mixed air pre-filters are clean and not in need of replacement (scoring 2 out of 5) and fit well. Mixed air pre-filters are installed correctly. Mixed air main filters are somewhat dirty and on the border of needing replacement (scoring 3 out of 5) and fit well. Mixed air main filters are installed correctly. Drain pans are not plugged. Drain pan condition is good. Heating coils are clean. Heat wheels are not present. Exterior ducting is visible. Exterior ducting insulation is in good condition. Interior ducting is not visible. Interior ducting insulation is in an unknown condition. Interior ducting is of unknown cleanliness. Air handling room is free of trash/chemicals. Outside damper is open, and its condition is good. Return damper is open, and its condition is good. The general condition of the unit is good.

Mixed Main Filter Cleanliness

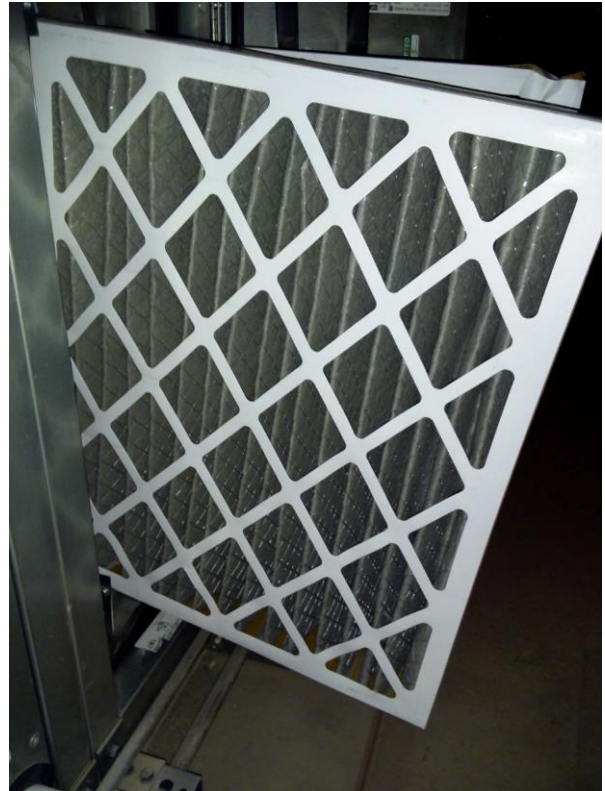
Unit Designation:	AHU-18	
Location of Unit:	Crawl space south	
Areas Served:	See attached map Room 0208 / Wood Shop	
System Enhancements:	None	
Supply System	Outdoor Air	Cleanliness and Observations
Type <ul style="list-style-type: none"> Supply System - VAV Heating - Hot Water Cooling - Chilled Water Energy Recovery Unit (ERU) - None 	Outdoor air intake is inaccessible Outdoor air intake is located in an unknown location. It is not known if there are nearby pollution sources. Outdoor air intake is in good condition.	Outdoor air filters are not present. Return air filters are not present. Mixed air pre-filters are clean and not in need of replacement (scoring 2 out of 5) and fit well. Mixed air pre-filters are installed correctly. Mixed air main filters are somewhat dirty and on the border of needing replacement (scoring 3 out of 5) and fit well. Mixed air main filters are installed correctly. Drain pans are not plugged. Drain pan condition is good. Heating coils are clean and cooling coils are clean. Heat wheels are not present. Exterior ducting is visible. Exterior ducting insulation is in good condition. Interior ducting is not visible. Interior ducting insulation is in an unknown condition. Interior ducting is of unknown cleanliness. Air handling room is free of trash/chemicals. Outside damper is open, and its condition is good. Return damper is open, and its condition is good. The general condition of the unit is good.

Mixed Main Filter Cleanliness

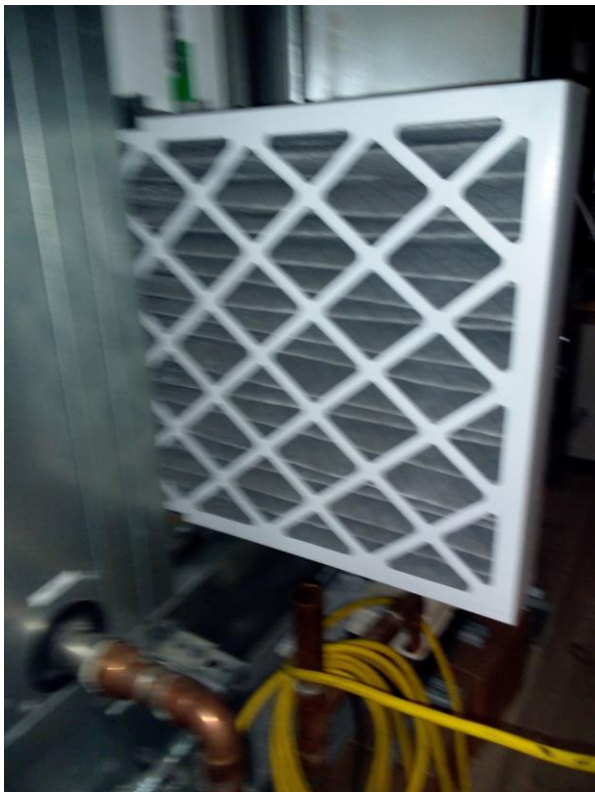
Unit Designation:	AHU-20	
Location of Unit:	Crawl space south	
Areas Served:	See attached map Room 0201 / Drafting	
System Enhancements:	None	
Supply System	Outdoor Air	Cleanliness and Observations
Type <ul style="list-style-type: none"> Supply System - VAV Heating - Hot Water Cooling - Chilled Water Energy Recovery Unit (ERU) - None 	Outdoor air intake is inaccessible Outdoor air intake is located in an unknown location. It is not known if there are nearby pollution sources. Outdoor air intake is in good condition.	Outdoor air filters are not present. Return air filters are not present. Mixed air pre-filters are clean and not in need of replacement (scoring 2 out of 5) and fit well. Mixed air pre-filters are installed correctly. Mixed air main filters are somewhat dirty and on the border of needing replacement (scoring 3 out of 5) and fit well. Mixed air main filters are installed correctly. Drain pans are not plugged. Drain pan condition is good. Heating coils are clean and cooling coils are dirty. Heat wheels are not present. Exterior ducting is visible. Exterior ducting insulation is in good condition. Interior ducting is not visible. Interior ducting insulation is in an unknown condition. Interior ducting is of unknown cleanliness. Air handling room is free of trash/chemicals. Outside damper is open, and its condition is good. Return damper is open, and its condition is good. The general condition of the unit is good.

Mixed Main Filter Cleanliness

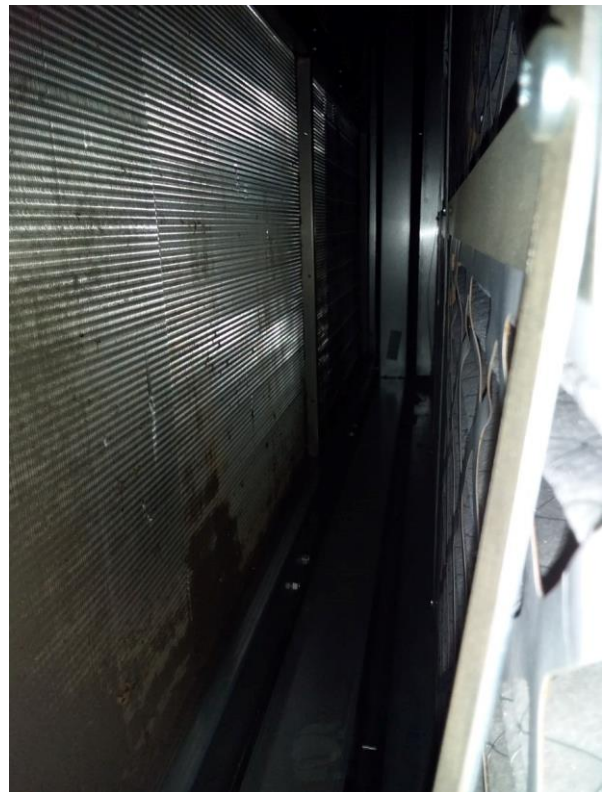
AHU-20

Cooling Coils

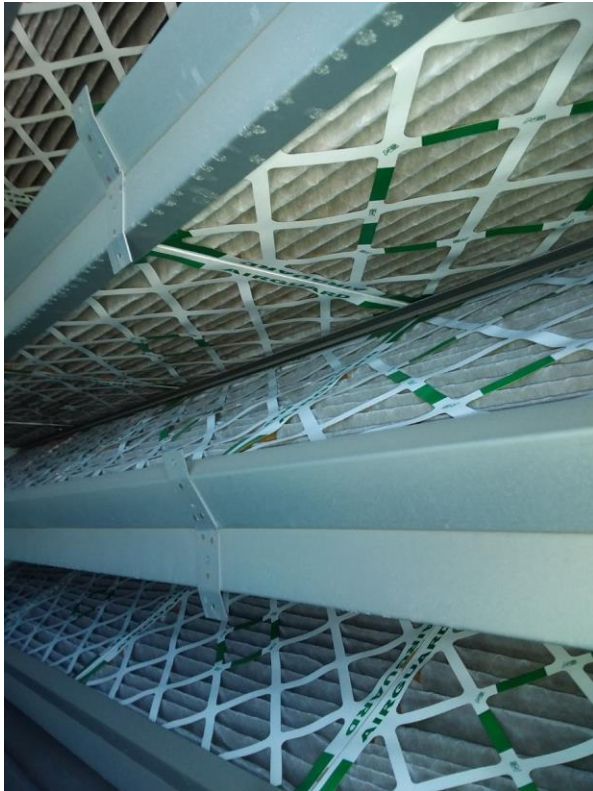
Unit Designation:	ERTU-01	
Location of Unit:	Roof E Center	
Areas Served:	See attached map 1st Floor Admin, 2nd Floor E. Classrooms	
System Enhancements:	None	
Supply System	Outdoor Air	Cleanliness and Observations
Type <ul style="list-style-type: none"> Supply System - Constant Volume Heating - Hot Water Cooling - Dx Energy Recovery Unit (ERU) - Wheel 	Outdoor air intake is accessible	Outdoor air pre-filters are not present. Outdoor air main filters are somewhat dirty and on the border of needing replacement (scoring 3 out of 5) and fit well. Outdoor air main filters are installed correctly.
	Outdoor air intake is located on the roof.	Return air pre-filters are not present. Return air main filters are clean and not in need of replacement (scoring 2 out of 5) and fit well. Return air main filters are installed correctly.
	No nearby pollution sources were found.	Mixed air pre-filters are not present. Mixed air main filters are clean and not in need of replacement (scoring 2 out of 5) and fit well. Mixed air main filters are installed correctly.

Outdoor Main Filter Cleanliness
