IEA, INC.

2023 - 2024 Ventilation Assessment

Saint Paul Public Schools Johnson Senior High School

Assessment Date:
Thursday, April 6, 2023

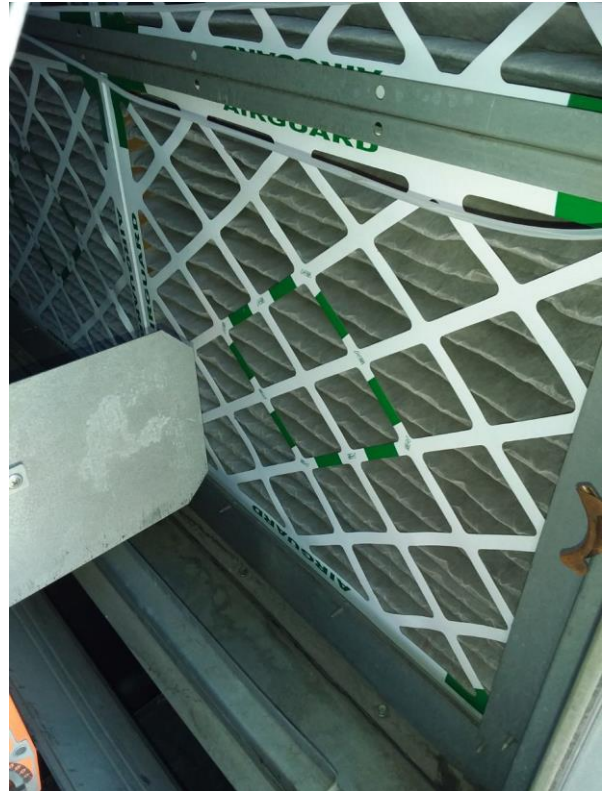
Unit Designation:	RTU-01	
Location of Unit:	Roof SW	
Areas Served:	See attached map 2nd Floor Southwest Addition	
System Enhancements:	None	
Supply System	Outdoor Air	Cleanliness and Observations
Type <ul style="list-style-type: none"> Supply System - Constant Volume Heating - Hot Water Cooling - Chilled Water Energy Recovery Unit (ERU) - None 	Outdoor air intake is accessible Outdoor air intake is located on the roof. No nearby pollution sources were found.	Outdoor air filters are not present. Return air filters are not present. Mixed air pre-filters are not present. Mixed air main filters are somewhat dirty and on the border of needing replacement (scoring 3 out of 5) and fit well. Mixed air main filters are installed correctly. Drain pans are not plugged. Drain pan condition is good. Heating coils are clean and cooling coils are clean.
Filter Type - Mixed <ul style="list-style-type: none"> Pre-filter: None Main filter: Pleated, MERV 13 	Outdoor air intake is in good condition.	Heat wheels are not present. Exterior ducting is not visible. Exterior ducting insulation is in an unknown condition. Interior ducting is not visible. Interior ducting insulation is in an unknown condition. Interior ducting is of unknown cleanliness. Air handling room is free of trash/chemicals. Outside damper is open, and its condition is good. Return damper is open, and its condition is good. The general condition of the unit is good.

Mixed Main Filter Cleanliness

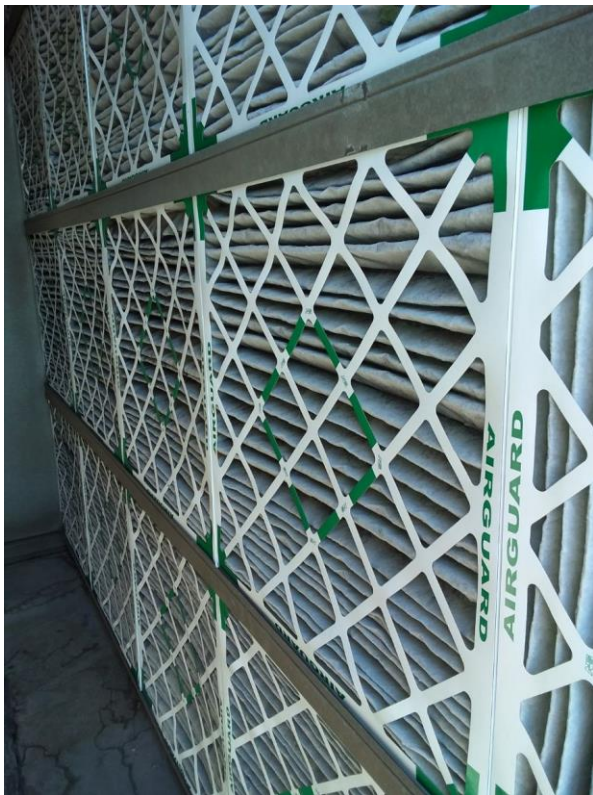
Unit Designation:	RTU-02	
Location of Unit:	Above field house	
Areas Served:	See attached map.	
System Enhancements:	None	
Supply System	Outdoor Air	Cleanliness and Observations
Type <ul style="list-style-type: none"> Supply System - Unknown Heating - Hot Water Cooling - Chilled Water Energy Recovery Unit (ERU) - None 	Outdoor air intake is accessible Outdoor air intake is located on the roof. No nearby pollution sources were found.	Outdoor air filters are not present. Return air filters are not present. Mixed air pre-filters are not present. Mixed air main filters are somewhat dirty and on the border of needing replacement (scoring 3 out of 5) and fit well. Mixed air main filters are installed correctly. Drain pan plugged status is not known. Drain pan condition is good.
Filter Type - Mixed <ul style="list-style-type: none"> Pre-filter: None Main filter: Pleated, MERV 11 	Outdoor air intake is in good condition.	Heating coils are inaccessible and cooling coils are inaccessible. Heat wheels are not present. Exterior ducting is not visible. Exterior ducting insulation is in an unknown condition. Interior ducting is not visible. Interior ducting insulation is in an unknown condition. Interior ducting is of unknown cleanliness. Air handling room is free of trash/chemicals. Outside damper is open, and its condition is good. Return damper is open, and its condition is good. The general condition of the unit is poor.

The general condition of units AHU-10, RTU-02, UV 2107, UV 2114 and UV 2203 was poor.

Mixed Main Filter Cleanliness

Recommendation: The units should be repaired or cleaned as needed.

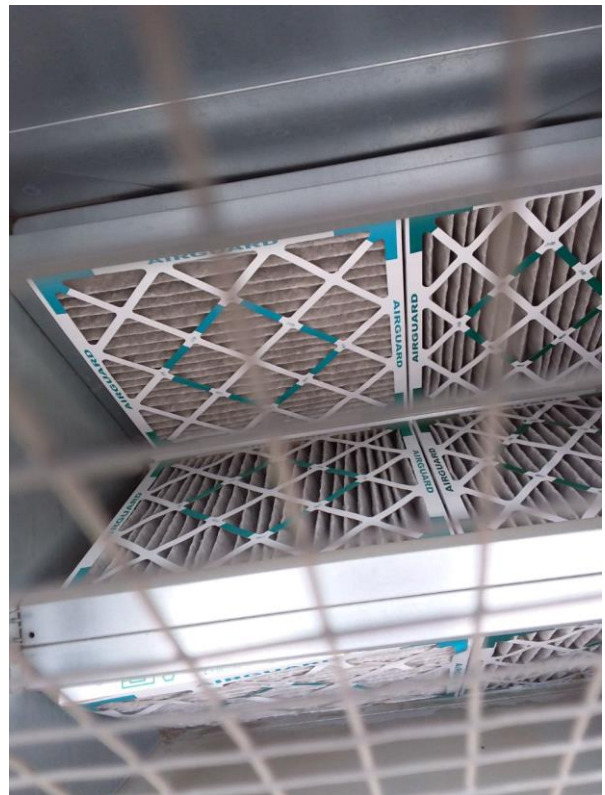
Unit Designation:	RTU-03	
Location of Unit:	Roof near West Penthouse	
Areas Served:	See attached map.	
System Enhancements:	None	
Supply System	Outdoor Air	Cleanliness and Observations
Type <ul style="list-style-type: none"> Supply System - Unknown Heating - Hot Water Cooling - Chilled Water Energy Recovery Unit (ERU) - None 	<p>Outdoor air intake is accessible</p> <p>Outdoor air intake is located on the roof.</p> <p>No nearby pollution sources were found.</p>	<p>Outdoor air pre-filters are not present. Outdoor air main filters are not present.</p> <p>Return air filters are not present.</p> <p>Mixed air filters are somewhat dirty and on the border of needing replacement (scoring 3 out of 5) and fit well. Mixed air filters are installed correctly.</p> <p>Drain pans are not plugged. Drain pan condition is good.</p>
Filter Type - Mixed <ul style="list-style-type: none"> Pre-filter: Pleated, MERV 8 Main filter: Pleated, MERV 13 	<p>Outdoor air intake is in good condition.</p>	<p>Heating coils are clean and cooling coils are clean.</p> <p>Heat wheels are not present.</p> <p>Exterior ducting is not visible. Exterior ducting insulation is in an unknown condition.</p> <p>Interior ducting is not visible. Interior ducting insulation is in an unknown condition. Interior ducting is of unknown cleanliness.</p> <p>Air handling room is free of trash/chemicals.</p> <p>Outside damper is open, and its condition is good.</p> <p>Return damper is open, and its condition is good.</p> <p>The general condition of the unit is good.</p>

Outdoor Main Filter Cleanliness

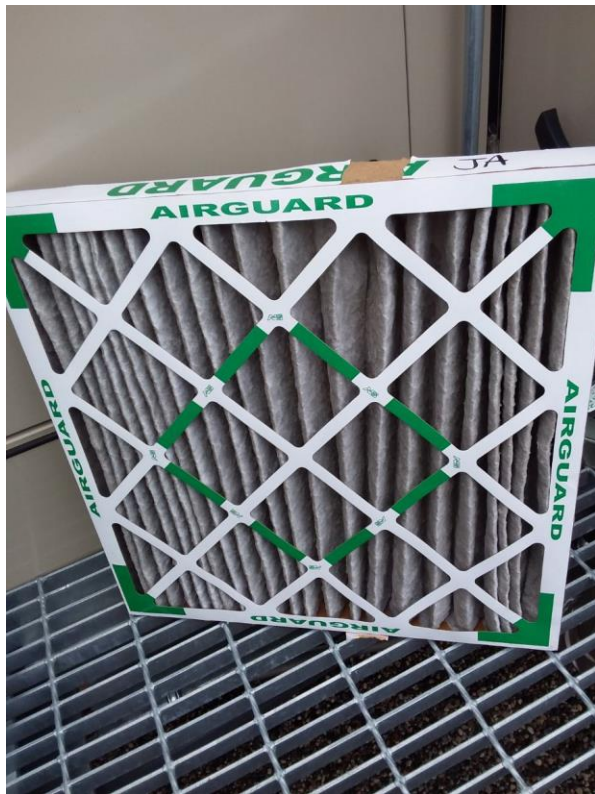
RTU-03

Mixed Pre-Filter Cleanliness

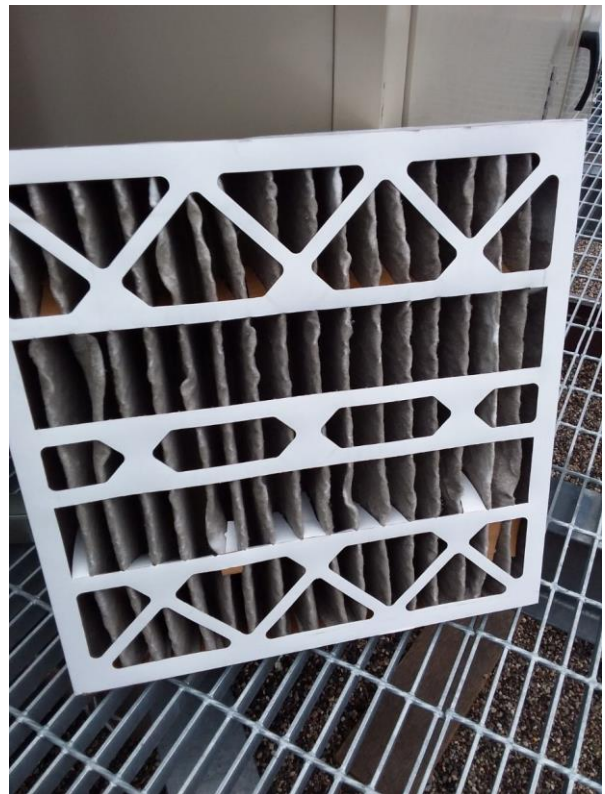
RTU-03

Mixed Main Filter Cleanliness

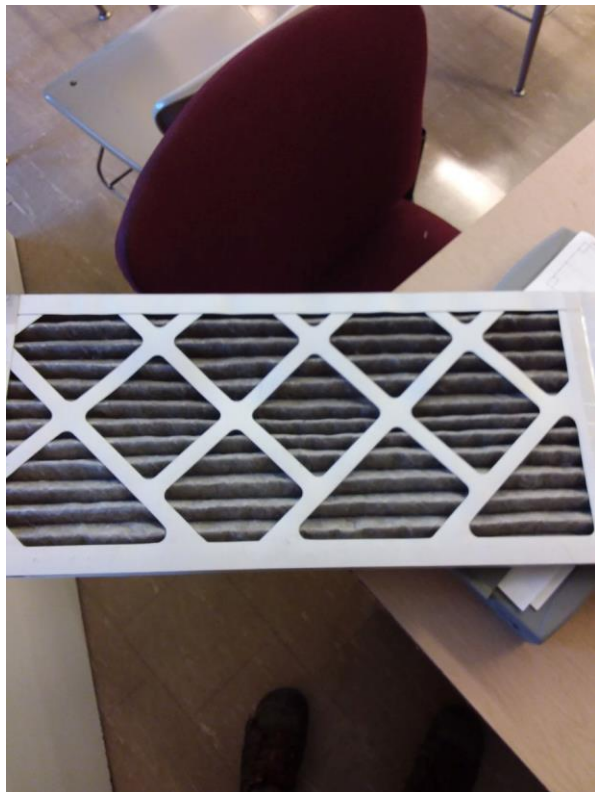
Unit Designation:	UV 2209	
Location of Unit:	2209	
Areas Served:	2209	
System Enhancements:	None	
Supply System	Outdoor Air	Cleanliness and Observations
Type <ul style="list-style-type: none"> Supply System - Unknown Heating - Hot Water Cooling - None Energy Recovery Unit (ERU) - None 	Outdoor air intake is accessible Outdoor air intake is located on the unit. No nearby pollution sources were found.	Outdoor air filters are not present. Return air pre-filters are not present. Return air main filters are somewhat dirty and on the border of needing replacement (scoring 4 out of 5) and fit well. Return air main filters are installed correctly. Drain pans are not plugged. Drain pan condition is good. Heating coils are clean. Heat wheels are not present.
Filter Type - Return <ul style="list-style-type: none"> Pre-filter: None Main filter: Pleated, MERV 8 	Outdoor air intake is in good condition.	Exterior ducting is not visible. Exterior ducting insulation is not present. Interior ducting is not visible. Interior ducting insulation is not present. Interior ducting is of unknown cleanliness. Air handling room is free of trash/chemicals. Outside damper is not present. Return damper is not present. The general condition of the unit is good.

Return Main Filter Cleanliness

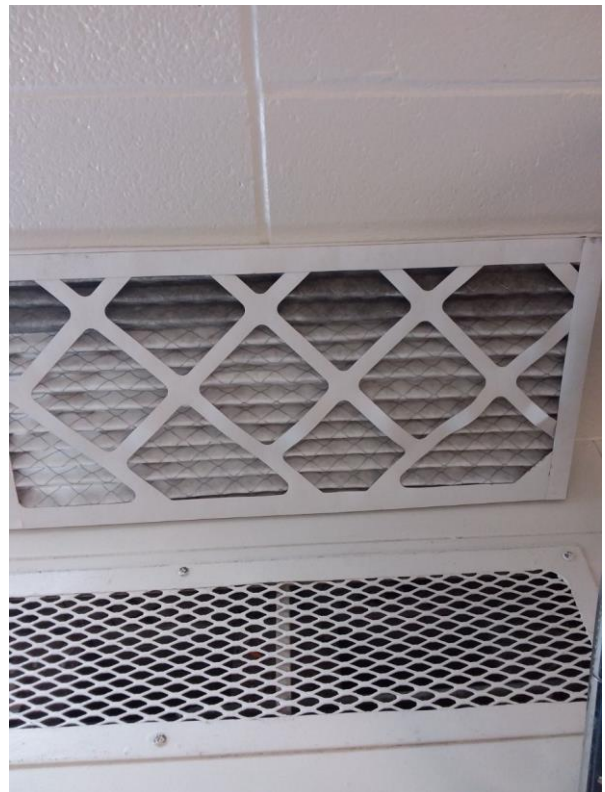
Unit Designation:	UV 2210	
Location of Unit:	2210	
Areas Served:	2210	
System Enhancements:	None	
Supply System	Outdoor Air	Cleanliness and Observations
Type <ul style="list-style-type: none"> Supply System - Unknown Heating - Hot Water Cooling - None Energy Recovery Unit (ERU) - None 	Outdoor air intake is accessible Outdoor air intake is located on the unit. No nearby pollution sources were found.	Outdoor air filters are not present. Return air pre-filters are not present. Return air main filters are somewhat dirty and on the border of needing replacement (scoring 3 out of 5) and fit well. Return air main filters are installed correctly. Drain pans are not plugged. Drain pan condition is good. Heating coils are clean. Heat wheels are not present.
Filter Type - Return <ul style="list-style-type: none"> Pre-filter: None Main filter: Pleated, MERV 8 	Outdoor air intake is in good condition.	Exterior ducting is not visible. Exterior ducting insulation is not present. Interior ducting is not visible. Interior ducting insulation is not present. Interior ducting is of unknown cleanliness. Air handling room is free of trash/chemicals. Outside damper is not present. Return damper is not present. The general condition of the unit is good.

Return Main Filter Cleanliness

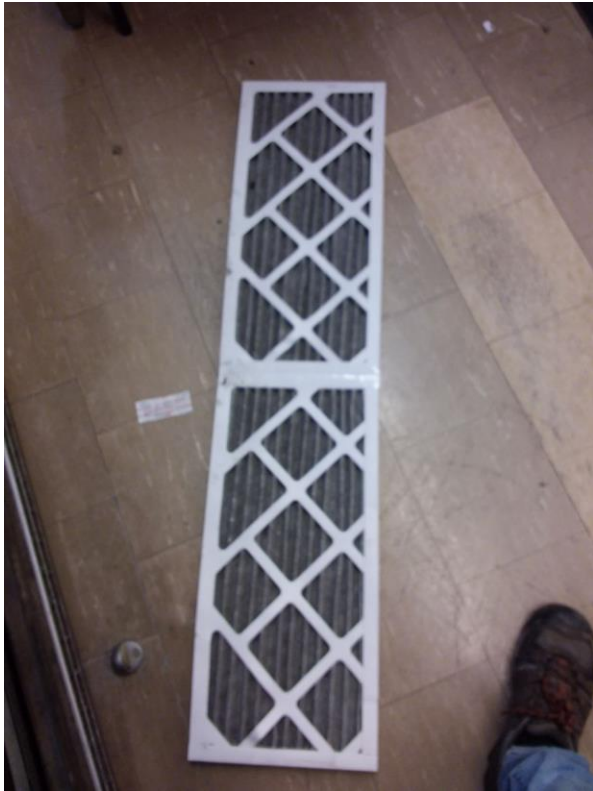
Unit Designation:	UV 2207	
Location of Unit:	2207	
Areas Served:	2207	
System Enhancements:	None	
Supply System	Outdoor Air	Cleanliness and Observations
Type <ul style="list-style-type: none"> Supply System - Unknown Heating - Hot Water Cooling - None Energy Recovery Unit (ERU) - None 	Outdoor air intake is accessible Outdoor air intake is located on the unit. No nearby pollution sources were found.	Outdoor air filters are not present. Return air pre-filters are not present. Return air main filters are somewhat dirty and on the border of needing replacement (scoring 4 out of 5) and fit well. Return air main filters are installed correctly. Drain pans are not plugged. Drain pan condition is poor. Heating coils are clean. Heat wheels are not present.
Filter Type - Return <ul style="list-style-type: none"> Pre-filter: None Main filter: Pleated, MERV 8 	Outdoor air intake is in good condition.	Exterior ducting is not visible. Exterior ducting insulation is not present. Interior ducting is not visible. Interior ducting insulation is not present. Interior ducting is of unknown cleanliness. Air handling room is free of trash/chemicals. Outside damper is not present. Return damper is not present. The general condition of the unit is good.

Return Main Filter Cleanliness

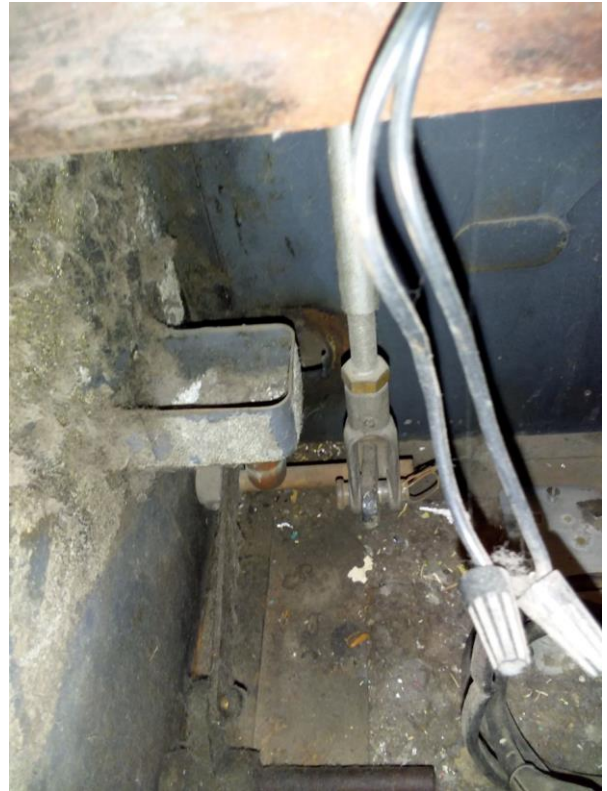
The drain pan for units AHU-01, AHU-09, AHU-10, AHU-13, UV 2107, UV 2112, UV 2114, UV 2203 and UV 2207 was plugged or damaged at the time of the site inspection.

Drain Pans

Recommendation: Damage to the drain pan should be repaired, or the drain pan should be inspected more frequently to ensure that it does not become plugged.

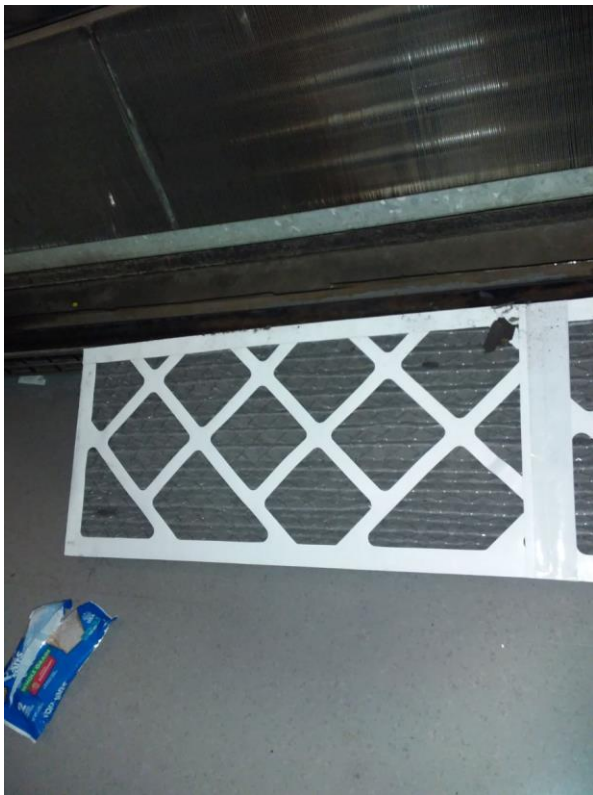
Dirty or poorly fitting filters were observed in units AHU-14 and UV 2203 during the ventilation inspection.

Return Main Filter Cleanliness

Recommendation: The operations and maintenance program for filter changes should be reviewed and revised to ensure proper filter changes to optimize filtration capacity.

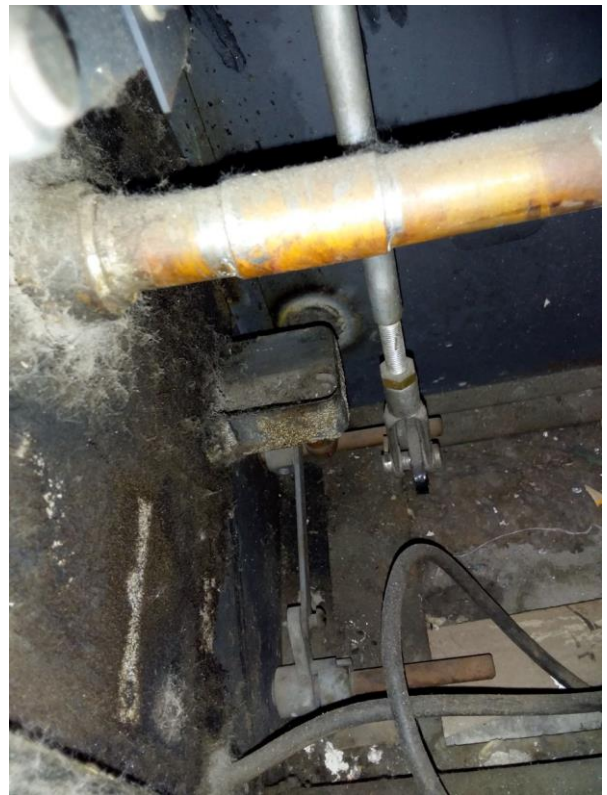
UV 2203

Drain Pans

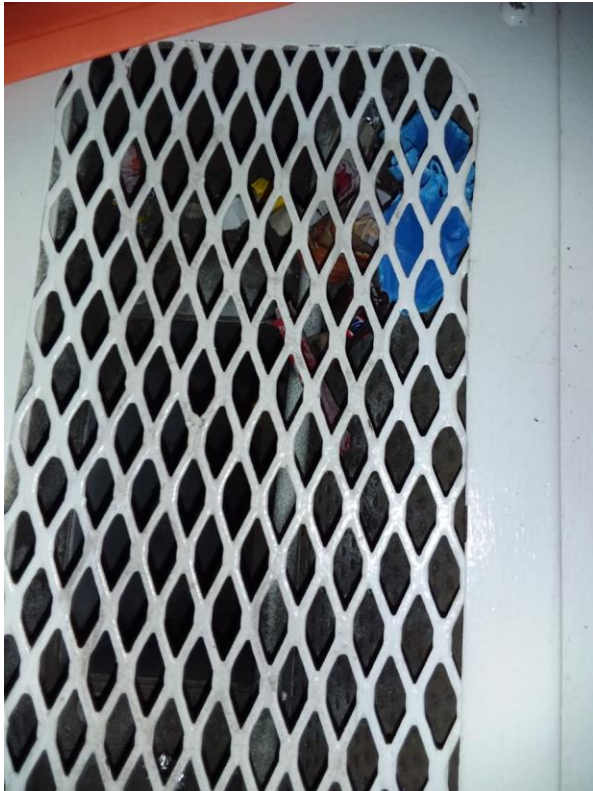
Unit Designation:	UV 2203	
Location of Unit:	2203	
Areas Served:	2203	
System Enhancements:	None	
Supply System	Outdoor Air	Cleanliness and Observations
Type <ul style="list-style-type: none"> Supply System - Unknown Heating - Hot Water Cooling - None Energy Recovery Unit (ERU) - None 	Outdoor air intake is accessible Outdoor air intake is located on the unit. No nearby pollution sources were found.	Outdoor air filters are not present. Return air pre-filters are not present. Return air main filters are dirty and in need of replacement (scoring 5 out of 5) and fit well. Return air main filters are installed correctly. Drain pans are not plugged. Drain pan condition is poor. Heating coils are clean. Heat wheels are not present.
Filter Type - Return <ul style="list-style-type: none"> Pre-filter: None Main filter: Pleated, MERV 8 	Outdoor air intake is in good condition.	Exterior ducting is not visible. Exterior ducting insulation is not present. Interior ducting is not visible. Interior ducting insulation is not present. Interior ducting is of unknown cleanliness. Air handling room is free of trash/chemicals. Outside damper is not present. Return damper is not present. The general condition of the unit is poor.

UV 2203
General Condition

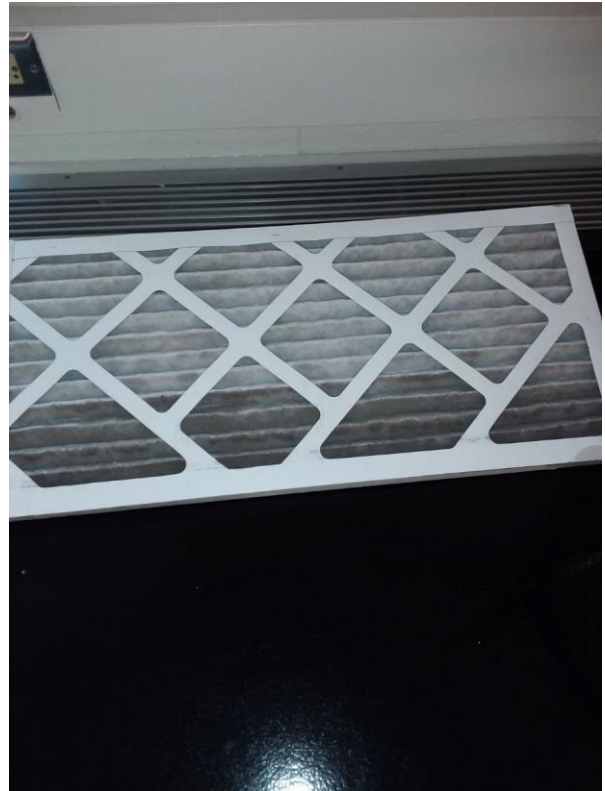
Unit Designation:	UV 2107	
Location of Unit:	2107	
Areas Served:	2107	
System Enhancements:	None	
Supply System	Outdoor Air	Cleanliness and Observations
Type <ul style="list-style-type: none"> Supply System - Heating - Hot Water Cooling - None Energy Recovery Unit (ERU) - None 	Outdoor air intake is accessible Outdoor air intake is located in an unknown location. No nearby pollution sources were found.	Outdoor air filters are not present. Return air pre-filters are not present. Return air main filters are somewhat dirty and on the border of needing replacement (scoring 3 out of 5) and fit well. Return air main filters are installed correctly. Drain pans are not plugged. Drain pan condition is poor. Heating coils are clean.
Filter Type - Return <ul style="list-style-type: none"> Pre-filter: None Main filter: Pleated, MERV 8 	Outdoor air intake is in good condition.	Heat wheels are not present. Exterior ducting is not visible. Exterior ducting insulation is not present. Interior ducting is not visible. Interior ducting insulation is not present. Interior ducting is of unknown cleanliness. Air handling room is free of trash/chemicals. Outside damper is not present. Return damper is not present. The general condition of the unit is poor.

UV 2107
Return Main Filter Cleanliness

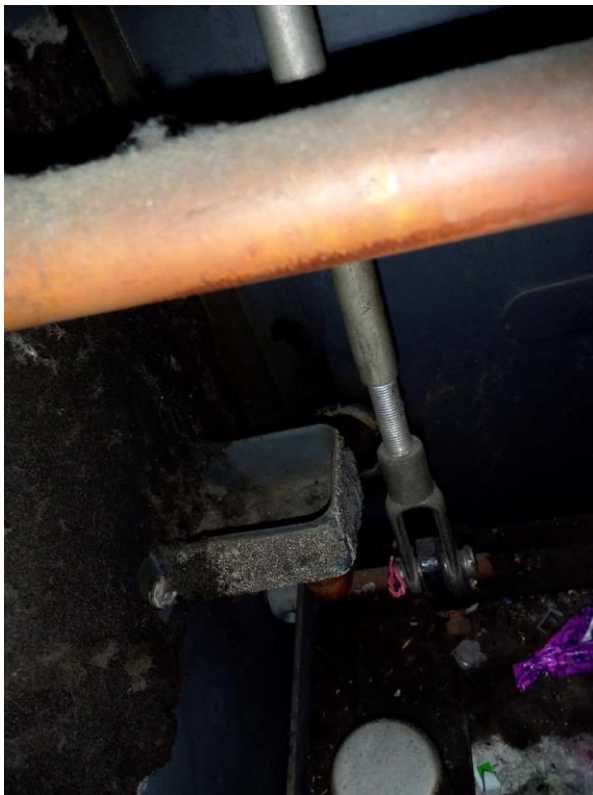
UV 2107
Drain Pans

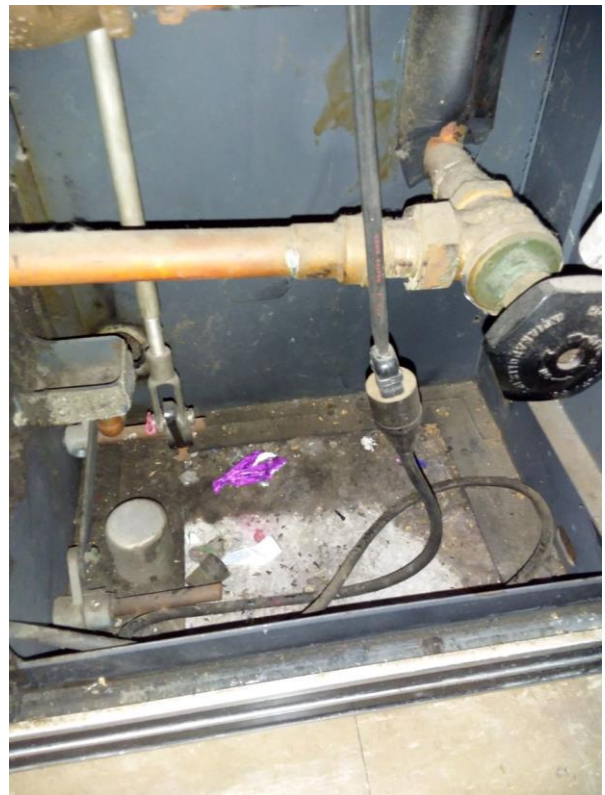
UV 2107
General Condition

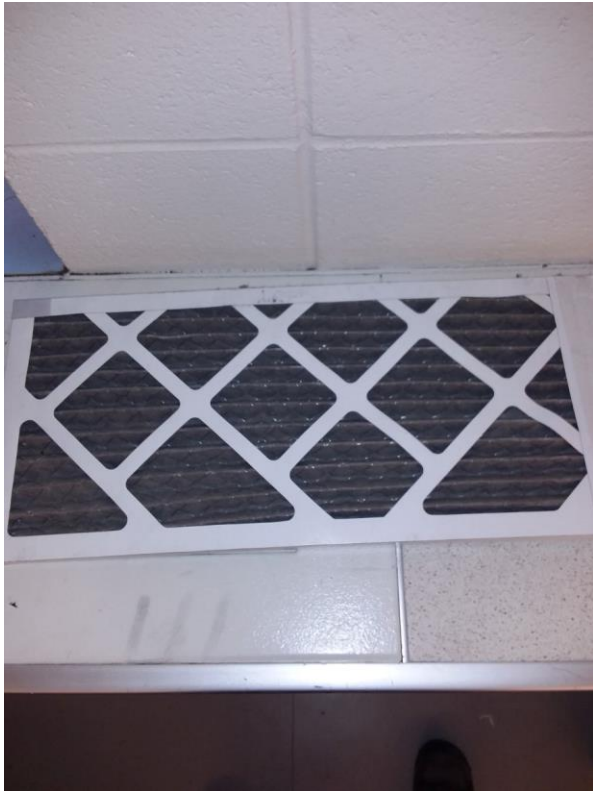
Unit Designation:	UV 2114	
Location of Unit:	2114	
Areas Served:	2114	
System Enhancements:	None	
Supply System	Outdoor Air	Cleanliness and Observations
Type <ul style="list-style-type: none"> Supply System - Unknown Heating - Hot Water Cooling - None Energy Recovery Unit (ERU) - None 	Outdoor air intake is accessible Outdoor air intake is located on the unit. No nearby pollution sources were found.	Outdoor air filters are not present. Return air pre-filters are not present. Return air main filters are somewhat dirty and on the border of needing replacement (scoring 4 out of 5) and fit well. Return air main filters are installed correctly. Drain pans are not plugged. Drain pan condition is poor. Heating coils are clean. Heat wheels are not present.
Filter Type - Return <ul style="list-style-type: none"> Pre-filter: None Main filter: Pleated, MERV 8 	Outdoor air intake is in good condition.	Exterior ducting is not visible. Exterior ducting insulation is not present. Interior ducting is not visible. Interior ducting insulation is not present. Interior ducting is of unknown cleanliness. Air handling room is free of trash/chemicals. Outside damper is not present. Return damper is not present. The general condition of the unit is poor.

UV 2114
Return Main Filter Cleanliness

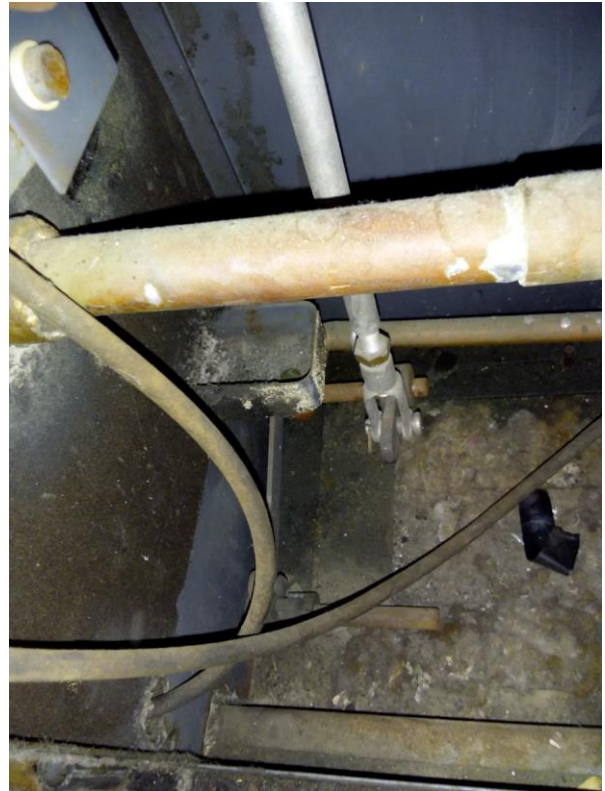
UV 2114
Drain Pans

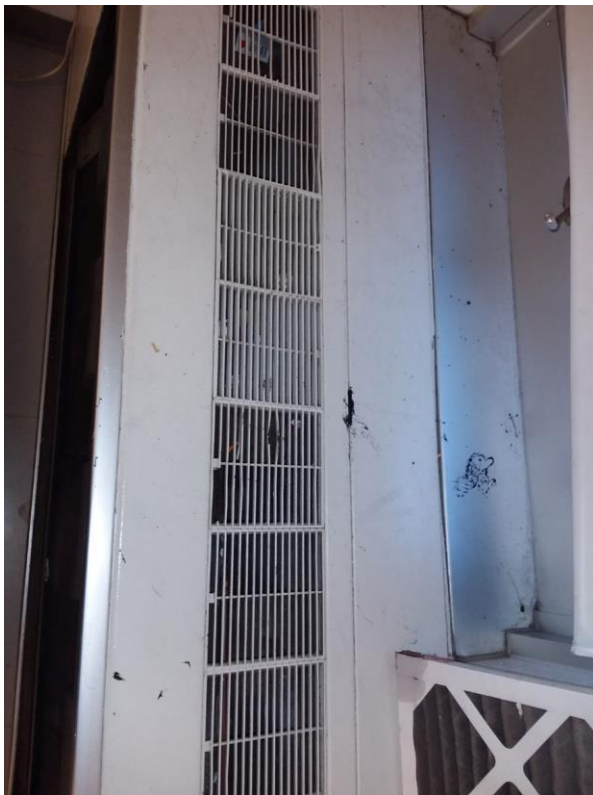
UV 2114
General Condition

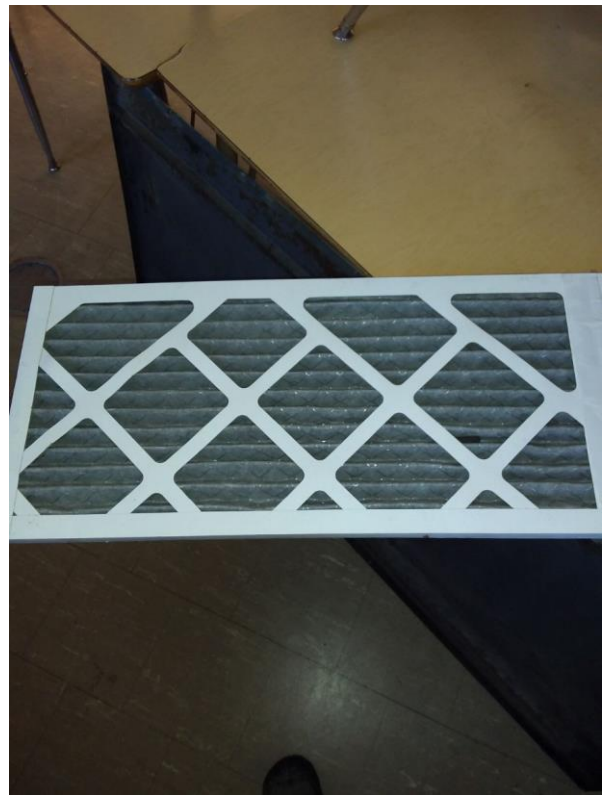
Unit Designation:	UV 2112	
Location of Unit:	2112	
Areas Served:	2112	
System Enhancements:	None	
Supply System	Outdoor Air	Cleanliness and Observations
Type <ul style="list-style-type: none"> Supply System - Unknown Heating - Hot Water Cooling - None Energy Recovery Unit (ERU) - None 	Outdoor air intake is accessible Outdoor air intake is located on the unit. No nearby pollution sources were found.	Outdoor air filters are not present. Return air pre-filters are not present. Return air main filters are somewhat dirty and on the border of needing replacement (scoring 3 out of 5) and fit well. Return air main filters are installed correctly. Drain pans are not plugged. Drain pan condition is poor. Heating coils are clean. Heat wheels are not present.
Filter Type - Return <ul style="list-style-type: none"> Pre-filter: None Main filter: Pleated, MERV 8 	Outdoor air intake is in good condition.	Exterior ducting is not visible. Exterior ducting insulation is not present. Interior ducting is not visible. Interior ducting insulation is not present. Interior ducting is of unknown cleanliness. Air handling room is free of trash/chemicals. Outside damper is not present. Return damper is not present. The general condition of the unit is good.

UV 2112
Return Main Filter Cleanliness

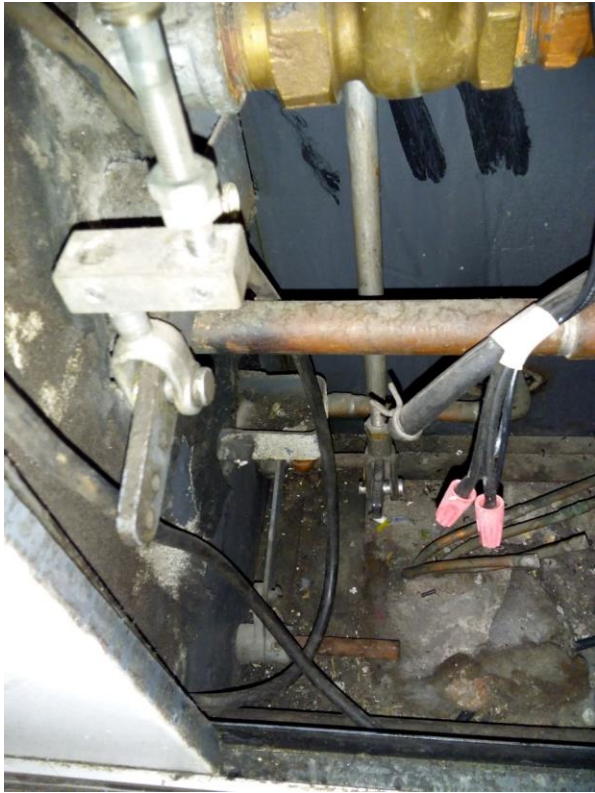
UV 2112
Drain Pans
