# 2022 - 2023 IAQ Walkthrough

## Saint Paul Public Schools Journeys Secondary School

Walkthrough Date:  
Tuesday, January 17, 2023

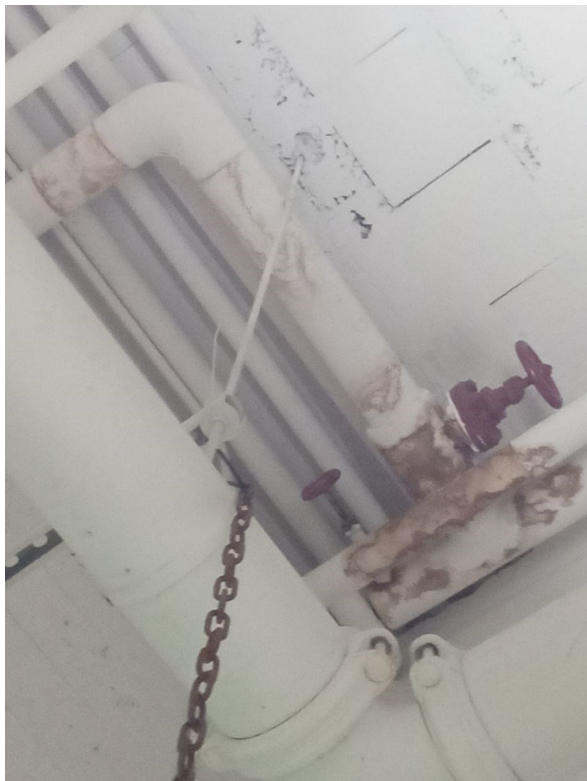
- CUSTODIAL OFFICE

**CUSTODIAL OFFICE**  
Moisture Impacted Materials

Moisture-impacted building materials should be repaired or replaced when discoloration or water staining is observed. Moisture-impacted building materials can be a source for microbial growth. The source for the moisture infiltration should be investigated and repaired if not easily identified.

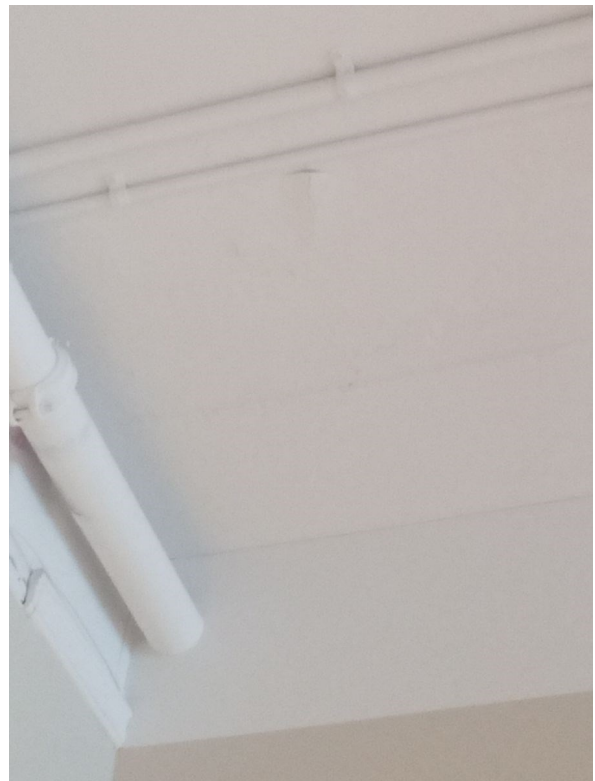
| • 1114 | <i>Above nurses desk</i> | • 3114A | <i>Underneath windows</i> |

**1114**  
Bubbling/Peeling Paint

Bubbling/peeling paint can be caused by moisture issues. IEA recommends investigating the cause and repairing the paint. IEA recommends ensuring that the paint is not lead-based prior to disturbance.

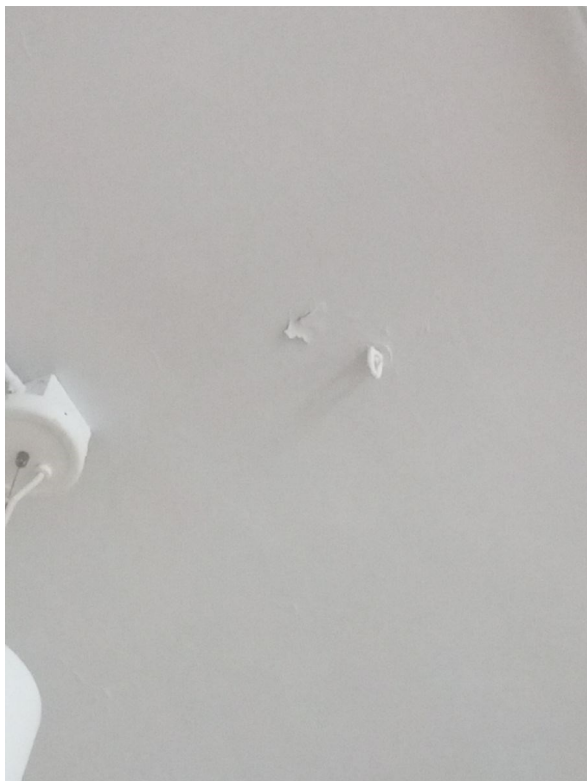
| • 1112 | <i>NE corner of room</i> | • 3112 | <i>On ceiling in front of windows ; Under windows on West side</i> |

**1112**  
Bubbling/Peeling Paint

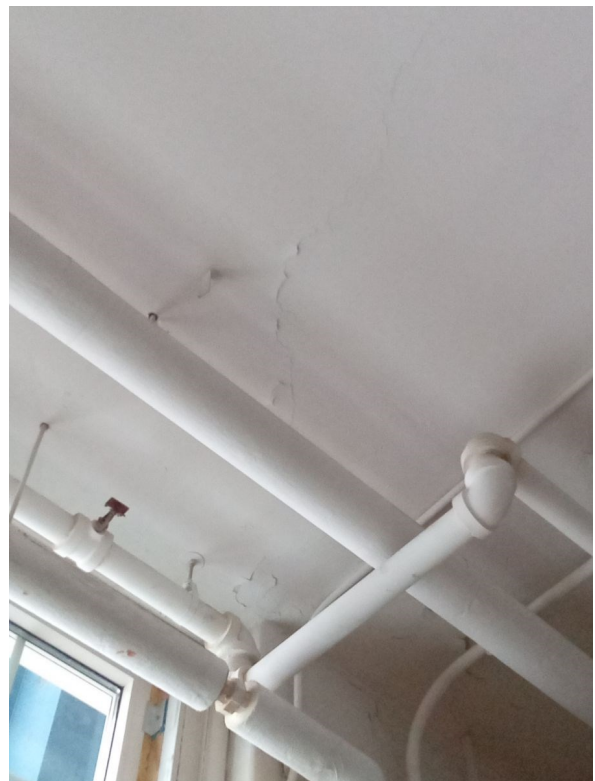
| • 1110 | <i>SW corner in front of window</i> | • 3105 | <i>Throughout ceiling</i> |

**1110 WOODSHOP**  
Bubbling/Peeling Paint

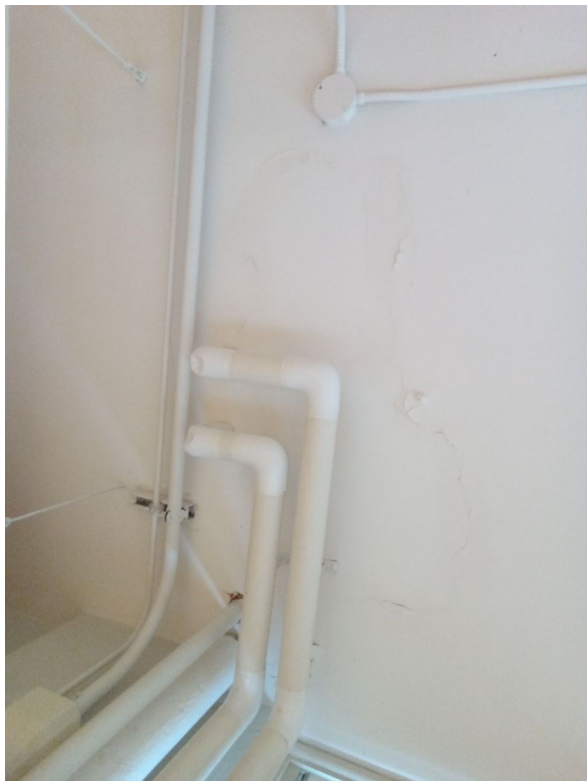
| • 1106 | <i>On ceiling in front of window</i> | • 3102 | <i>East Wall</i> |

Bubbling/Peeling Paint

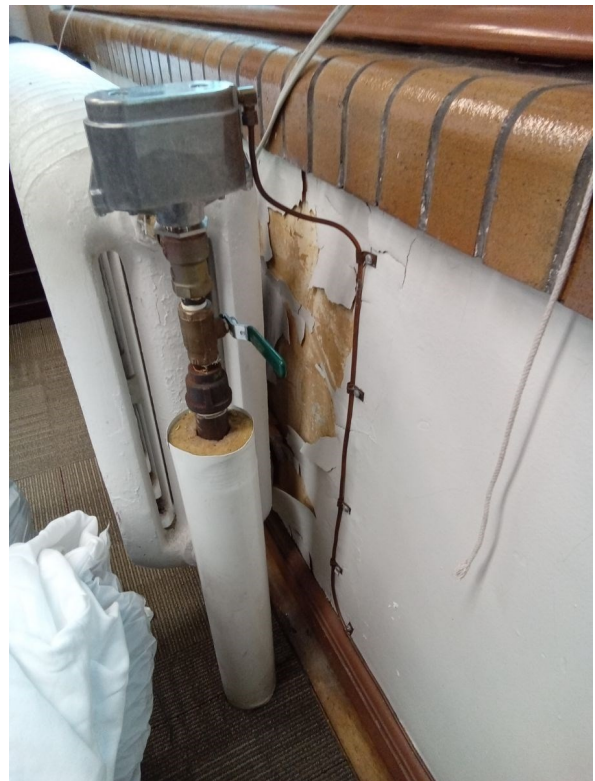
1101

Bubbling/Peeling Paint

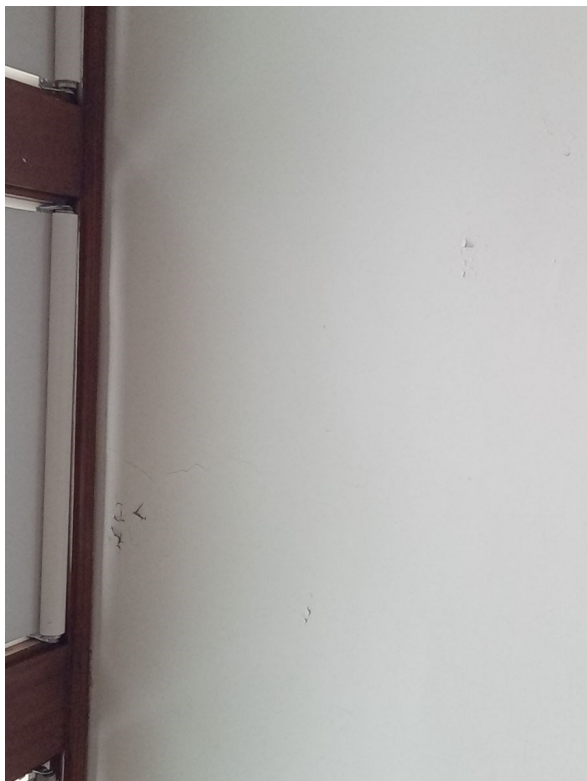
2114

Bubbling/Peeling Paint

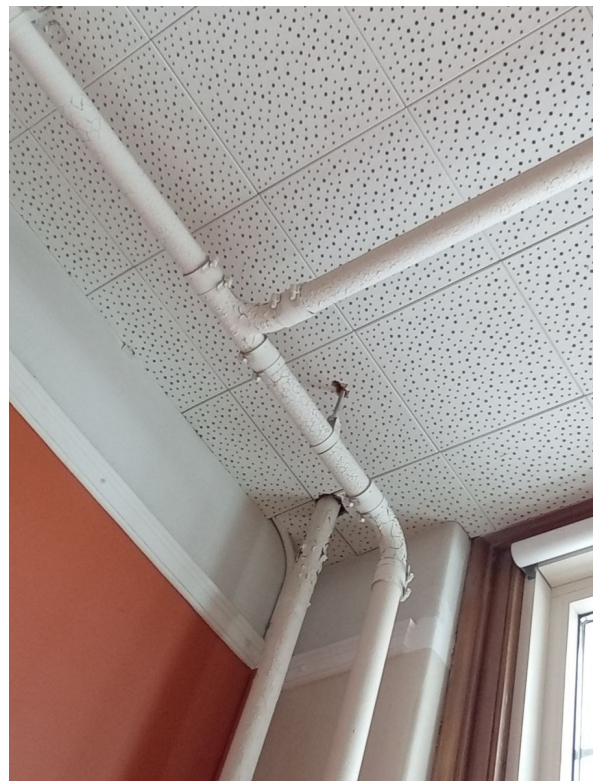
| • 2102 | <i>Associated with pipes</i> | | |

Bubbling/Peeling Paint

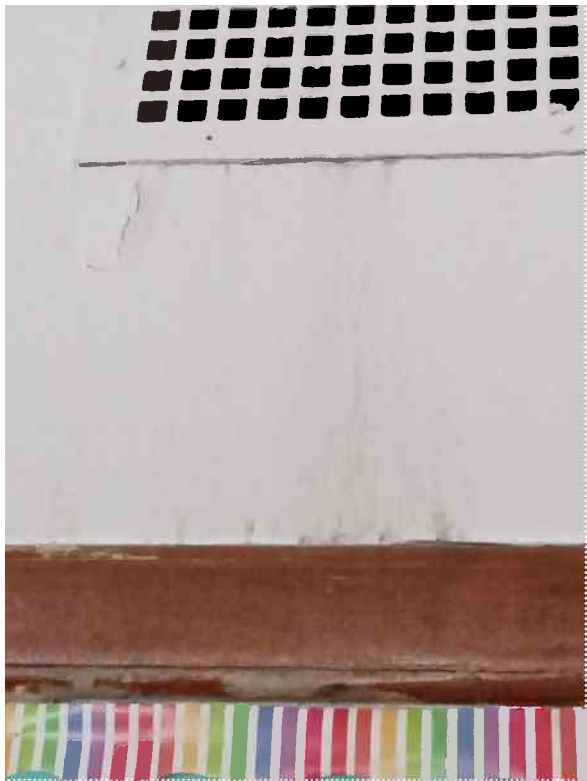
3102

Bubbling/Peeling Paint
