2022 - 2023 IAQ Walkthrough

Saint Paul Public Schools LEAP High School

Walkthrough Date:
Thursday, January 12, 2023

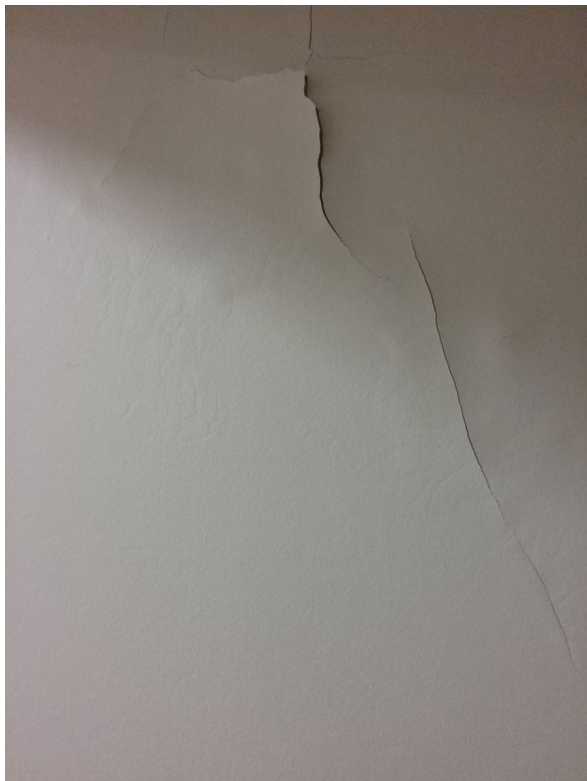
IEA observed bubbling/peeling paint in area(s) within the room(s) listed below.

Bubbling/peeling paint can be caused by moisture issues. IEA recommends investigating the cause and repairing the paint. IEA recommends ensuring that the paint is not lead-based prior to disturbance.

3302
Bubbling/Peeling Paint

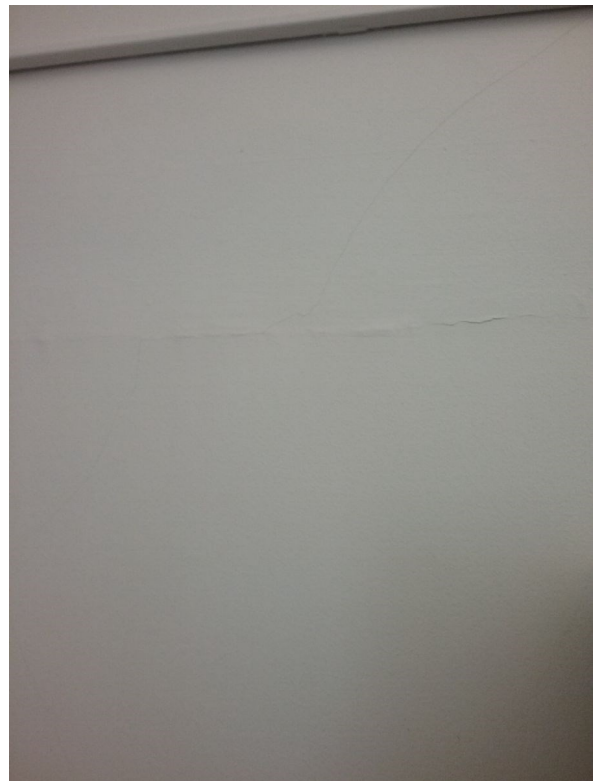
3306
Bubbling/Peeling Paint

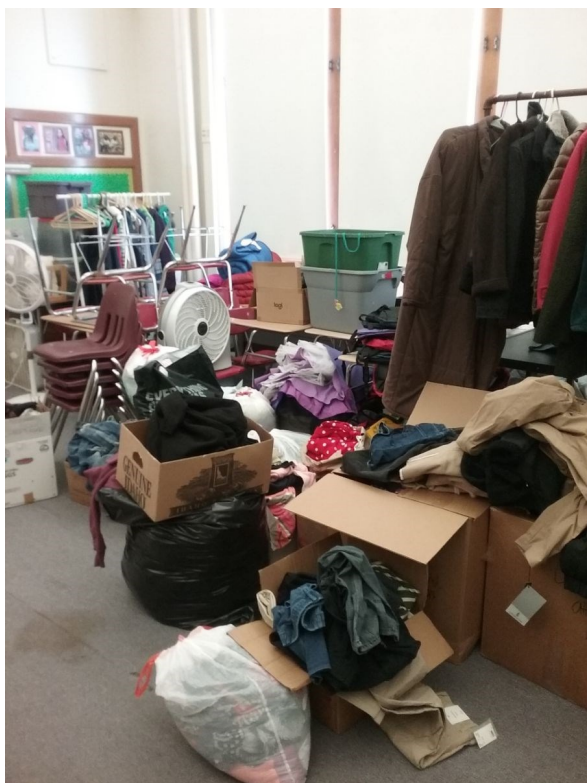
Area(s) identified by IEA as having poor housekeeping (excessive clutter, excessive dust/debris on horizontal surfaces, etc.) were documented within the building. Poor housekeeping can limit building maintenance from conducting a proper cleaning of the area. This can result in elevated potential for allergen issues in sensitized individuals due to dirt and debris loading. Poor housekeeping can also allow for pest (insects and rodents) issues in the space.

2304
Housekeeping

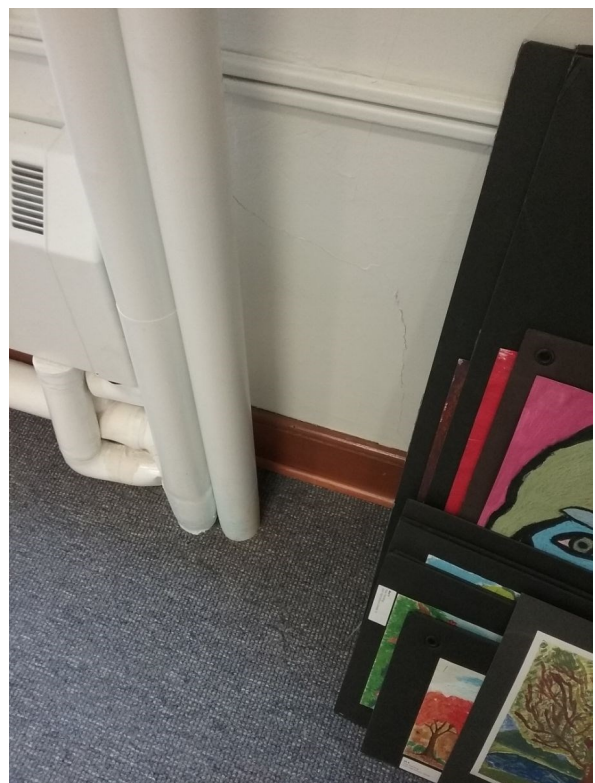
2002
Bubbling/Peeling Paint

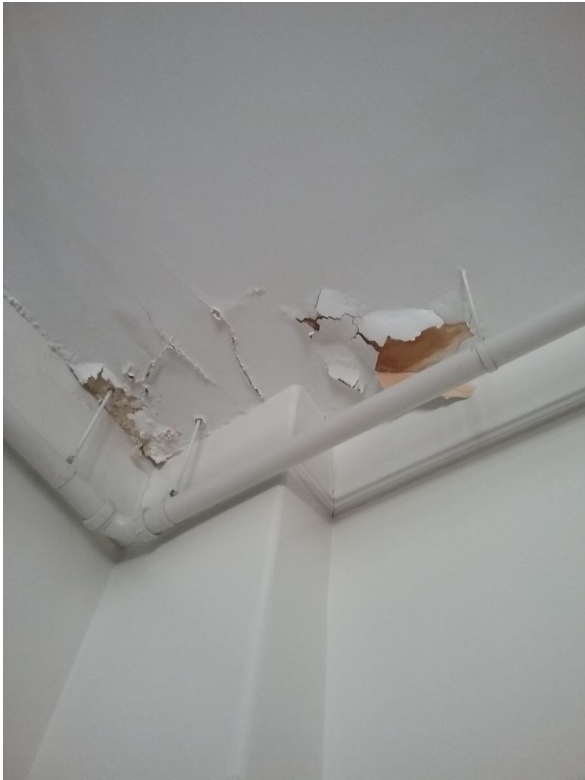
1302

Bubbling/Peeling Paint

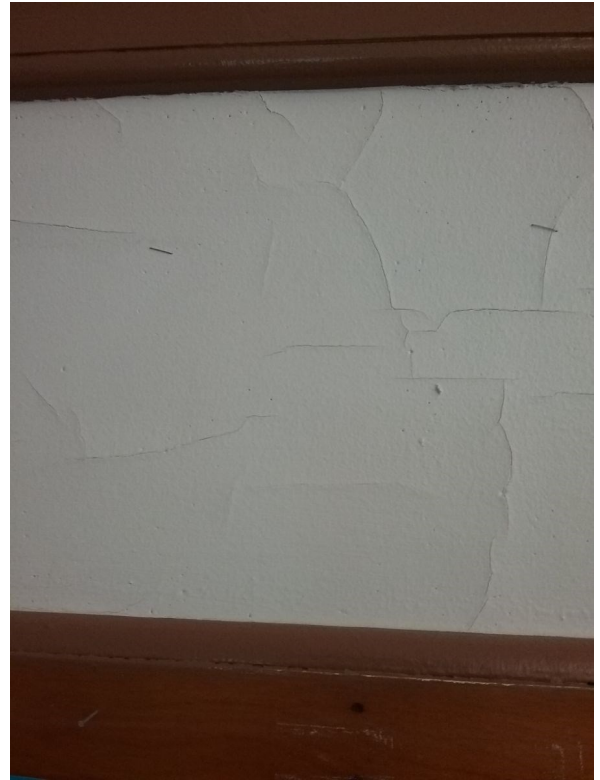
1304

Bubbling/Peeling Paint
