2023 - 2024 Ventilation Assessment

Saint Paul Public Schools L'Etoile du Nord - French Immersion

Assessment Date:
Wednesday, April 19, 2023

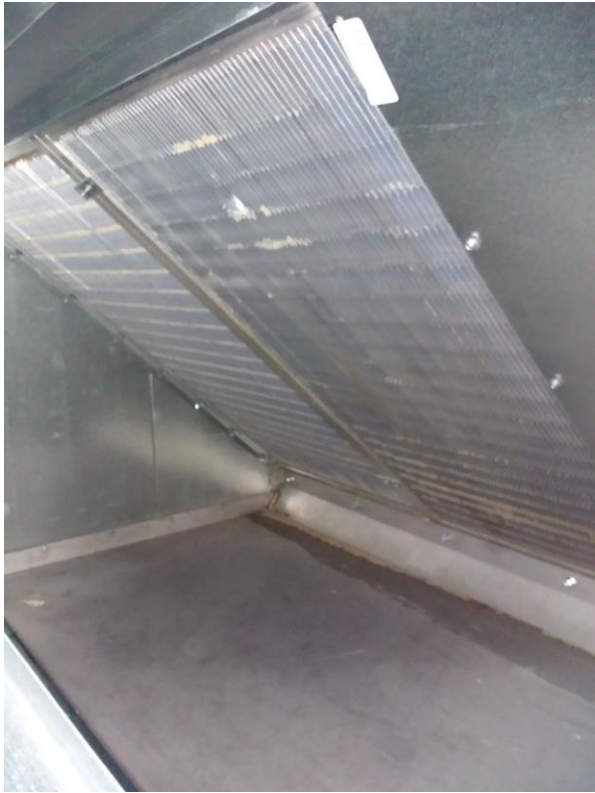
RTU1
Heat Wheel

| Filter Type - Outdoor <ul style="list-style-type: none"> Pre-filter: None Main filter: Pleated, MERV 11 | Outdoor air intake is in good condition. | Drain pans are not plugged. Drain pan condition is good. Heating coils are clean and cooling coils are clean. Heat wheels are dirty. |
