2022 - 2023 IAQ Walkthrough

Saint Paul Public Schools Maxfield Elementary School

Walkthrough Date:
Tuesday, December 13, 2022
Retest Date: January 26, 2023

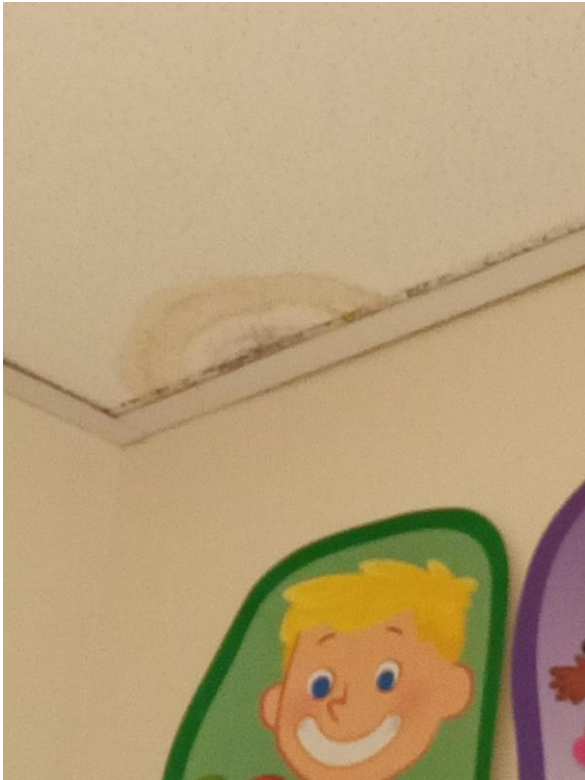
- 1503

Suspect Microbial Growth

IEA observed building materials with possible microbial growth that should be removed and/or cleaned under controlled conditions, per the Minnesota Department of Health *Recommended Best Practices for Mold Remediation in Minnesota Schools* guidelines

following the Institute of Inspection, Cleaning and Restoration (IICRC) S520 Standard and Guide for Professional Mold Remediation to prevent possible contamination of adjacent locations and impact to building occupants. Further assessment or fungal sampling may be necessary to identify a scope of work for a professional mold remediation contractor.

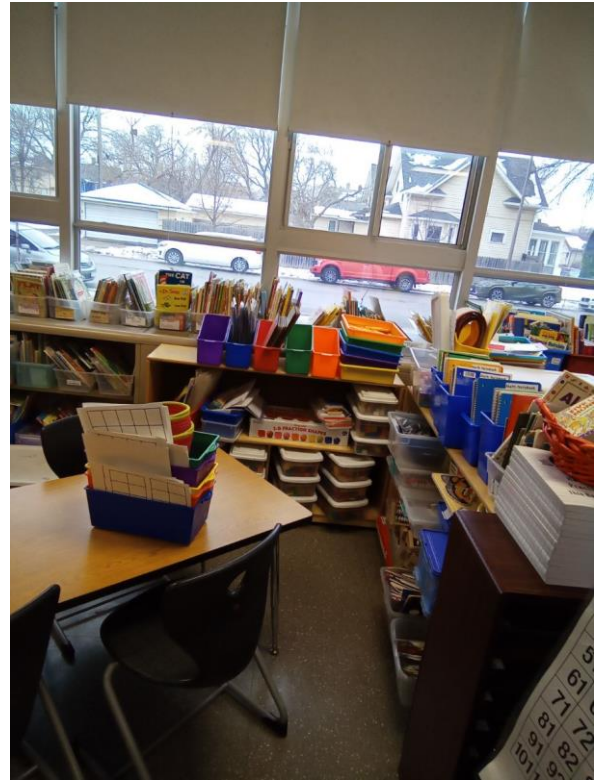
- 1105
- 1113 *Storage*

Housekeeping

Area(s) identified by IEA as having poor housekeeping (excessive clutter, excessive dust/debris on horizontal surfaces, etc.) were documented within the building. Poor housekeeping can limit building maintenance from conducting a proper cleaning of the area. This can result in elevated potential for allergen issues in sensitized individuals due to dirt and debris loading. Poor housekeeping can also allow for pest (insects and rodents) issues in the space.
