# 2022 - 2023 IAQ Walkthrough

## Saint Paul Public Schools Mississippi Elementary School

Walkthrough Date:  
Monday, November 21, 2022

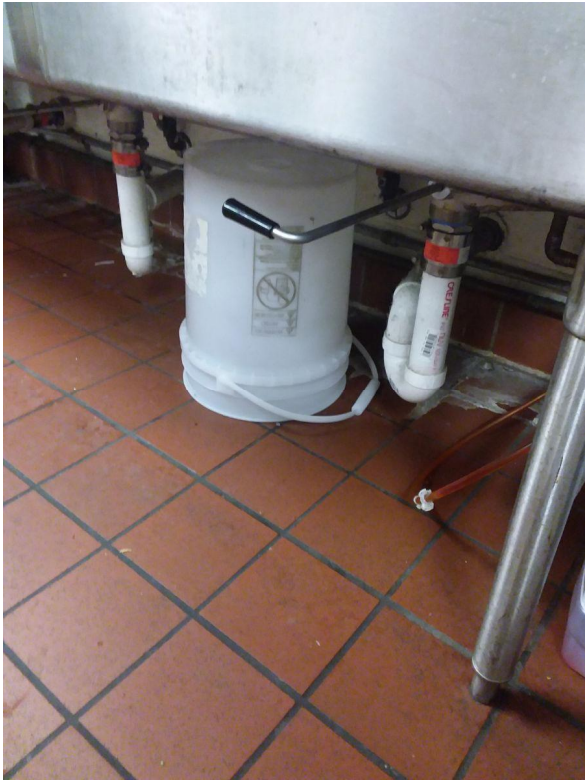
**KITCHEN**

Moisture-impacted building materials should be repaired or replaced when discoloration or water staining is observed. Moisture-impacted building materials can be a source for microbial growth. The source for the moisture infiltration should be investigated and repaired if not easily identified.

- KITCHEN

**Moisture Impacted Materials**

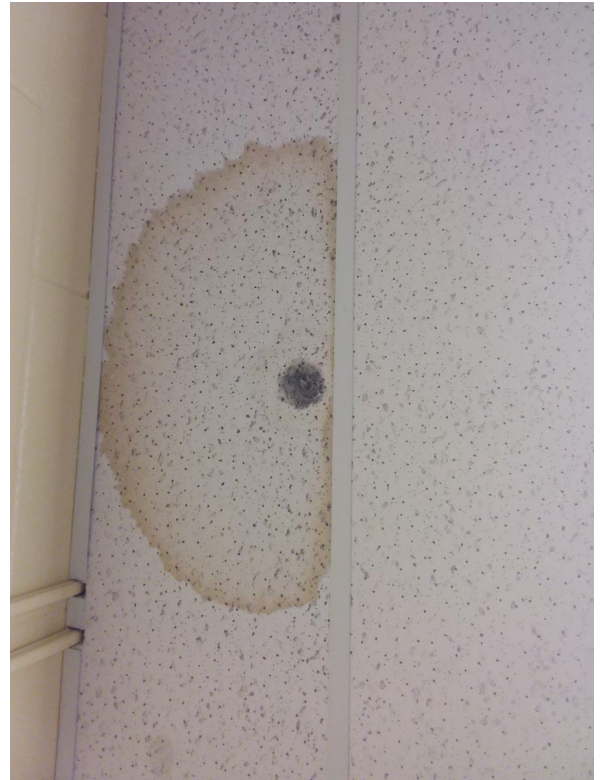
**1111**

Stained ceiling tiles were found in the room(s) shown below. The impacted ceiling tiles should be removed and replaced, and the cause of the moisture repaired.

IEA observed building materials with possible microbial growth that should be removed and/or cleaned under controlled conditions, per the Minnesota Department of Health *Recommended Best Practices for Mold Remediation in Minnesota Schools* guidelines (<https://www.health.state.mn.us/communities/environment/air/docs/schools/remediation.pdf>) or following the Institute of Inspection, Cleaning and Restoration (IICRC) S520 Standard and Guide for Professional Mold Remediation to prevent possible contamination of adjacent locations and impact to building occupants. Further assessment or fungal sampling may be necessary to identify a scope of work for a professional mold remediation contractor.

- 1111 *Associated with ceiling tile*

**Stained Ceiling Tiles**

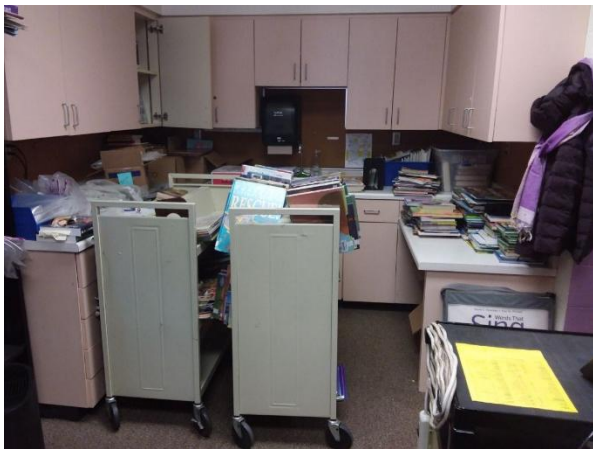
**1111A**

Area(s) identified by IEA as having poor housekeeping (excessive clutter, excessive dust/debris on horizontal surfaces, etc.) were documented within the building. Poor housekeeping can limit building maintenance from conducting a proper cleaning of the area. This can result in elevated potential for allergen issues in sensitized individuals due to dirt and debris loading. Poor housekeeping can also allow for pest (insects and rodents) issues in the space.

**Housekeeping**

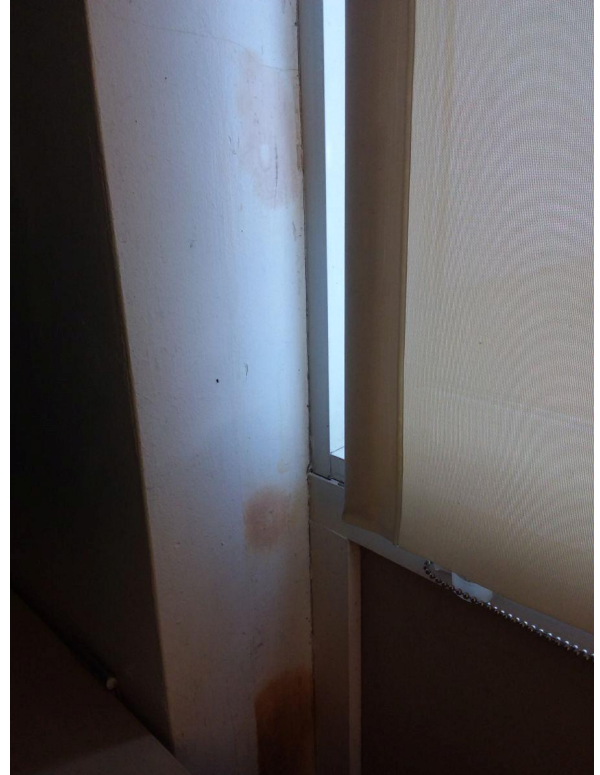
**1211**

IEA observed bubbling/peeling paint in area(s) within the room(s) listed below. Bubbling/peeling paint can be caused by moisture issues. IEA recommends investigating the cause and repairing the paint. IEA recommends ensuring that the paint is not lead-based prior to disturbance.

- 1211 *Dark spots throughout ledge under window*
- 1220 *On windowsill behind the air supply.*
- 1221 *Peeling paint on windowsill behind air supply*

**Bubbling/Peeling Paint**

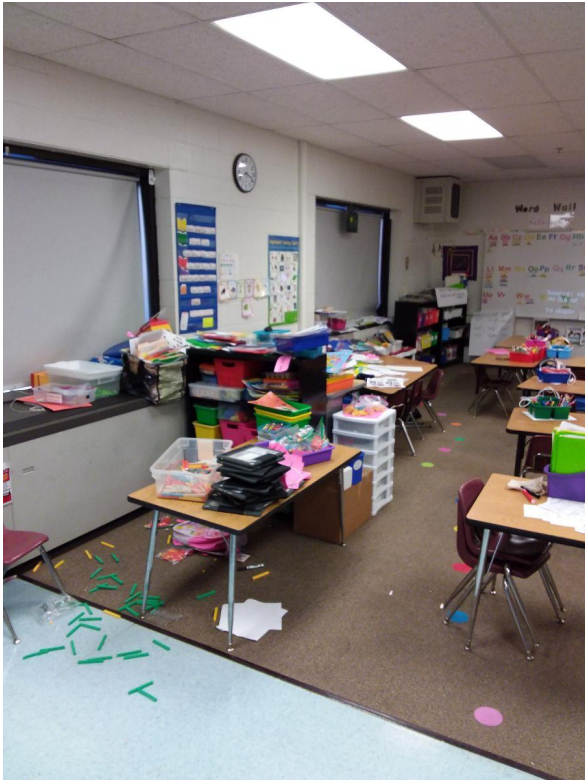
1311  
Housekeeping
