2023 - 2024 Ventilation Assessment

Saint Paul Public Schools Nokomis Montessori North

Assessment Date: Thursday, April 6, 2023

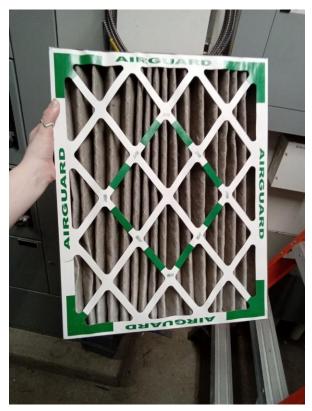
AHU_01 (100% OA) Outdoor Main Filter Cleanliness

ed for each unit below:	
Unit Designation:	AHU_01 (100% OA)		
Location of Unit:	Mechanical room 2201		
Areas Served:	Room 1102 Kitchen	1	
	See attached map		
System	None		
Enhancements:			
Supply System	Outdoor Air	Cleanliness and Observations	
Туре	Outdoor air intake	Outdoor air pre-filters are not present. Outdoor air main	
Supply System	is accessible	filters are somewhat dirty and on the border of needing

- Constant		replacement (scoring 3 out of 5) and fit well. Outdoor air	
Volume	Outdoor air intake	main filters are installed correctly.	
Heating - Hot	is located on an		
Water	exterior wall.	Return air filters are not present.	
Cooling - None

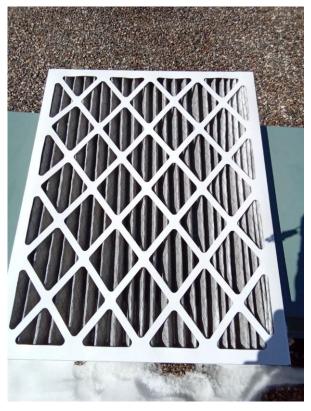
RTU_01 Mixed Main Filter Cleanliness

Unit Designation:	RTU_01	
Location of Unit:	Mechanical room roof access	
Areas Served:	See attached map	
System Enhancements:	None	
Supply System	Outdoor Air	Cleanliness and Observations
Type Supply System - Constant Volume Heating - Hot Water Cooling - None Energy Recovery Unit (ERU) - None Filter Type - Mixed Pre-filter: None Main filter:	Outdoor air intake is accessible Outdoor air intake is located on the roof. No nearby pollution sources were found. Outdoor air intake is in good condition.	Cleanliness and Observations Outdoor air filters are not present. Return air filters are not present. Mixed air pre-filters are not present. Mixed air main filters are somewhat dirty and on the border of needing replacement (scoring 3 out of 5) and fit well. Mixed air main filters are installed correctly. Drain pans are not applicable or not present. Drain pan condition is not known. Heating coils are clean. Heat wheels are not present. Exterior ducting is not visible. Exterior ducting insulation is in an unknown condition. Interior ducting is not visible. Interior ducting insulation is in an unknown condition. Interior ducting is of unknown cleanliness. Air handling room is free of trash/chemicals. Outside damper is open, and its condition is good.

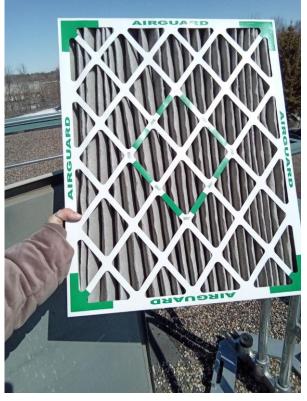
RTU_03 Mixed Main Filter Cleanliness

Unit Designation: RTU_03			
Locatio	on of Unit:	Mechanical room Roof over Gym	
Areas S	erved:	Room 1111 Gym N	North
		See attached map	
System	Enhancements:	None	
Su	pply System	Outdoor Air	Cleanliness and Observations
Type • • • • •	Water Cooling - None Energy Recovery Unit (ERU) - None ype - Mixed Pre-filter: None Main filter:	accessible Outdoor air intake is located on the roof. No nearby pollution sources were found.	Outdoor air filters are not present. Return air filters are not present. Mixed air pre-filters are not present. Mixed air main filters are somewhat dirty and on the border of needing replacement (scoring 4 out of 5) and fit well. Mixed air main filters are installed correctly. Drain pans are not applicable or not present. Drain pan condition is not known. Heating coils are clean. Heat wheels are not present. Exterior ducting is not visible. Exterior ducting insulation is in an unknown condition. Interior ducting is not visible. Interior ducting insulation is in an unknown condition. Interior ducting is of unknown cleanliness. Air handling room is free of trash/chemicals. Outside damper is open, and its condition is good.

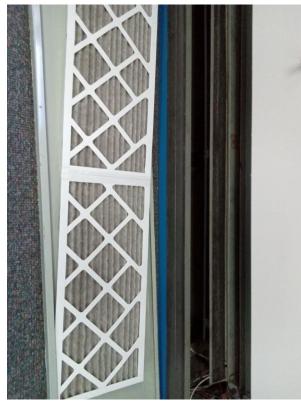
UV-1406 Mixed Main Filter Cleanliness

Unit Designation:	UV-1406	
Location of Unit:	1406	
Areas Served:	1406	
System Enhancements:	ts: None	
Supply System	Outdoor Air	Cleanliness and Observations
 Supply System - Constant Volume Heating - Hot Water Cooling - None Energy Recovery Unit (ERU) - None 	accessible Outdoor air intake is located on an exterior wall. No nearby pollution sources were found. Outdoor air intake is in good condition.	Outdoor air pre-filters are not present. Outdoor air main filters are not present. Return air filters are not present. Mixed air main filters are dirty and in need of replacement (scoring 5 out of 5) and fit well. Mixed air main filters are installed correctly. Drain pans are not applicable or not present. Drain pan condition is not known. Heating coils are clean. Heat wheels are not present. Exterior ducting is not visible. Exterior ducting insulation is in an unknown condition. Interior ducting is not visible. Interior ducting insulation is in an unknown condition. Interior ducting is of unknown cleanliness. Air handling room is free of trash/chemicals. Outside damper is open, and its condition is good. Return damper is open, and its condition is good.

Dirty or poorly fitting filters were observed in units UV-1, UV-1406, UV-15, UV-18 and UV-3 during the ventilation inspection.

Recommendation: The operations and maintenance program for filter changes should be reviewed and revised to ensure proper filter changes to optimize filtration capacity.

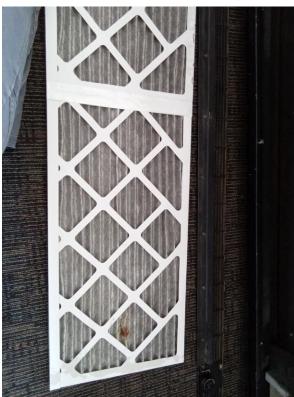
UV-15 Mixed Main Filter Cleanliness

Unit Desi	ignation:	UV-15	
Location	of Unit:	1301, south wall	
Areas Se	rved:	1301	
System E	nhancements:	None	
Sup	oly System	Outdoor Air	Cleanliness and Observations
C V • F V • C • E R (1 Filter Typ • P • N • P	upply System - Constant /olume leating - Hot Vater Cooling - None Energy Recovery Unit ERU) - None	accessible Outdoor air intake is located on an exterior wall. No nearby pollution sources were found.	Outdoor air filters are not present. Return air filters are not present. Mixed air pre-filters are not present. Mixed air main filters are dirty and in need of replacement (scoring 5 out of 5) and fit well. Mixed air main filters are installed correctly. Drain pans are not plugged. Drain pan condition is good. Heating coils are clean. Heat wheels are not present. Exterior ducting is not visible. Exterior ducting insulation is in an unknown condition. Interior ducting is not visible. Interior ducting insulation is in an unknown condition. Interior ducting is of unknown cleanliness. Air handling room is free of trash/chemicals. Outside damper is open, and its condition is good. Return damper is open, and its condition is good.

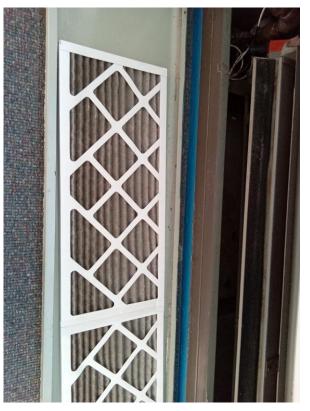
UV-18 Mixed Main Filter Cleanliness

Unit Designation:	UV-18	
Location of Unit:	1307	
Areas Served:	1307	
System Enhancements:	None	
Supply System	Outdoor Air	Cleanliness and Observations
Supply System • Supply System - Constant Volume • Heating - Hot Water • Cooling - None • Energy Recovery Unit (ERU) - None Filter Type - Mixed • Pre-filter: None • Main filter: Pleated, MERV 11	Outdoor air intake is accessible Outdoor air intake is located on an exterior wall. No nearby pollution sources were found. Outdoor air intake is	Outdoor air filters are not present. Return air filters are not present. Mixed air pre-filters are not present. Mixed air main filters are dirty and in need of replacement (scoring 5 out of 5) and fit well. Mixed air main filters are installed correctly. Drain pans are not applicable or not present. Drain pan condition is not known. Heating coils are clean. Heat wheels are not present. Exterior ducting is not visible. Exterior ducting insulation is in an unknown condition. Interior ducting is not visible. Interior ducting insulation is in an unknown condition. Interior ducting is of unknown cleanliness. Air handling room is free of trash/chemicals. Outside damper is open, and its condition is good. Return damper is open, and its condition is good. The general condition of the unit is good.

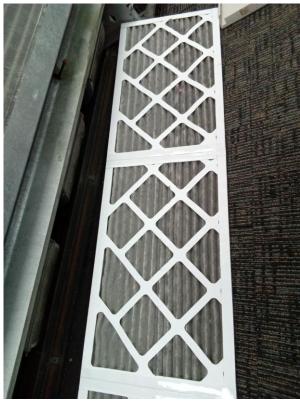
UV-3 Mixed Main Filter Cleanliness

Unit Designation:	UV-3	
Location of Unit:	1207	
Areas Served:	1207	
System Enhancements:	None	
Supply System	Outdoor Air	Cleanliness and Observations
Type Supply System - Constant Volume Heating - Hot Water Cooling - None Energy Recovery Unit (ERU) - None	Outdoor air intake is located on an exterior wall. No nearby pollution sources were found.	Outdoor air filters are not present. Return air filters are not present. Mixed air pre-filters are not present. Mixed air main filters are dirty and in need of replacement (scoring 5 out of 5) and fit well. Mixed air main filters are installed correctly. Drain pans are not plugged. Drain pan condition is good.
Filter Type - Mixed Pre-filter: None Main filter: Pleated, MERV 11	Outdoor air intake is in good condition.	 Heating coils are clean. Heat wheels are not present. Exterior ducting is not visible. Exterior ducting insulation is in an unknown condition. Interior ducting is not visible. Interior ducting insulation is in an unknown condition. Interior ducting is of unknown cleanliness. Air handling room is free of trash/chemicals. Outside damper is open, and its condition is good. Return damper is open, and its condition is good. The general condition of the unit is good.

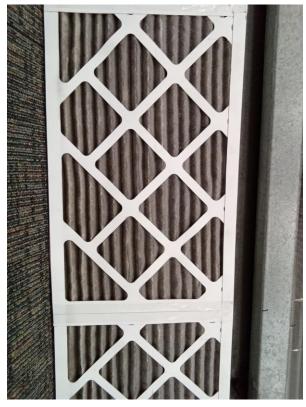
UV-1 Mixed Main Filter Cleanliness

Unit Designation:	UV-1	
Location of Unit:	1203	
Areas Served:	1203	
System Enhancements:	None	
Supply System	Outdoor Air	Cleanliness and Observations
	Outdoor air intake is located on an exterior wall. No nearby pollution sources were found.	Outdoor air filters are not present. Return air filters are not present. Mixed air pre-filters are not present. Mixed air main filters are dirty and in need of replacement (scoring 5 out of 5) and fit well. Mixed air main filters are installed correctly. Drain pans are not plugged. Drain pan condition is good.
Filter Type - Mixed Pre-filter: None Main filter: Pleated, MERV 11	Outdoor air intake is in good condition.	 Heating coils are clean. Heat wheels are not present. Exterior ducting is not visible. Exterior ducting insulation is in an unknown condition. Interior ducting is not visible. Interior ducting insulation is in an unknown condition. Interior ducting is of unknown cleanliness. Air handling room is free of trash/chemicals. Outside damper is open, and its condition is good. Return damper is open, and its condition is good. The general condition of the unit is good.

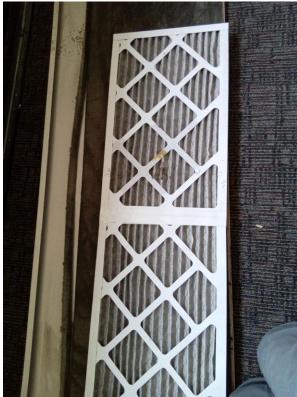
UV-10 Mixed Main Filter Cleanliness

- Constant Volume	Outdoor air intake is	Return air filters are not present.
		Mixed air pre-filters are not present. Mixed air main filters
Water	exterior wall.	are somewhat dirty and on the border of needing
Cooling - None		replacement (scoring 4 out of 5) and fit well. Mixed air main
Energy	No nearby pollution	filters are installed correctly.
	sources were found.	,
(ERU) - None		Drain pans are not plugged. Drain pan condition is good.
	Outdoor air intake is	
Filter Type - Mixed	in good condition.	Heating coils are clean.
Pre-filter:		
NoneMain filter:		Heat wheels are not present.
Pleated, MERV		Exterior ducting is not visible. Exterior ducting insulation is
11		in an unknown condition.
		Interior ducting is not visible. Interior ducting insulation is in
		an unknown condition. Interior ducting is of unknown
		cleanliness.
		Air handling room is free of trash/chemicals.
		Outside damper is open, and its condition is good.

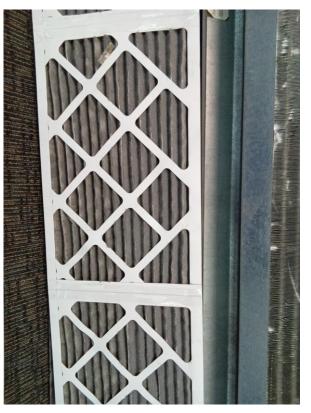
UV-6 Mixed Main Filter Cleanliness

- Constant		Return air filters are not present.
	Outdoor air intake is located on an	Mixed air pro filters are not present. Mixed air main filters
Ũ		Mixed air pre-filters are not present. Mixed air main filters are somewhat dirty and on the border of needing
Cooling - None		replacement (scoring 4 out of 5) and fit well. Mixed air main
_		filters are installed correctly.
	sources were found.	
(ERU) - None		Drain pans are not plugged. Drain pan condition is good.
	Outdoor air intake is	
	in good condition.	Heating coils are clean.
Pre-filter:		
None		Heat wheels are not present.
Main filter:		Exterior ducting is not visible. Exterior ducting insulation is
Pleated, MERV 11		Exterior ducting is not visible. Exterior ducting insulation is in an unknown condition.
		Interior ducting is not visible. Interior ducting insulation is in
		an unknown condition. Interior ducting is of unknown
		cleanliness.
		Air handling room is free of trash/chemicals.

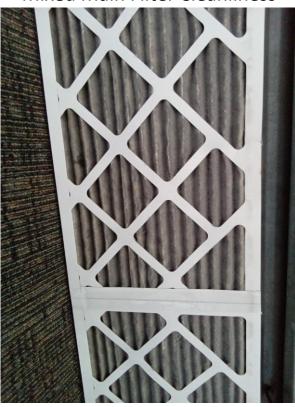
UV-8 Mixed Main Filter Cleanliness

Unit Designation:	UV-8	
Location of Unit:	2207	
Areas Served:	2207	
System	None	
Enhancements:		
Supply System	Outdoor Air	Cleanliness and Observations
<u>Type</u>		Outdoor air filters are not present.
Supply System Constant	inaccessible	Daturn air filtars are not present
Volume	Outdoor air intake is	Return air filters are not present.
		Mixed air pre-filters are not present. Mixed air main filters
_		are somewhat dirty and on the border of needing
Cooling - None		replacement (scoring 4 out of 5) and fit well. Mixed air main
		filters are installed correctly.
	sources were found.	
(ERU) - None		Drain pans are not plugged. Drain pan condition is good.
	Outdoor air intake is	
 Filter Type - Mixed Pre-filter: 	in good condition.	Heating coils are clean.

• Pre-Inter. None		Heat wheels are not present.
Main filter:		
Pleated, MERV		Exterior ducting is not visible. Exterior ducting insulation is
11		in an unknown condition.
		Interior ducting is not visible. Interior ducting insulation is in
		an unknown condition. Interior ducting is of unknown
		cleanliness.
		Air handling room is free of trash/chemicals.
		Outside damper is open, and its condition is good.
		Return damper is open, and its condition is good.
		The general condition of the unit is good.
