2022 - 2023 IAQ Walkthrough

Saint Paul Public Schools Obama Elementary School

Walkthrough Date:
Tuesday, December 6, 2022

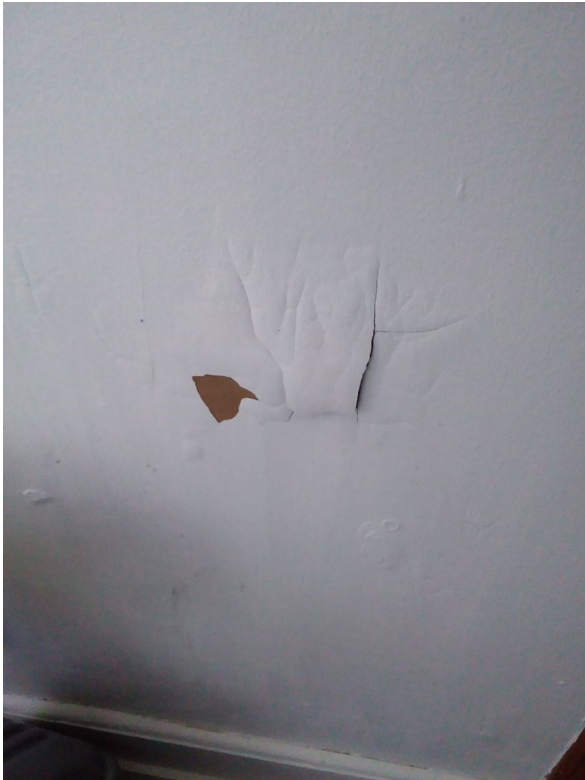
1305

IEA observed bubbling/peeling paint in area(s) within the room(s) listed below.

Bubbling/Peeling Paint

Bubbling/peeling paint can be caused by moisture issues. IEA recommends investigating the cause and repairing the paint. IEA recommends ensuring that the paint is not lead-based prior to disturbance.

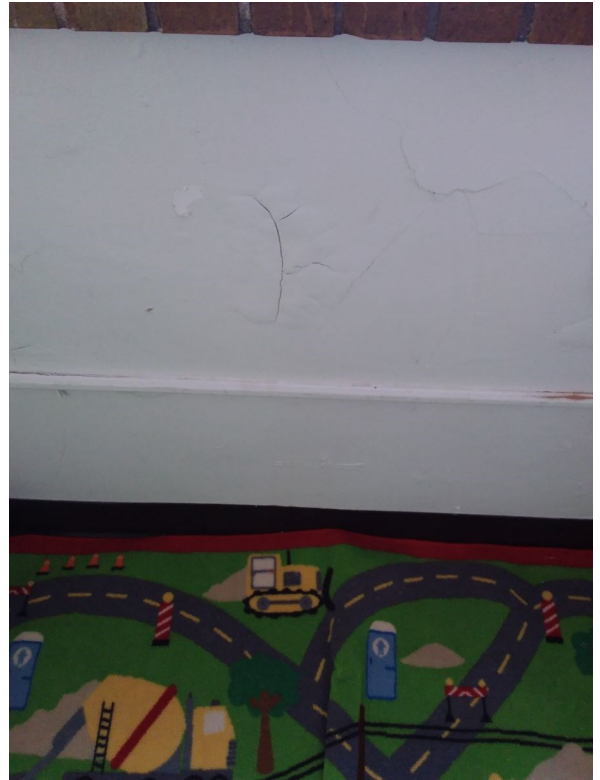
1306

Bubbling/Peeling Paint

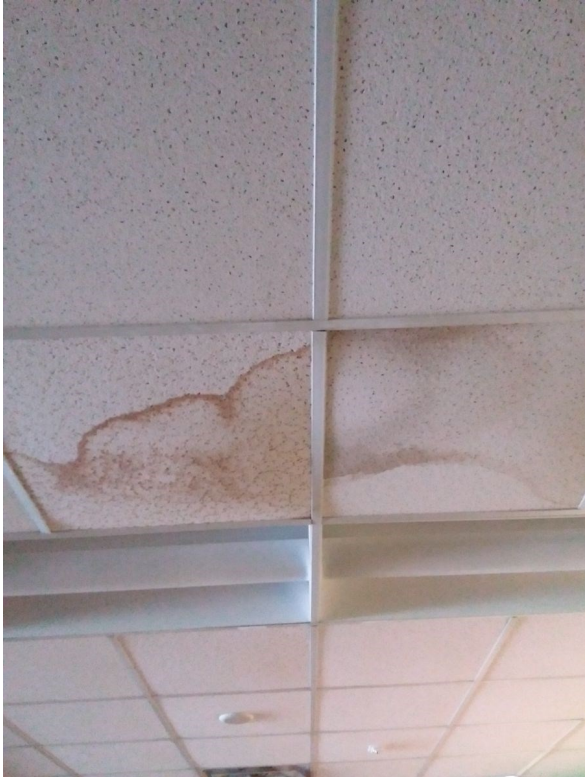
Stained ceiling tiles were found in the room(s) shown below. The impacted ceiling tiles should be removed and replaced, and the cause of the moisture repaired.

MEDIA CENTER WEST
Stained Ceiling Tiles

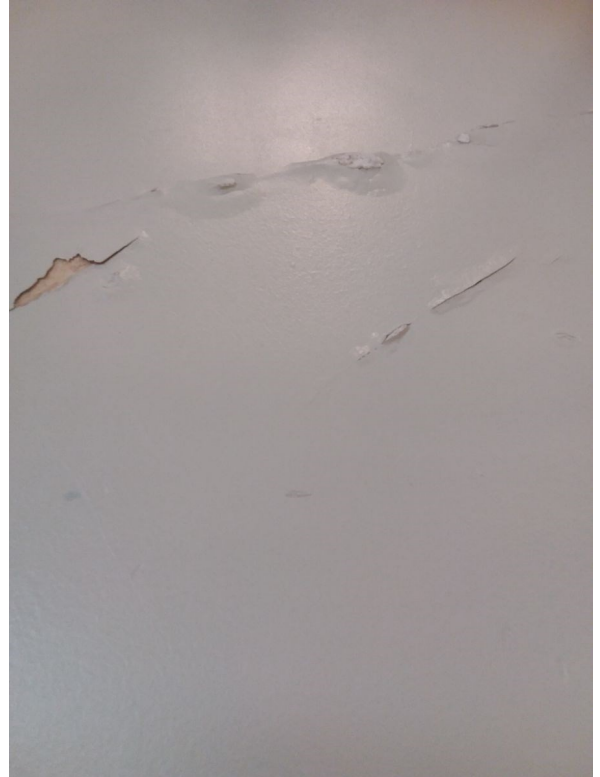
1201 GYMNASIUM
Bubbling/Peeling Paint

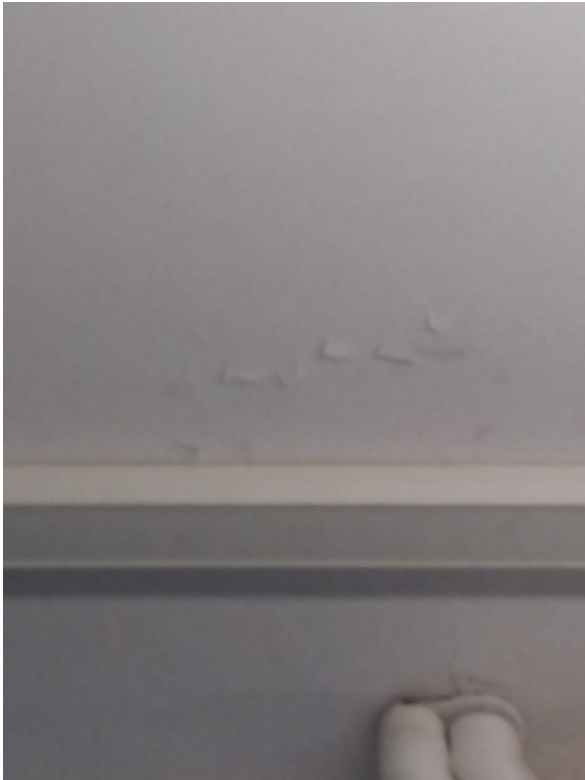
2208

Bubbling/Peeling Paint

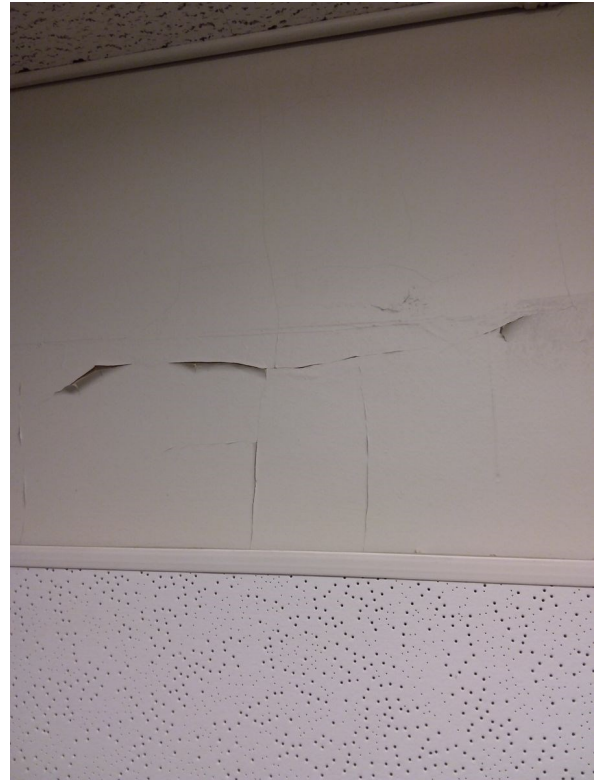
2230

Bubbling/Peeling Paint

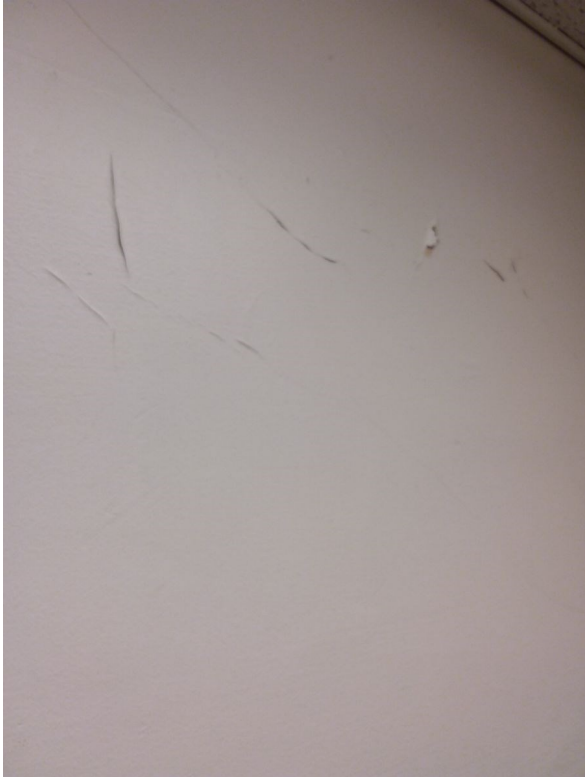
2229

Bubbling/Peeling Paint

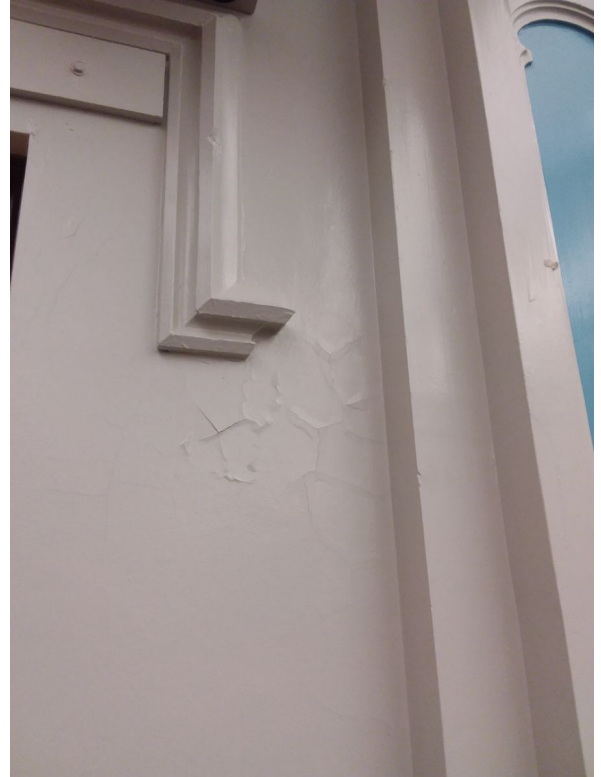
2224

Bubbling/Peeling Paint

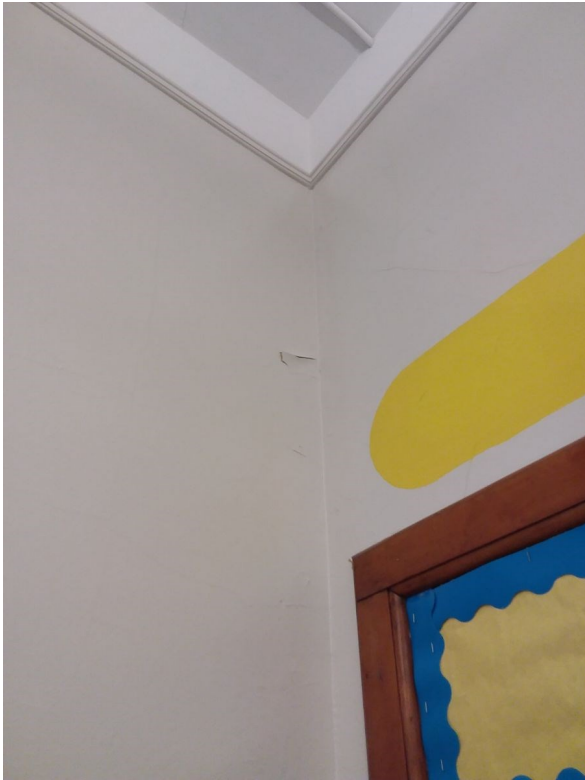
3216

Bubbling/Peeling Paint

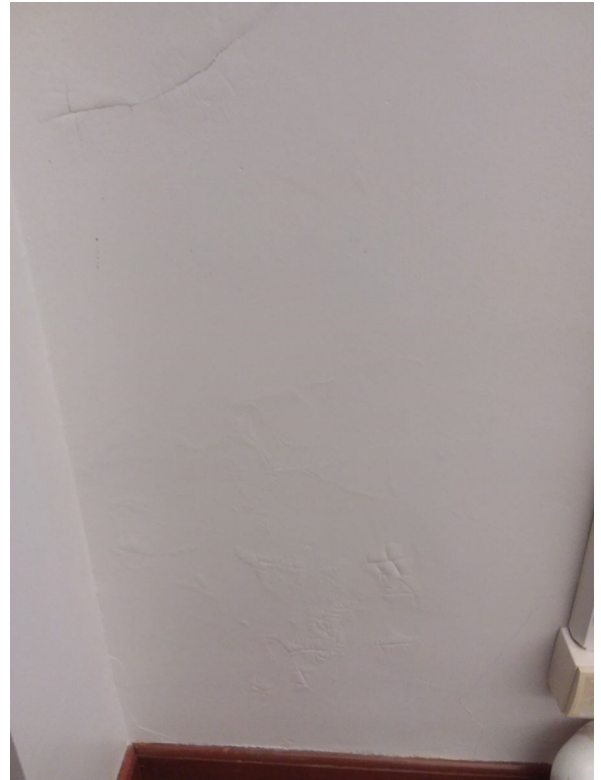
3214

Bubbling/Peeling Paint
