## 2022 - 2023 IAQ Walkthrough

## Saint Paul Public Schools Randolph Heights Elementary School

Walkthrough Date:  
Tuesday, January 17, 2023

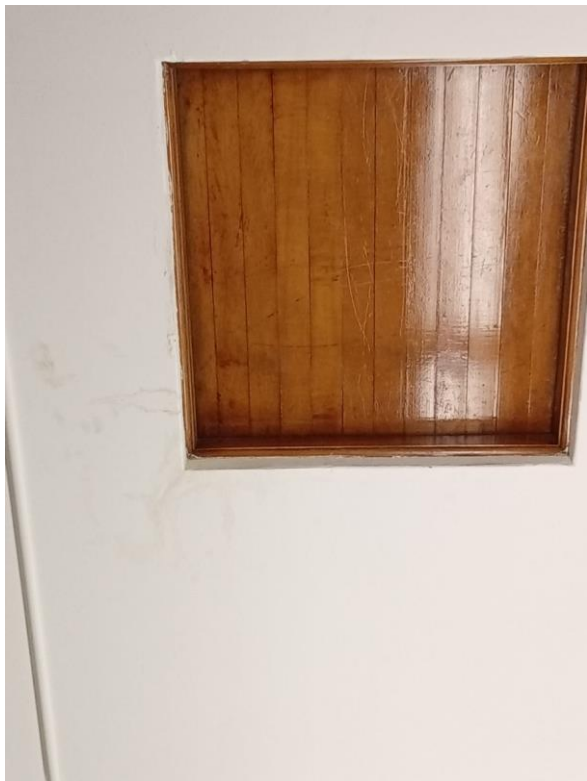
| Room / Location | Number of Occupants | Odor Present | Observations | Dust Accumulation | CO <sub>2</sub> (ppm) | CO (ppm) | RH (%) | Temp (°F) |
|---|---|---|---|---|---|---|---|---|
| 2212 | 1 | No | • Moisture Impacted Materials:<br>See Appendix A | No | 870 | 0.8 | 29.7 | 69.6 |

Moisture-impacted building materials should be repaired or replaced when discoloration or water staining is observed. Moisture-impacted building materials can be a source for microbial growth. The source for the moisture infiltration should be investigated and repaired if not easily identified.

Moisture-Impacted Materials

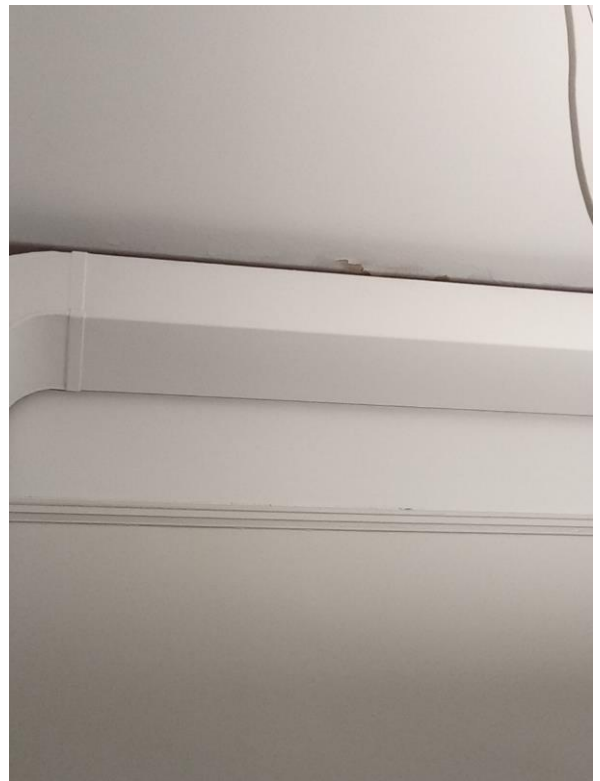
| Room / Location | Number of Occupants | Odor Present | Observations | Dust Accumulation | CO <sub>2</sub> (ppm) | CO (ppm) | RH (%) | Temp (°F) |
|---|---|---|---|---|---|---|---|---|
| 2003 | 0 | No | <ul style="list-style-type: none"> <li>Bubbling/Peeling Paint: See Appendix A</li> </ul> | No | 685 | 0.6 | 28.4 | 70.7 |

IEA observed bubbling/peeling paint in area(s) within the room(s) listed below. Bubbling/peeling paint can be caused by moisture issues. IEA recommends investigating the cause and repairing the paint. IEA recommends ensuring that the paint is not lead-based prior to disturbance.

Bubbling/Peeling Paint
