## 2022 - 2023 IAQ Walkthrough

## Saint Paul Public Schools Rondo Education Center

Walkthrough Date:  
Tuesday, December 13, 2022  
Retest Date: January 26, 2023

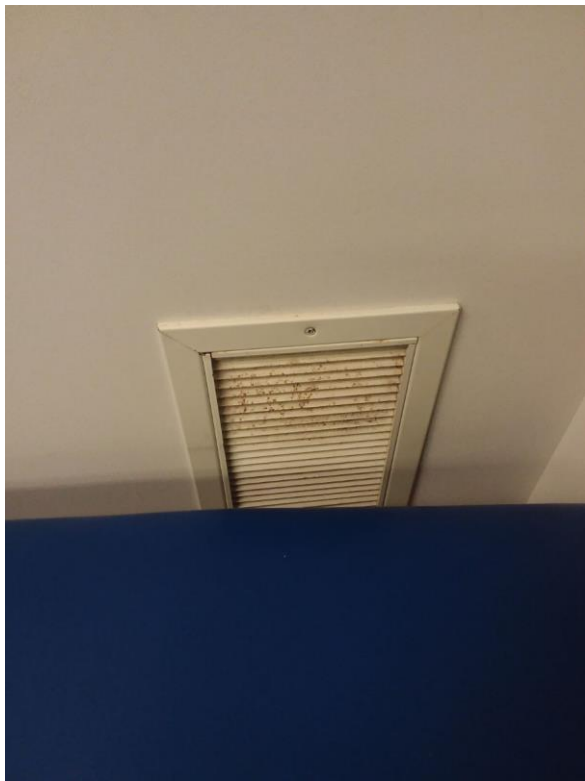
| Room / Location | Number of Occupants | Odor Present | Observations | Dust Accumulation | CO <sub>2</sub> (ppm) | CO (ppm) | RH (%) | Temp (°F) |
|---|---|---|---|---|---|---|---|---|
| 2203 | 0 | No | <ul style="list-style-type: none"> <li>Moisture Impacted Materials:<br/>See Appendix A</li> <li>Stained Ceiling Tiles</li> </ul> | No | 491 | 0.3 | 22.0 | 73.4 |

Moisture-Impacted Materials

Moisture-impacted building materials should be repaired or replaced when discoloration or water staining is observed. Moisture-impacted building materials can be a source for microbial growth. The source for the moisture infiltration should be investigated and repaired if not easily identified.

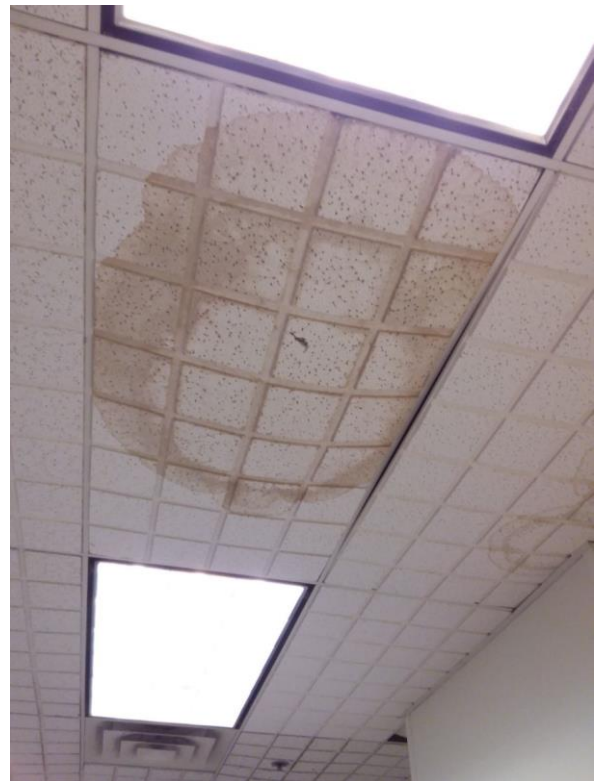
| Room / Location | Number of Occupants | Odor Present | Observations | Dust Accumulation | CO <sub>2</sub> (ppm) | CO (ppm) | RH (%) | Temp (°F) |
|---|---|---|---|---|---|---|---|---|
| 2613 | 24 | No | <ul style="list-style-type: none"> <li>Stained Ceiling Tiles: See Appendix A</li> </ul> | No | 710 | 0.1 | 26.5 | 70.2 |

Stained Ceiling Tiles

Stained ceiling tiles were found in the room(s) shown below. The impacted ceiling tiles should be removed and replaced, and the cause of the moisture repaired.
