2023 - 2024 Ventilation Assessment

Saint Paul Public Schools St. Anthony Park Elementary School

Assessment Date:
Tuesday, April 18, 2023

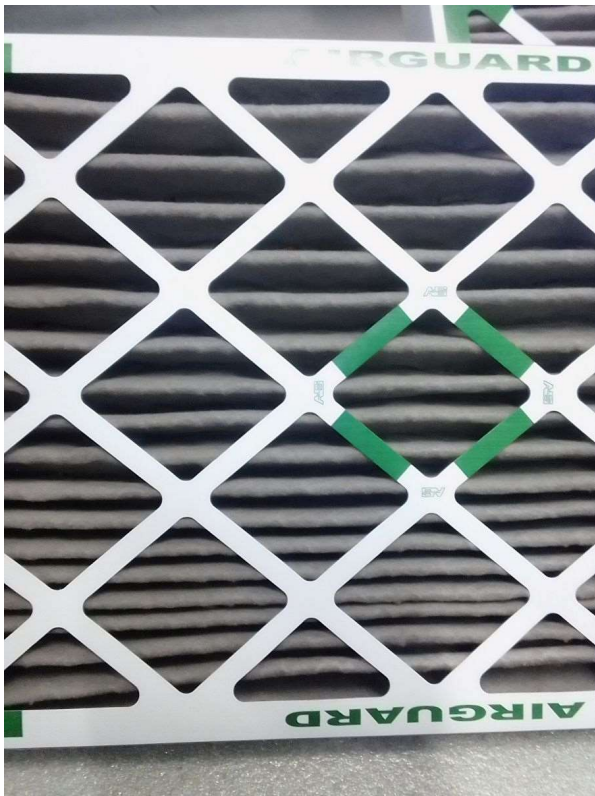
Unit Designation:	AHU4	
Location of Unit:	Mechanical room 2407	
Areas Served:	Center Classrooms 2nd Flr See attached map	
System Enhancements:	None	
Supply System	Outdoor Air	Cleanliness and Observations
Type <ul style="list-style-type: none"> Supply System - VAV Heating - Hot Water Cooling - None Energy Recovery Unit (ERU) - Fixed Plate 	<p>Outdoor air intake is accessible</p> <p>Outdoor air intake is located on the roof.</p> <p>No nearby pollution sources were found.</p>	<p>Outdoor air filters are not present.</p> <p>Return air filters are not present.</p> <p>Mixed air pre-filters are not present. Mixed air main filters are somewhat dirty and on the border of needing replacement (scoring 3 out of 5) and fit well. Mixed air main filters are installed correctly.</p> <p>Drain pans are not applicable or not present. Drain pan condition is not known.</p>
Filter Type - Mixed <ul style="list-style-type: none"> Pre-filter: None Main filter: Pleated, MERV 13 	<p>Outdoor air intake is in good condition.</p>	<p>Heating coils are clean.</p> <p>Heat wheels are clean.</p> <p>Exterior ducting is visible. Exterior ducting insulation is in good condition.</p> <p>Interior ducting is not visible. Interior ducting insulation is in an unknown condition. Interior ducting is of unknown cleanliness.</p> <p>Air handling room is free of trash/chemicals.</p> <p>Outside damper is open, and its condition is good.</p> <p>Return damper is open, and its condition is good.</p> <p>The general condition of the unit is good.</p>

Mixed Main Filter Cleanliness

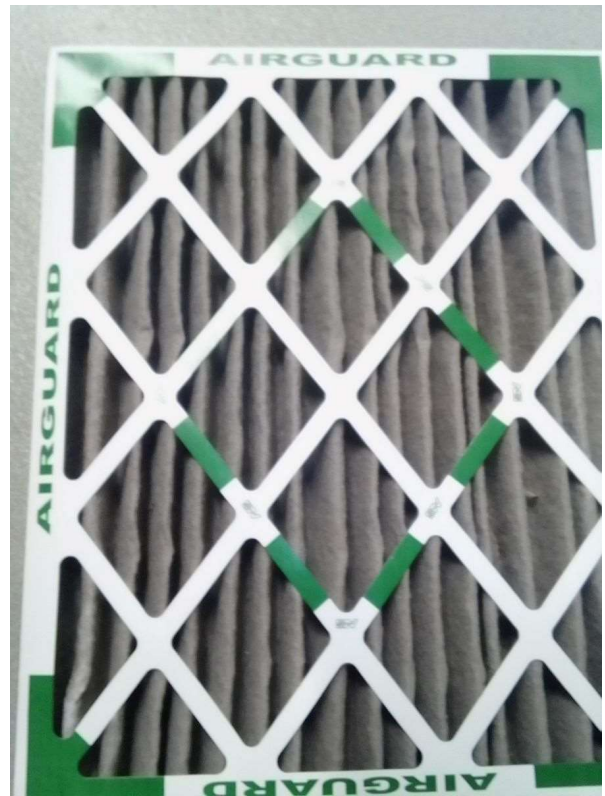
Unit Designation:	AHU5	
Location of Unit:	Mechanical room 1101 C	
Areas Served:	West Wing Classrooms 1st Flr See attached map	
System Enhancements:	None	
Supply System	Outdoor Air	Cleanliness and Observations
Type <ul style="list-style-type: none"> Supply System - VAV Heating - Hot Water Cooling - None Energy Recovery Unit (ERU) - Fixed Plate 	Outdoor air intake is accessible Outdoor air intake is located on the roof. No nearby pollution sources were found.	Outdoor air filters are not present. Return air filters are not present. Mixed air pre-filters are not present. Mixed air main filters are somewhat dirty and on the border of needing replacement (scoring 3 out of 5) and fit well. Mixed air main filters are installed correctly. Drain pans are not applicable or not present. Drain pan condition is not known.
Filter Type - Mixed <ul style="list-style-type: none"> Pre-filter: None Main filter: Pleated, MERV 13 	Outdoor air intake is in good condition.	Heating coils are clean. Heat wheels are clean. Exterior ducting is visible. Exterior ducting insulation is in good condition. Interior ducting is not visible. Interior ducting insulation is in an unknown condition. Interior ducting is of unknown cleanliness. Air handling room is free of trash/chemicals. Outside damper is open, and its condition is good. Return damper is open, and its condition is good. The general condition of the unit is good.

Mixed Main Filter Cleanliness

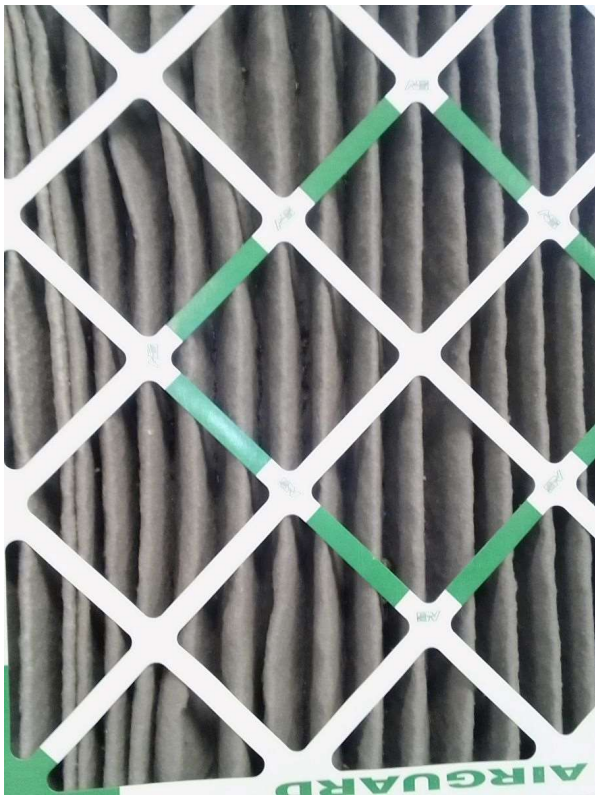
Unit Designation:	AHU7	
Location of Unit:	Mechanical room 1101 C	
Areas Served:	Cafeteria See attached map	
System Enhancements:	None	
Supply System	Outdoor Air	Cleanliness and Observations
Type <ul style="list-style-type: none"> Supply System - Constant Volume Heating - Hot Water Cooling - None Energy Recovery Unit (ERU) - Fixed Plate 	Outdoor air intake is accessible Outdoor air intake is located on the roof. No nearby pollution sources were found.	Outdoor air filters are not present. Return air filters are not present. Mixed air pre-filters are not present. Mixed air main filters are somewhat dirty and on the border of needing replacement (scoring 3 out of 5) and fit well. Mixed air main filters are installed correctly. Drain pans are not applicable or not present. Drain pan condition is not known.
Filter Type - Mixed <ul style="list-style-type: none"> Pre-filter: None Main filter: Pleated, MERV 13 	Outdoor air intake is in good condition.	Heating coils are clean. Heat wheels are clean. Exterior ducting is visible. Exterior ducting insulation is in good condition. Interior ducting is not visible. Interior ducting insulation is in an unknown condition. Interior ducting is of unknown cleanliness. Air handling room is free of trash/chemicals. Outside damper is open, and its condition is good. Return damper is open, and its condition is good. The general condition of the unit is good.

Mixed Main Filter Cleanliness

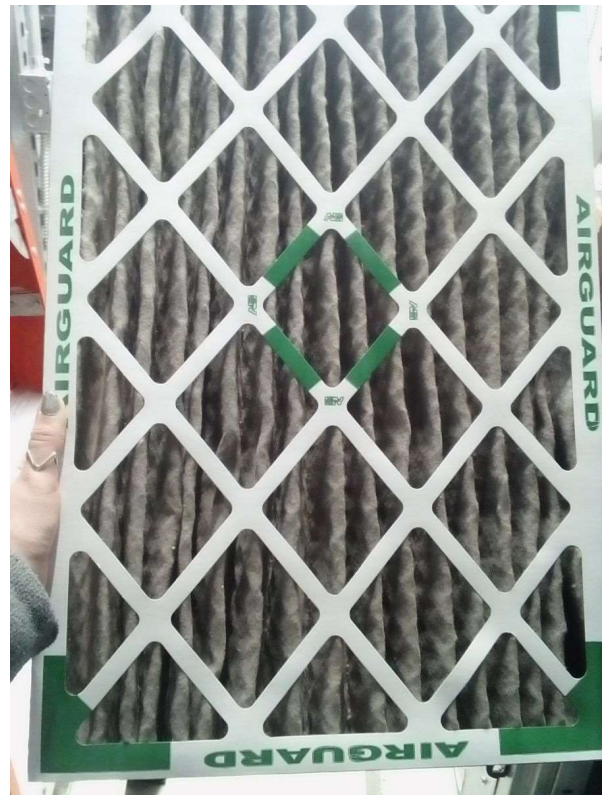
Unit Designation:	AHU8	
Location of Unit:	Mechanical room 2316 (S. Roof)	
Areas Served:	South Science Classrooms See attached map	
System Enhancements:	None	
Supply System	Outdoor Air	Cleanliness and Observations
Type <ul style="list-style-type: none"> Supply System - VAV Heating - Hot Water Cooling - None Energy Recovery Unit (ERU) - Fixed Plate 	Outdoor air intake is accessible Outdoor air intake is located on the roof. No nearby pollution sources were found.	Outdoor air filters are not present. Return air filters are not present. Mixed air pre-filters are not present. Mixed air main filters are somewhat dirty and on the border of needing replacement (scoring 3 out of 5) and fit well. Mixed air main filters are installed correctly. Drain pans are not applicable or not present. Drain pan condition is not known.
Filter Type - Mixed <ul style="list-style-type: none"> Pre-filter: None Main filter: Pleated, MERV 13 	Outdoor air intake is in good condition.	Heating coils are clean. Heat wheels are inaccessible. Exterior ducting is visible. Exterior ducting insulation is in good condition. Interior ducting is not visible. Interior ducting insulation is in an unknown condition. Interior ducting is of unknown cleanliness. Air handling room is free of trash/chemicals. Outside damper is open, and its condition is good. Return damper is open, and its condition is good. The general condition of the unit is good.

Mixed Main Filter Cleanliness

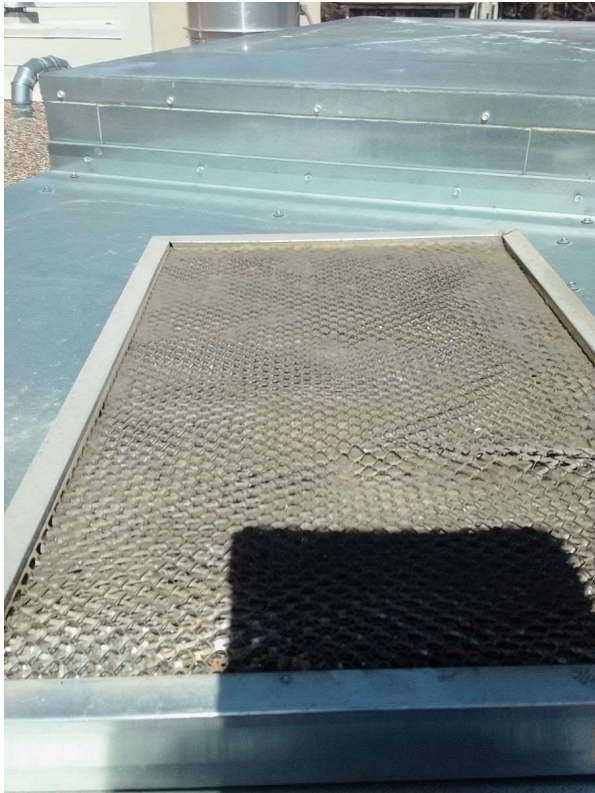
Unit Designation:	MAU1 (100% OA)	
Location of Unit:	Mechanical room Roof, access from 1113	
Areas Served:	Kitchen See attached map	
System Enhancements:	None	
Supply System	Outdoor Air	Cleanliness and Observations
Type <ul style="list-style-type: none"> Supply System - Constant Volume Heating - None Cooling - None Energy Recovery Unit (ERU) - None 	Outdoor air intake is accessible	Outdoor air pre-filters are not present. Outdoor air main filters are somewhat dirty and on the border of needing replacement (scoring 3 out of 5) and fit well. Outdoor air main filters are installed correctly.
	Outdoor air intake is located on the roof.	Return air filters are not present.
	No nearby pollution sources were found.	Drain pans are not applicable or not present. Drain pan condition is not known.
Filter Type - Outdoor <ul style="list-style-type: none"> Pre-filter: None Main filter: Metal Mesh, N/A 	Outdoor air intake is in good condition.	Heat wheels are not present.

MAU1 (100% OA)
Outdoor Main Filter Cleanliness
