# 2022 - 2023 IAQ Walkthrough

## Saint Paul Public Schools Washington Technology Magnet

Walkthrough Date:  
Monday, January 9, 2023  
Retest Date: March 23, 2023

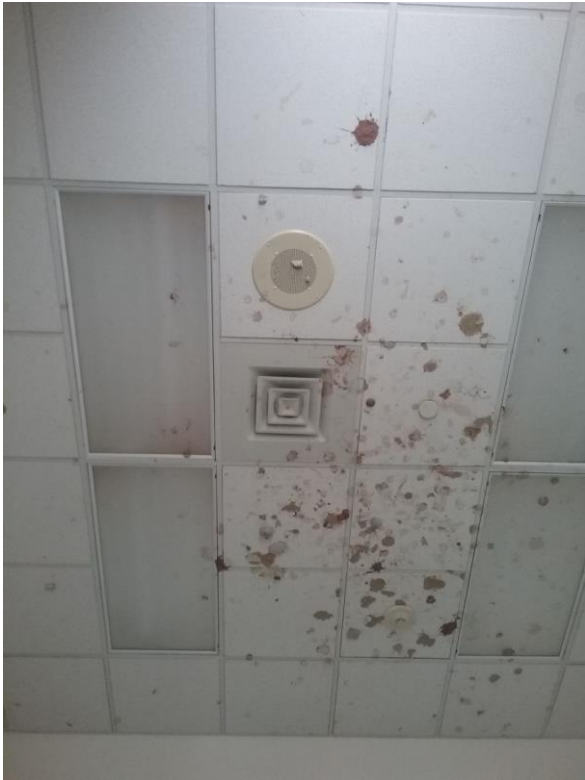
2731	1	No	• Stained Ceiling Tiles: See Appendix A	No	643	0.1	20.6	70.7
2720	12	No		No	675	0.1	20.8	70.3
2724	1	No	• Stained Ceiling Tiles	No	659	0.1	20.9	70.0
2727	0	No	• Stained Ceiling Tiles	No	612	0.1	20.8	69.6
2710	8	No		No	687	0.1	23.4	68.5

Stained Ceiling Tiles

Stained ceiling tiles were found in the room(s) shown below. The impacted ceiling tiles should be removed and replaced, and the cause of the moisture repaired.

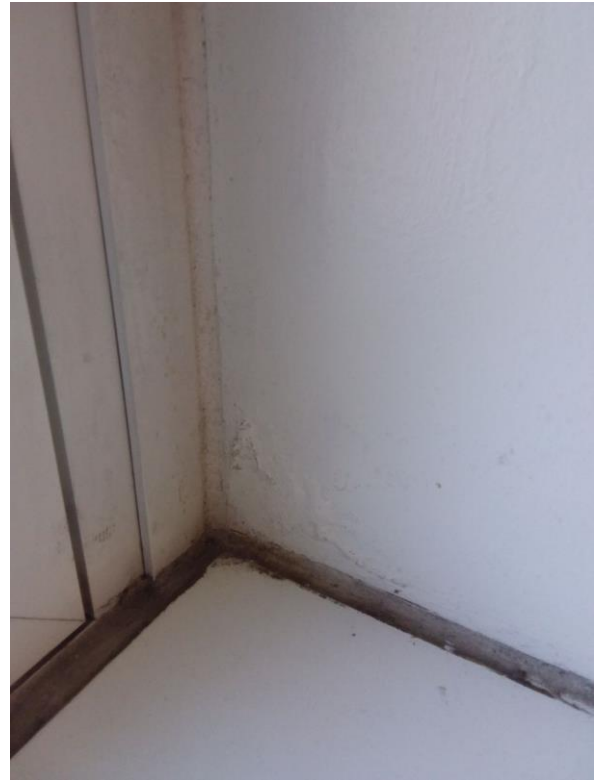
- 4110 *Eastern most window*
- 4261
- 4320 *Under window by flag*
- 4460 *Northern window.*

Bubbling/Peeling Paint

IEA observed bubbling/peeling paint in area(s) within the room(s) listed below. Bubbling/peeling paint can be caused by moisture issues. IEA recommends investigating the cause and repairing the paint. IEA recommends ensuring that the paint is not lead-based prior to disturbance.

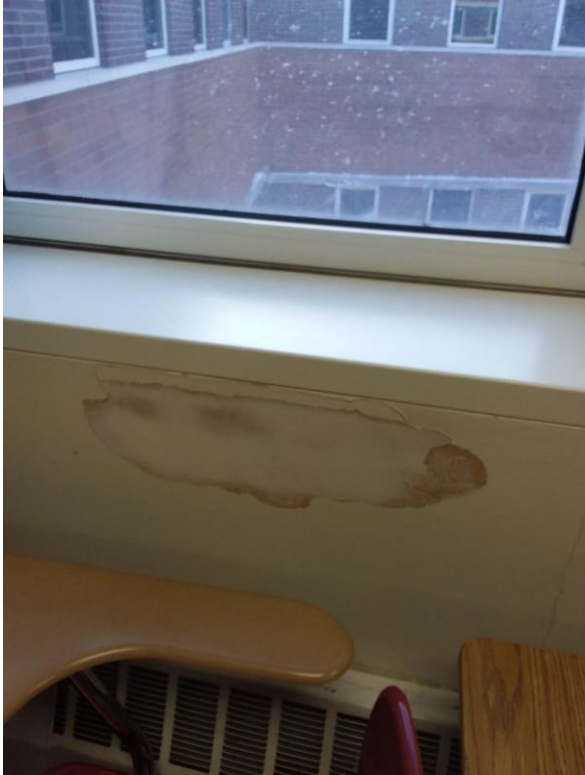
4440	24	No		No	793	0.2	13.7	70.5
4441	0	No		No	636	0.2	12.0	70.2
4410	11	No		No	715	0.2	13.6	70.5
4420	17	No		No	791	0.3	15.0	70.4
4408	0	No	<ul style="list-style-type: none"> <li>Aquariums (fish)</li> </ul>	No	859	0.2	14.7	71.3
4373	0	No	<ul style="list-style-type: none"> <li>Stained Ceiling Tiles</li> </ul>	No	795	0.3	13.8	71.0
4370/4371	1	No		No	866	0.2	14.4	69.8
4360	22	No		No	1,314	0.1	15.6	70.8
RETEST 4360	26	No		No	1,188	0.0	23.4	72.0
4350	12	No		No	1,084	0.2	17.3	71.0
4340	28	No		No	1,242	0.1	18.2	71.7
RETEST 4340	14	No		No	1,148	0.0	21.6	72.1
4330	14	No		No	1,060	0.3	16.6	70.6
4320	29	No	<ul style="list-style-type: none"> <li>Bubbling/Peeling Paint: Under window by flag; See Appendix A</li> </ul>	No	1,048	0.2	16.5	70.8
4321	0	No		No	803	0.2	14.2	69.8

Bubbling/Peeling Paint

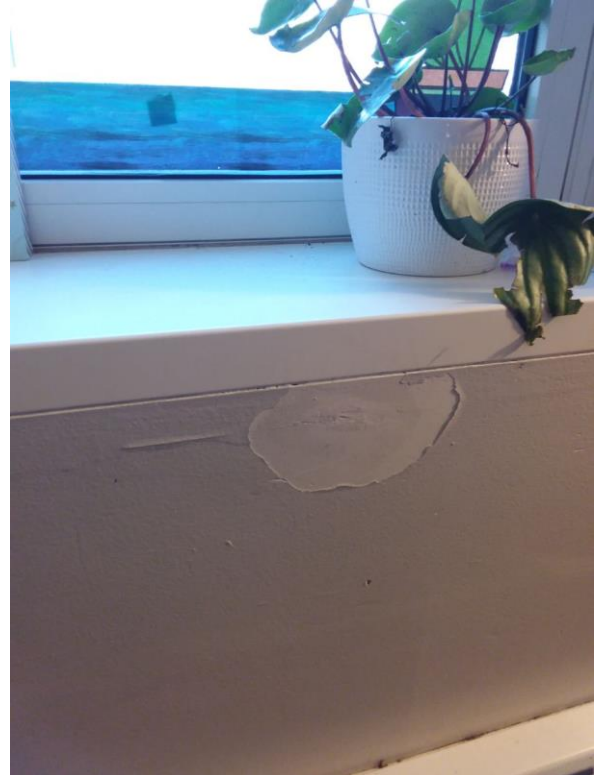
4261

Bubbling/Peeling Paint

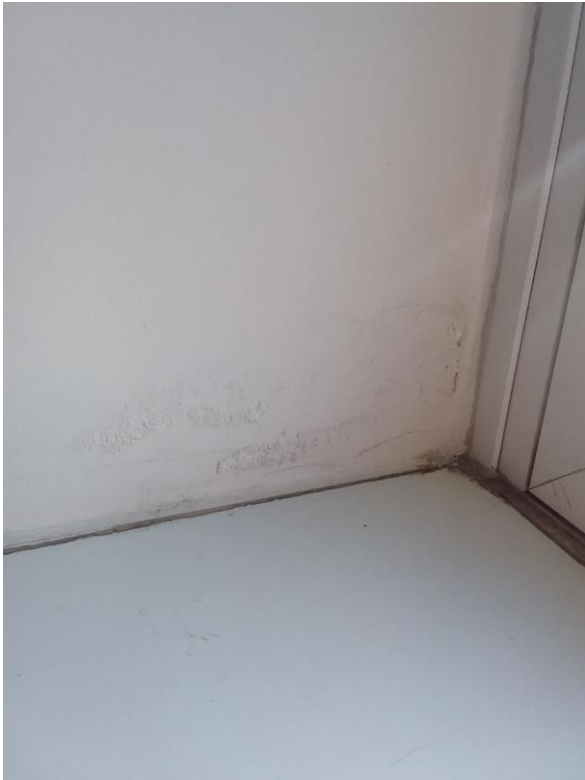
4230	21	No		No	903	0.2	15.8	69.1
4210	23	No	<ul style="list-style-type: none"> <li>Stained Ceiling Tiles</li> <li>Aquariums (fish)</li> <li>Plants</li> </ul>	No	1,021	0.2	12.1	69.8
4110	0	No	<ul style="list-style-type: none"> <li>Bubbling/Peeling Paint: Eastern most window; See Appendix A</li> </ul>	No	775	0.2	17.0	71.8
4120	19	No		No	1,060	0.1	20.5	70.8
4140	25	No		No	806	0.0	18.2	71.4
4150	22	No	<ul style="list-style-type: none"> <li>Stained Ceiling Tiles</li> </ul>	No	866	0.1	18.2	73.2
4160	21	No		No	1,080	0.1	21.3	73.6
4121	2	No		No	781	0.2	18.5	72.8
4141	0	No		No	661	0.1	15.5	71.9
4130	16	No		No	796	0.1	16.7	72.1
4170/4171	0	No	<ul style="list-style-type: none"> <li>Stained Ceiling Tiles</li> </ul>	No	647	0.0	17.3	73.1

**4110**  
**Bubbling/Peeling Paint**

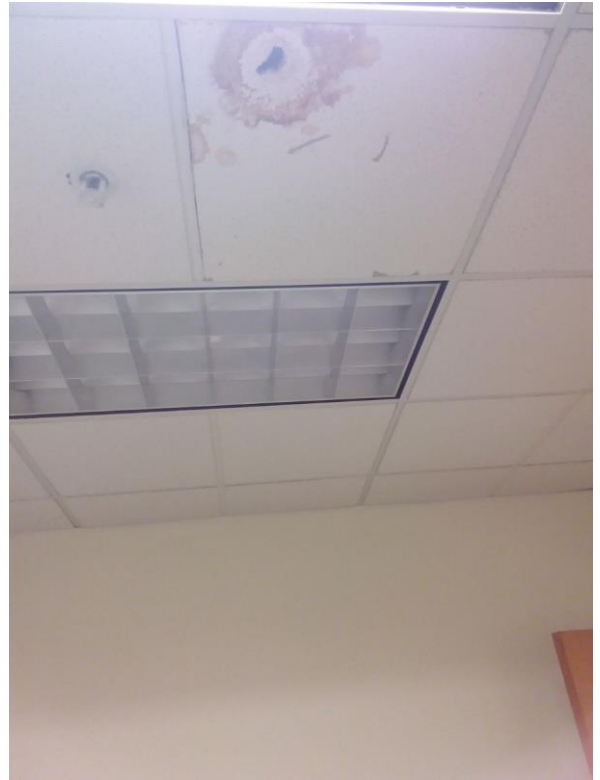
- 2422 *Hole in ceiling tile from active leak, currently have a coffee can under to catch water.*

**2422**  
**Moisture-Impacted Materials**

Moisture-impacted building materials should be repaired or replaced when discoloration or water staining is observed. Moisture-impacted building materials can be a source for microbial growth. The source for the moisture infiltration should be investigated and repaired if not easily identified.
