2022 - 2023 IAQ Walkthrough

Saint Paul Public Schools Washington Technology Magnet

Walkthrough Date:
Monday, January 9, 2023
Retest Date: March 23, 2023

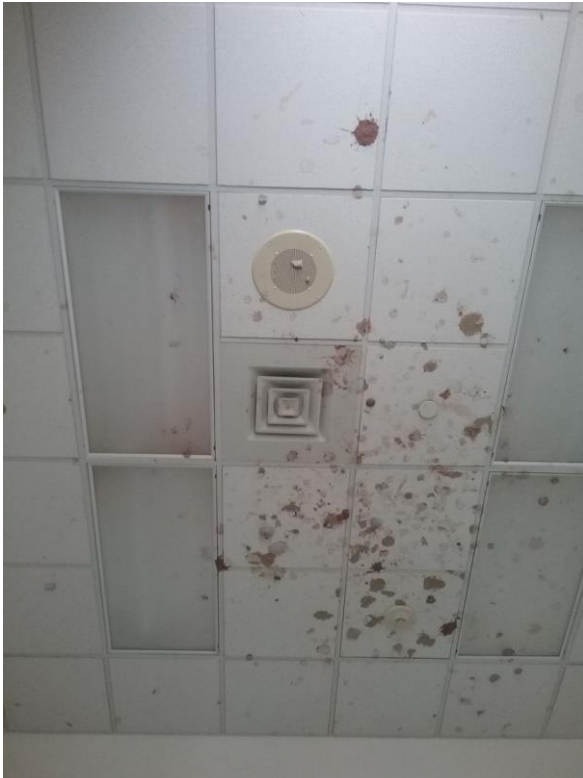
Room / Location	Number of Occupants	Odor Present	Observations	Dust Accumulation	CO ₂ (ppm)	CO (ppm)	RH (%)	Temp (°F)
2270	0	No		No	454	0.1	19.5	70.2
2273	1	No		No	506	0.1	19.9	70.2
2274	2	No		No	665	0.1	20.9	70.5
2308	7	No		No	809	0.1	22.4	70.2
2311	1	No		No	649	0.1	19.9	70.9
2310	1	No		No	843	0.1	21.1	70.9
2320	35	No		No	1,106	0.1	24.2	71.1
2321	6	No		No	985	0.1	27.6	71.4
2330	20	No		No	889	0.1	22.5	71.2
2340	30	No		No	1,010	0.1	23.7	70.9
2341	1	No		No	774	0.1	21.1	70.9
2350	30	No		No	885	0.1	23.0	70.7
2370	2	No	• Stained Ceiling Tiles	No	704	0.1	21.1	70.9
2373	1	No		No	682	0.1	20.7	71.2
2750	35	No		No	795	0.1	21.9	70.5
2751	0	No		No	772	0.1	21.4	70.0
2760	20	No		No	699	0.1	21.0	70.3
2765	0	No		No	583	0.1	20.6	70.0
2764	0	No		No	600	0.1	20.5	69.8
2761	0	No		No	630	0.1	20.6	70.5
2740	15	No		No	827	0.1	22.7	70.7
2752	0	No		No	664	0.1	20.9	70.5
2730	20	No		No	800	0.1	22.6	70.3
2733	0	No		No	639	0.1	20.7	70.0
2731	1	No	• Stained Ceiling Tiles: See Appendix A	No	643	0.1	20.6	70.7

Stained Ceiling Tiles

Stained ceiling tiles were found in the room(s) shown below. The impacted ceiling tiles should be removed and replaced, and the cause of the moisture repaired.

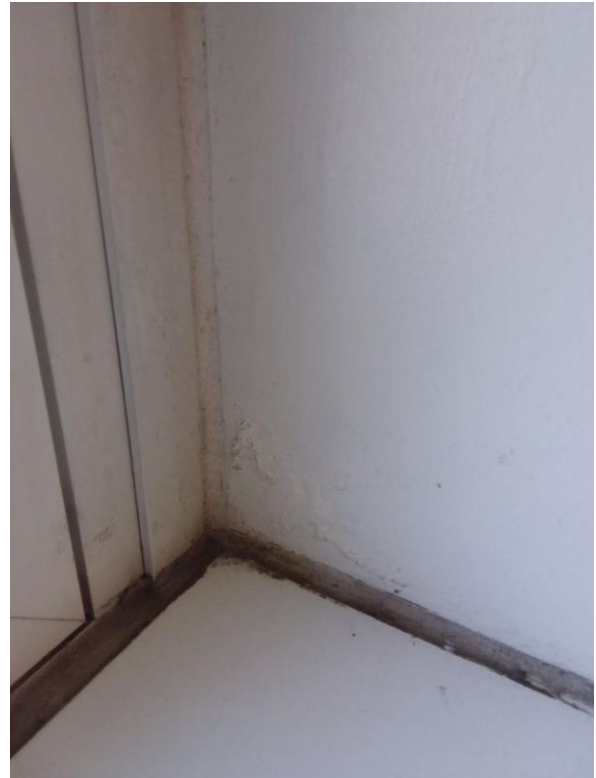
| • 4261 | • 4460 <i>Northern window.</i> |

Bubbling/Peeling Paint

IEA observed bubbling/peeling paint in area(s) within the room(s) listed below. Bubbling/peeling paint can be caused by moisture issues. IEA recommends investigating the cause and repairing the paint. IEA recommends ensuring that the paint is not lead-based prior to disturbance.

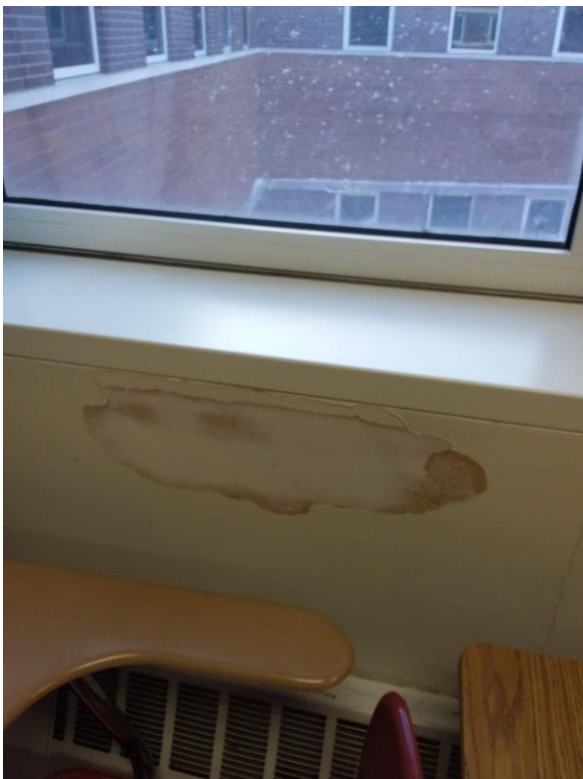
4370/4371	1	No		No	866	0.2	14.4	69.8
4360	22	No		No	1,314	0.1	15.6	70.8
RETEST 4360	26	No		No	1,188	0.0	23.4	72.0
4350	12	No		No	1,084	0.2	17.3	71.0
4340	28	No		No	1,242	0.1	18.2	71.7
RETEST 4340	14	No		No	1,148	0.0	21.6	72.1
4330	14	No		No	1,060	0.3	16.6	70.6
4320	29	No	• Bubbling/Peeling Paint: Under window by flag; See Appendix A	No	1,048	0.2	16.5	70.8
4321	0	No		No	803	0.2	14.2	69.8

| • 4110 <i>Eastern most window</i> | • 4320 <i>Under window by flag</i> |

Bubbling/Peeling Paint

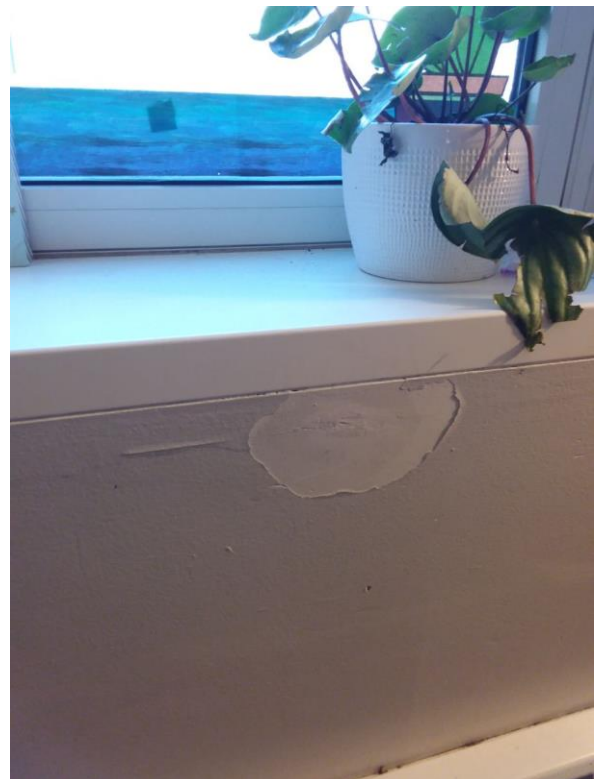
4261

Bubbling/Peeling Paint

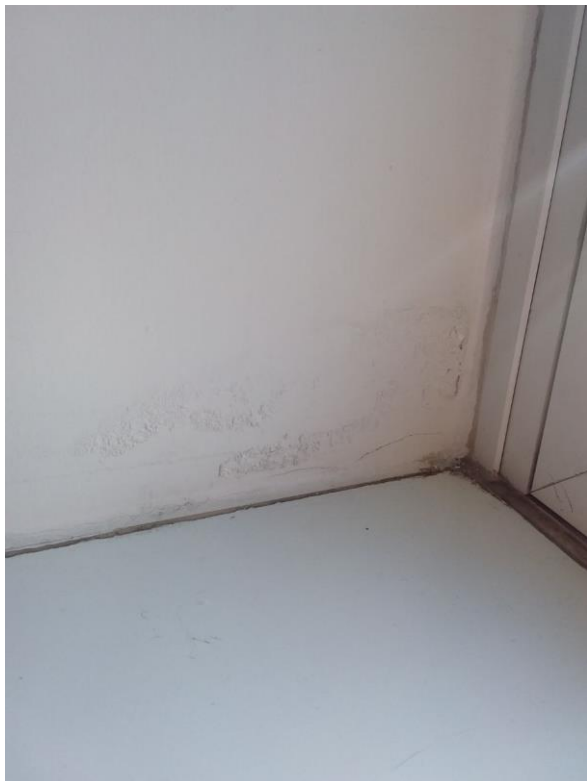
4230	21	No		No	903	0.2	15.8	69.1
4210	23	No	<ul style="list-style-type: none"> Stained Ceiling Tiles Aquariums (fish) Plants 	No	1,021	0.2	12.1	69.8
4110	0	No	<ul style="list-style-type: none"> Bubbling/Peeling Paint: Eastern most window; See Appendix A 	No	775	0.2	17.0	71.8
4120	19	No		No	1,060	0.1	20.5	70.8
4140	25	No		No	806	0.0	18.2	71.4
4150	22	No	<ul style="list-style-type: none"> Stained Ceiling Tiles 	No	866	0.1	18.2	73.2
4160	21	No		No	1,080	0.1	21.3	73.6
4121	2	No		No	781	0.2	18.5	72.8
4141	0	No		No	661	0.1	15.5	71.9
4130	16	No		No	796	0.1	16.7	72.1
4170/4171	0	No	<ul style="list-style-type: none"> Stained Ceiling Tiles 	No	647	0.0	17.3	73.1

4110
Bubbling/Peeling Paint

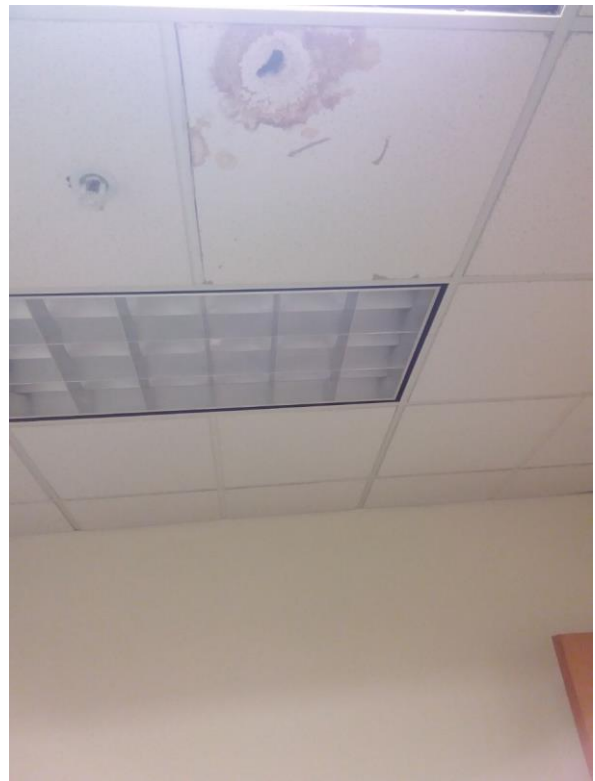
- 2422 *Hole in ceiling tile from active leak, currently have a coffee can under to catch water.*

2422
Moisture-Impacted Materials

Moisture-impacted building materials should be repaired or replaced when discoloration or water staining is observed. Moisture-impacted building materials can be a source for microbial growth. The source for the moisture infiltration should be investigated and repaired if not easily identified.
