ROOFING AND HVAC PLANNING STUDY

at Chimacum School District

studio Meng Strazzara

October 11, 2023

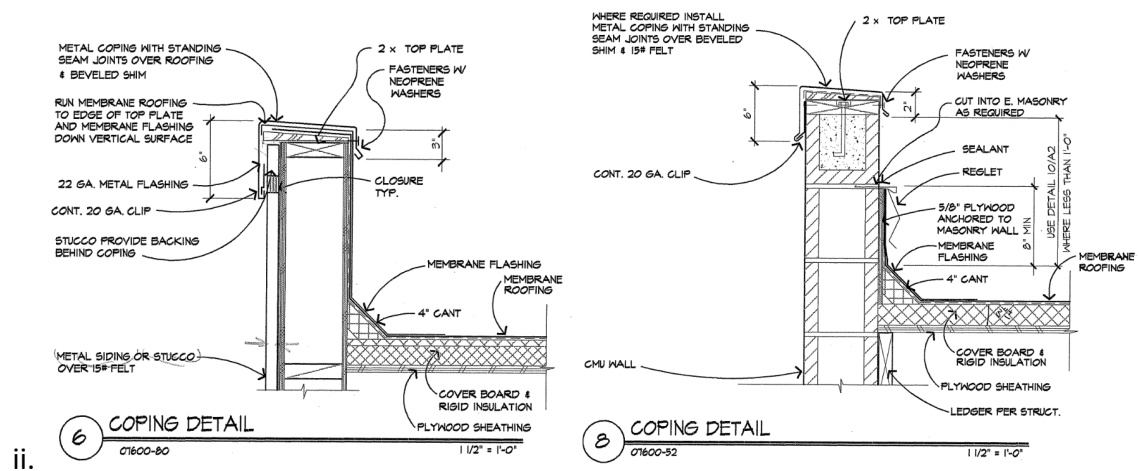
- i. Membrane roofing over 3" rigid insulation and coped parapet conditions.

- i. Demolish existing: roofing membrane system; cover board; cant strips; parapet coping.
Provide new: 4" additional polyiso rigid insulation atop existing insulation; build up (heighten) parapets and equipment curbs as required to accommodate added rigid insulation; 1/2" cover board; membrane roofing system; structural support as required for new HVAC equipment.

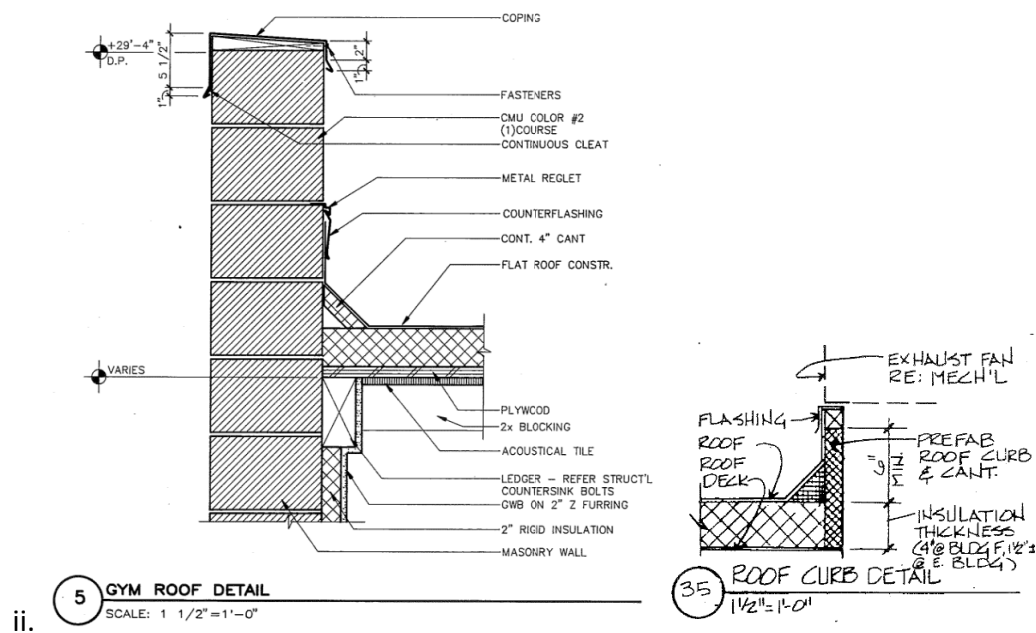
- i. Membrane roofing over 4" rigid insulation and coped parapet conditions.

- i. Demolish existing: roofing membrane system; cover board; cant strips; parapet coping.
Provide new: 3" additional polyiso rigid insulation atop existing insulation; build up (heighten) parapets and equipment curbs as required to accommodate added rigid insulation; ½" cover board; membrane roofing system.

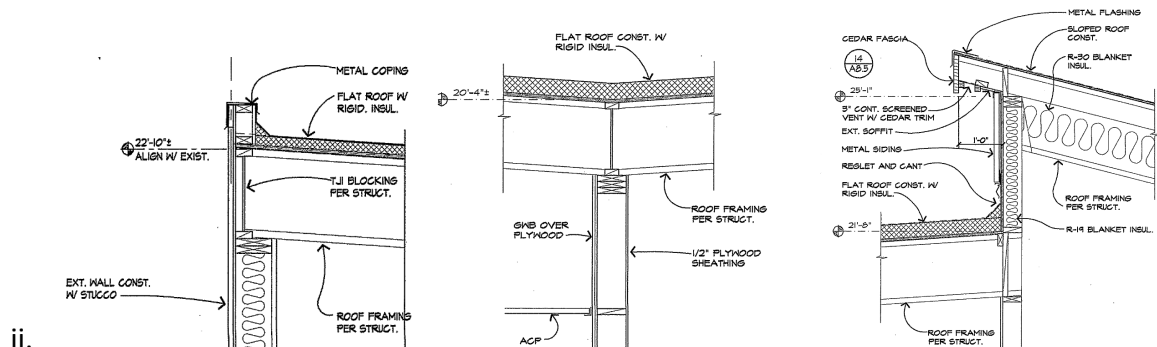
- i. Membrane roofing over 2" rigid insulation and parapet conditions.

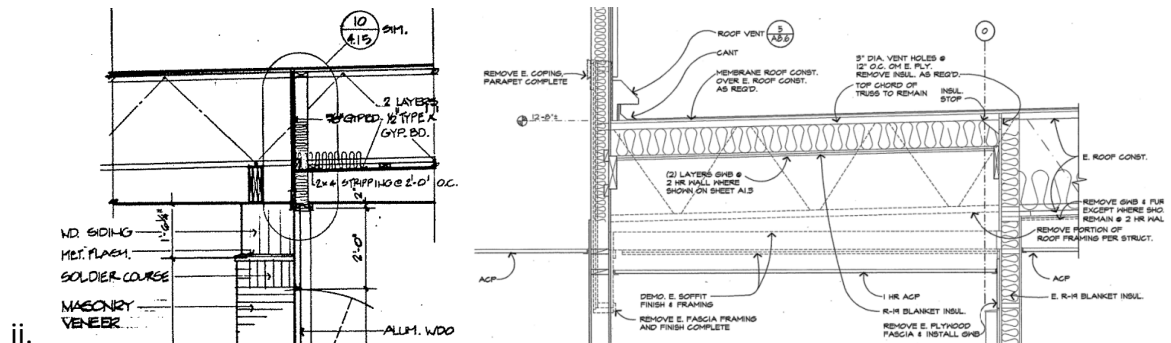
to R-19. Areas of the 1999 Modernization and Additions where the new addition connects to the existing conditions are shown as R-19 batt insulation as well.

- i. Demolish existing: roofing membrane system; cover board; cant strips; parapet coping.
Provide new: 7" polyiso rigid insulation atop existing decking; build up (heighten) parapets and equipment curbs as required to accommodate added rigid insulation; 1/2" cover board; membrane roofing system; structural support as required for new HVAC equipment.
