Addendum 1

Project: **BRFP NUMBER 2324-03 – TROY SCHOOL DISTRICT 2024 SITE IMPROVEMENTS PAVING PROJECTS**

Report on Geotechnical
Pavement Investigation

**Baker Middle School
1359 Torpey Road
Troy, Michigan 48083**

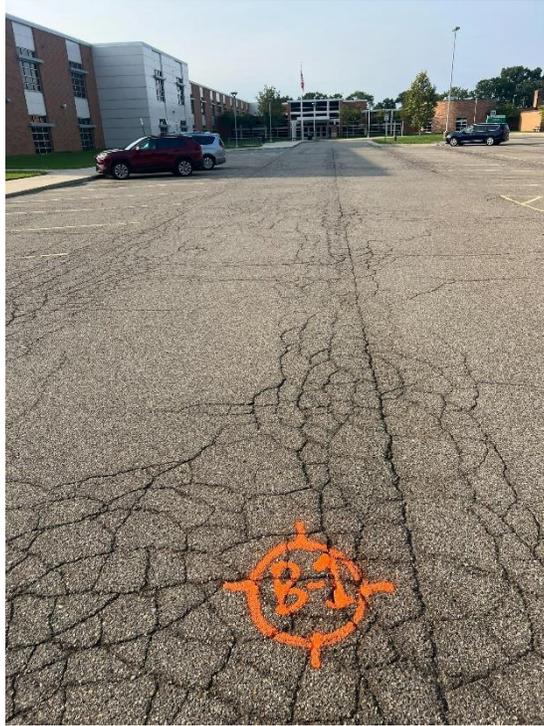
The east parking lot (borings B-1 through B-4) is exhibiting high severity joint, block, and fatigue cracking throughout (Photograph Nos. 1 through 7) in the Appendix. The observed distresses appears to be a result of poorly constructed joints (potentially during cold weather). The cracking along the joints allows infiltration of water into the aggregate base and subgrade and subsequent fatigue cracking develops and propagating outward.

Photograph No. 1: Looking south toward B-1. High severity fatigue and joint cracking.

The existing pavements at the ***east lot and east entrance to the west lot*** are in poor condition with more than half of the pavement exhibiting high severity block, joint, and fatigue cracking. We recommend the existing bituminous concrete be completely removed, and a new pavement section constructed atop the existing aggregate base.

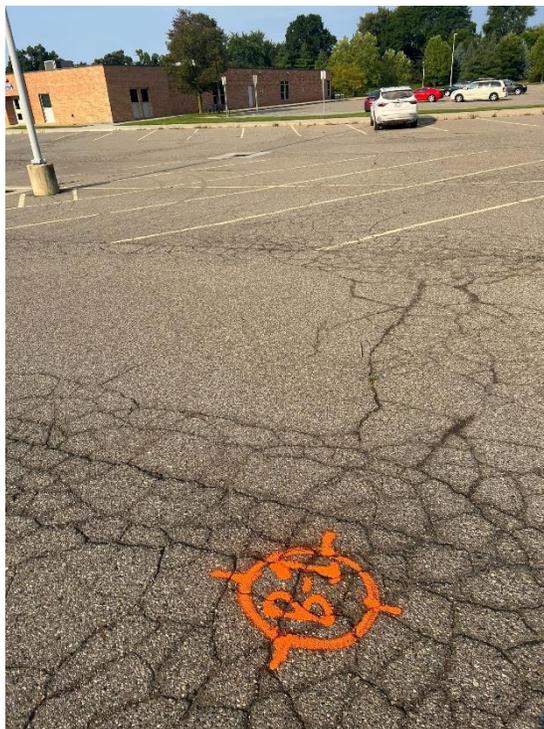
Photograph No. 2: Looking west at B-1. High severity fatigue and joint cracking.

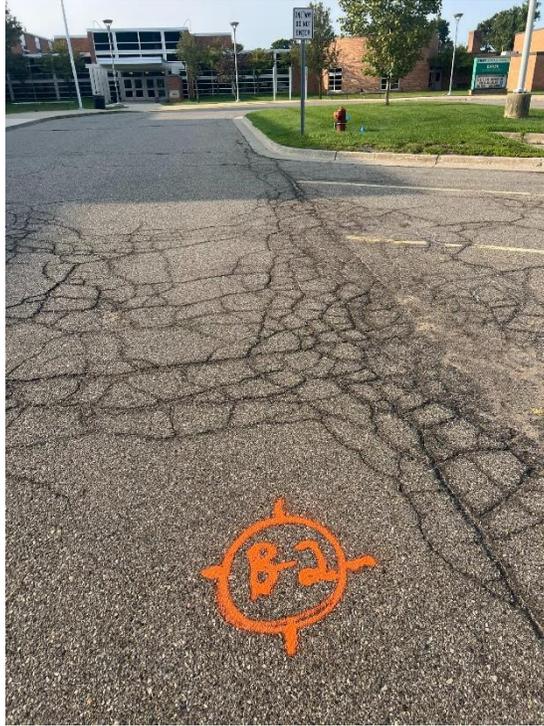
Photograph No. 3: Looking south at B-2. High severity fatigue and joint cracking.

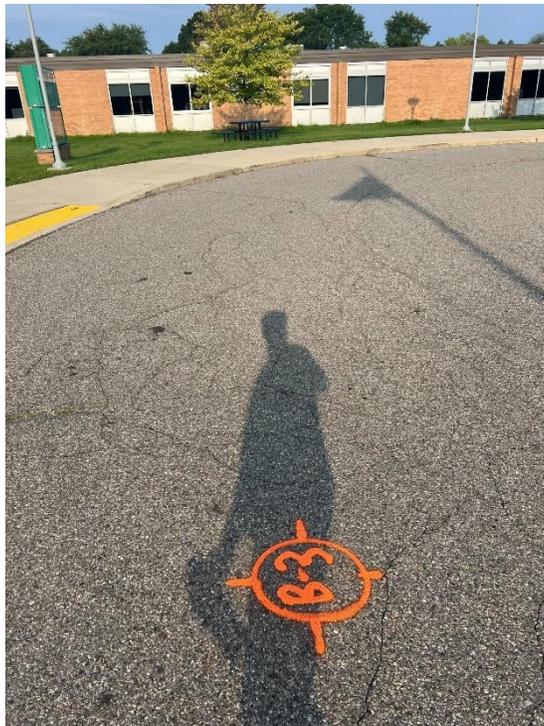
Photograph No. 4: Looking west at B-3. Low severity fatigue
Cracking at access loop.

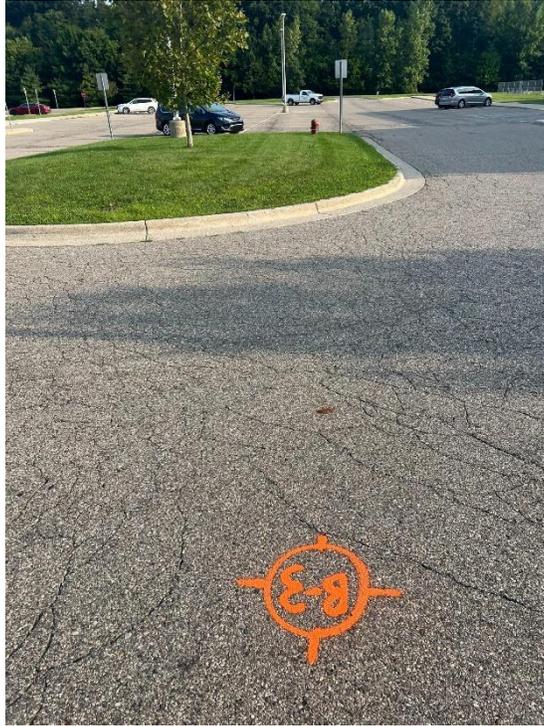
Photograph No. 5: Looking north toward B-3. Low to moderate severity fatigue and cracking.

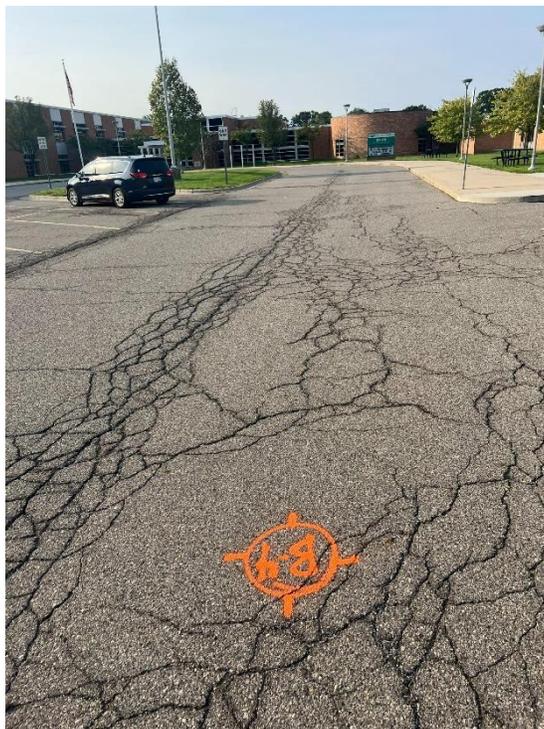
Photograph No. 6: Look south at B-4. High severity joint and fatigue cracking.

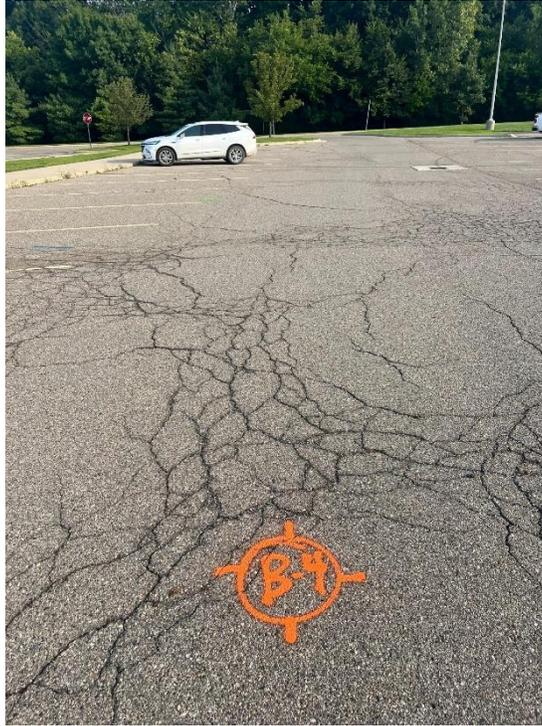
Photograph No. 7: Moderate to high severity fatigue cracking looking north toward B-4. Note concrete collar around catch basin.

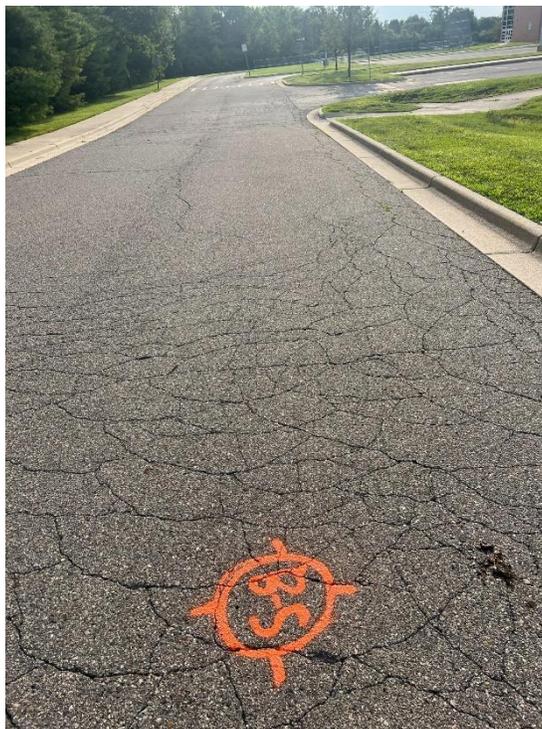
Photograph No. 8: Moderate severity fatigue and edge cracking, looking east toward B-5.

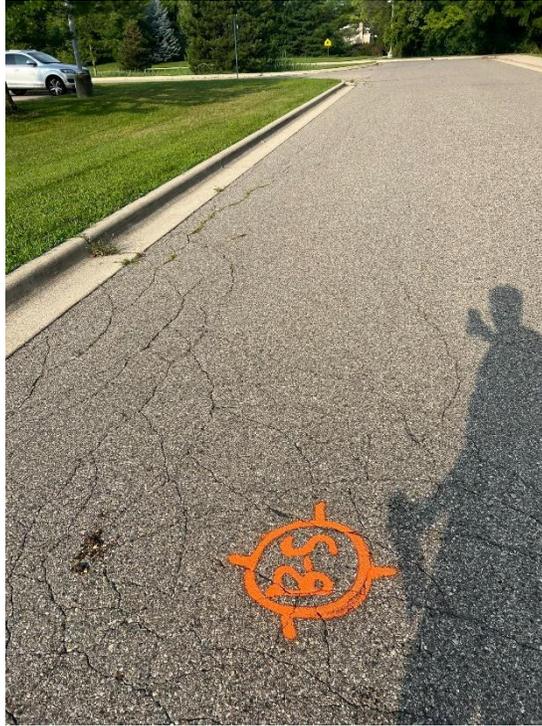
The access drive from Torpey Road to both of the parking lots (borings B-5, B-9, and B-10) is in relatively good condition, exhibiting low to moderate severity fatigue and edge cracking (Photograph No. 9 and 15 through 18). Concrete curb and gutter line the drive and two drainage structures are present along the east curb line (Photograph No. 15).

Photograph No. 9: Low to moderate severity edge fatigue cracking looking west toward B-5.

The ***access drive and west lot*** are in relatively good condition, exhibiting low to moderate severity block, fatigue, and edge cracking. The existing pavements at these areas are generally not suitable to be rehabilitated by mill and overlay due to the thin existing pavement section (as thin as 2-1/2 inches at boring B-5). However, in consideration of the performance of the pavements and suitable aggregate base thickness, we recommend the existing bituminous concrete be completely removed and a new pavement section be constructed atop the existing aggregate base.

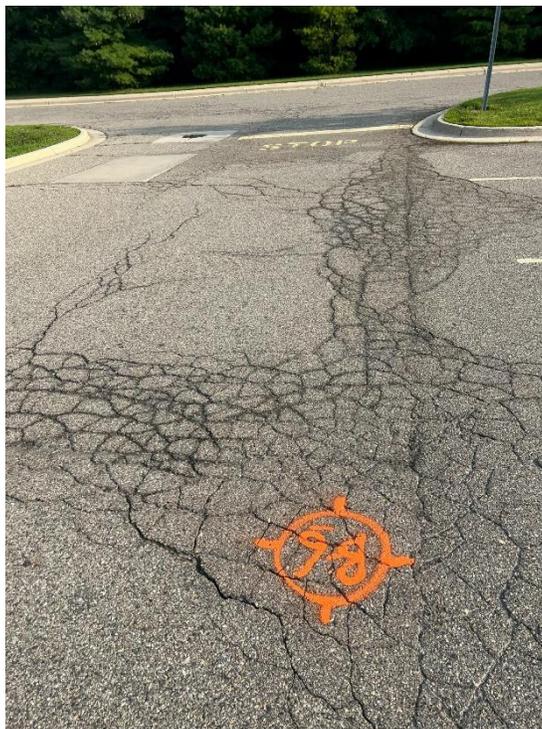
Photograph No. 10: High severity fatigue and joint cracking looking north toward B-6.
Note concrete collar around basin and patch south of basin.

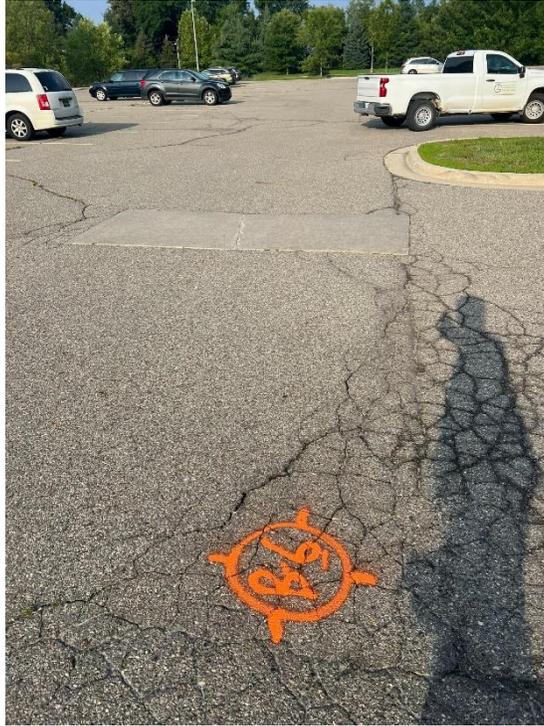
Photograph No. 11: Moderate to high severity fatigue and block cracking looking west toward B-6. Note previous concrete patch.

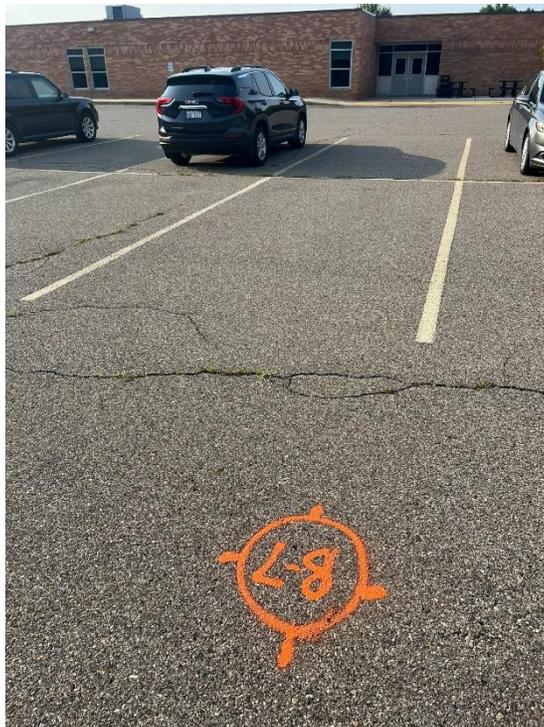
The west parking lot (borings B-6 through B-8) is in relatively good condition with low to moderate severity block and secondary fatigue cracking (Photograph Nos. 12 through 14). However, at the east entrance to the lot, high severity fatigue and joint cracking is present and previous pavement patches were noted (Photograph Nos. 10 and 11). Concrete sidewalk extends along the south side of the lot, adjacent to the school. The remaining perimeter of the lot is surrounded by concrete curb and gutter. Except for the one catch basin at the east entrance to the lot, no other drainage structures are present.

Photograph No. 12: Low to moderate severity block cracking in west lot.

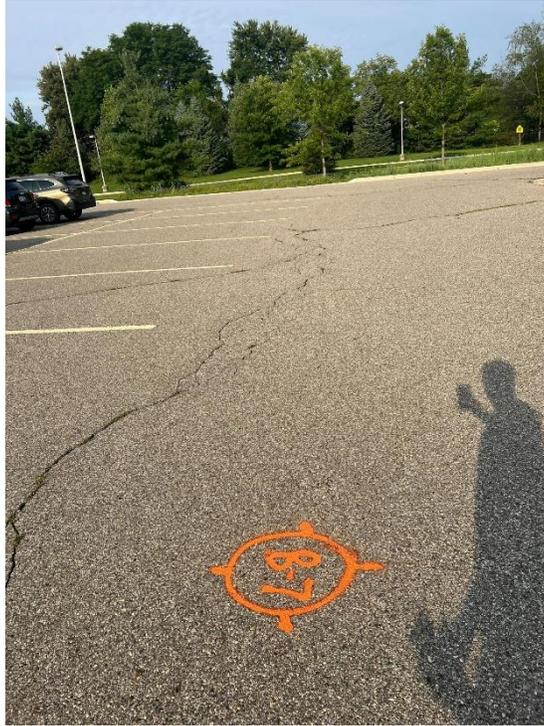
Photograph No. 13: Low to moderate severity block and fatigue cracking.
Note drainage path in curb on west side of lot to drainage swale.

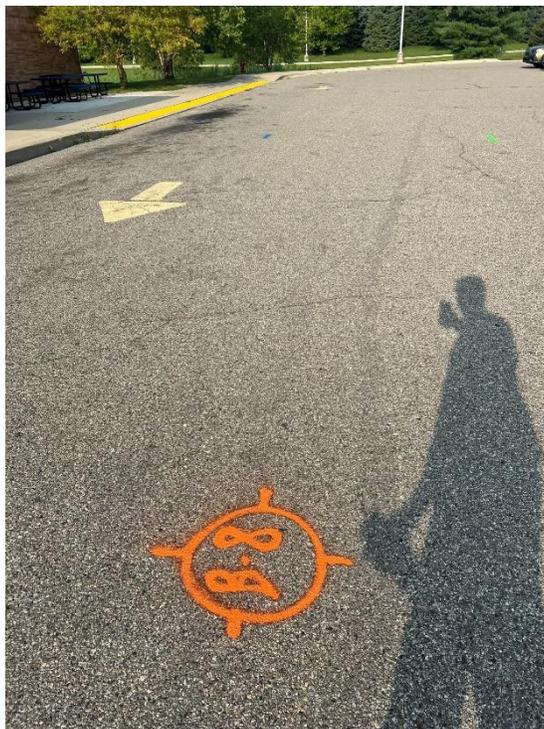
Photograph No. 14: Low severity block cracking.

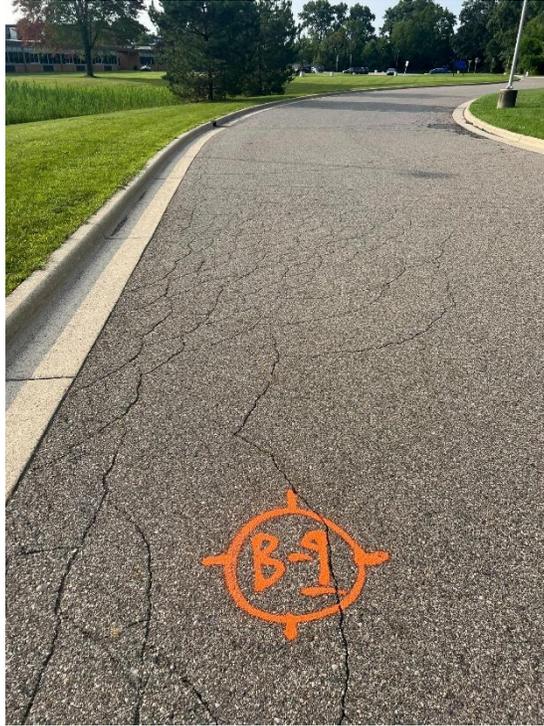
Photograph No. 15: Low to moderate severity edge cracking propagating outward. Note transverse cracking and previous patch along west side of drive. Drainage structure in gutter on east side of drive. Looking south.

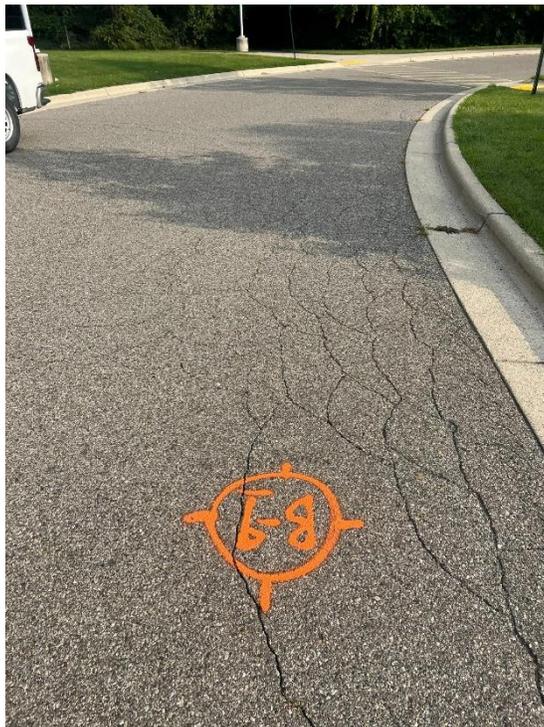
Photograph No. 16: Low to moderate severity edge cracking propagating outward. Looking north.

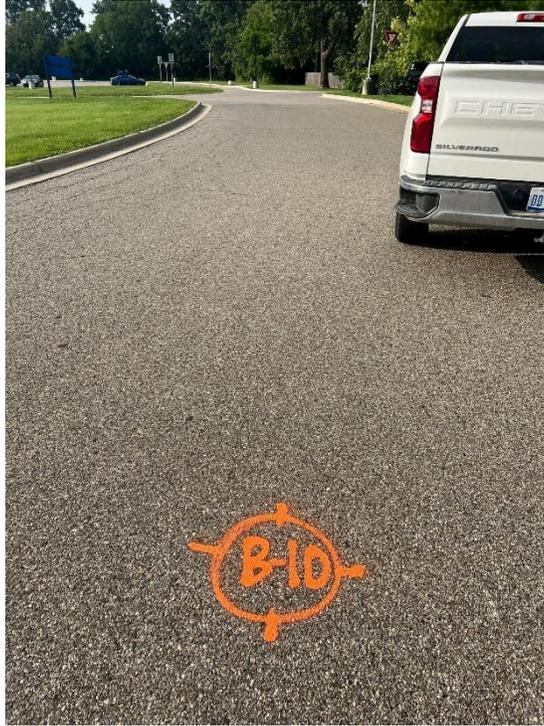
Photograph No. 17: Low to moderate severity edge cracking propagating outward. Looking south.

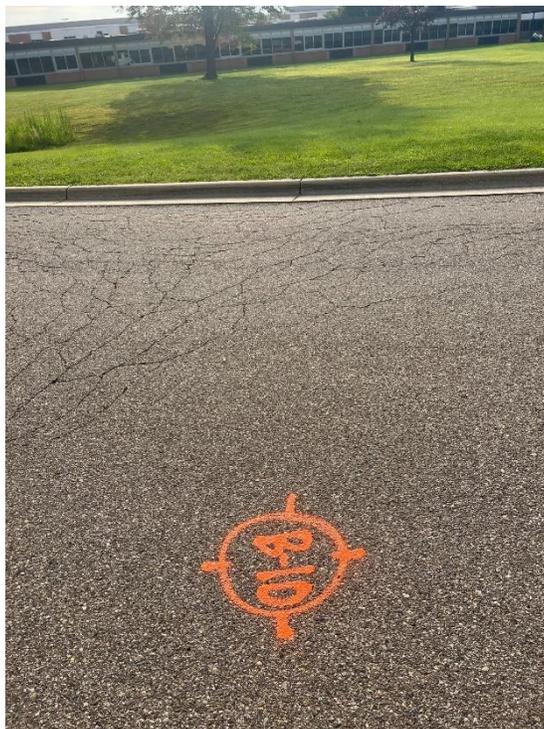
Photograph No. 18: Moderate severity transverse, fatigue, and edge cracking looking east toward B-10.

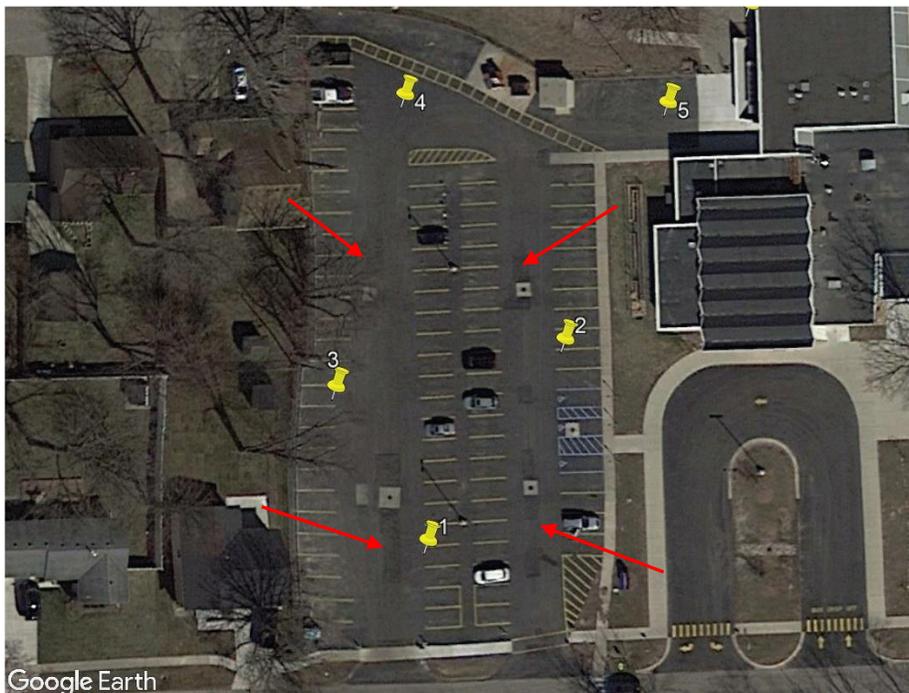
The age of the existing pavements was not available upon completion of this report. However, after reviewing Google Earth Historical Aerial Photographs, it appears the pavements were constructed sometime prior to 1999. Concrete collars were constructed around the catch basins between 2007 and 2010 and between 2011 and 2015. Concrete patches were constructed throughout the parking lot between 2020 and 2021, indicated with red arrows below.

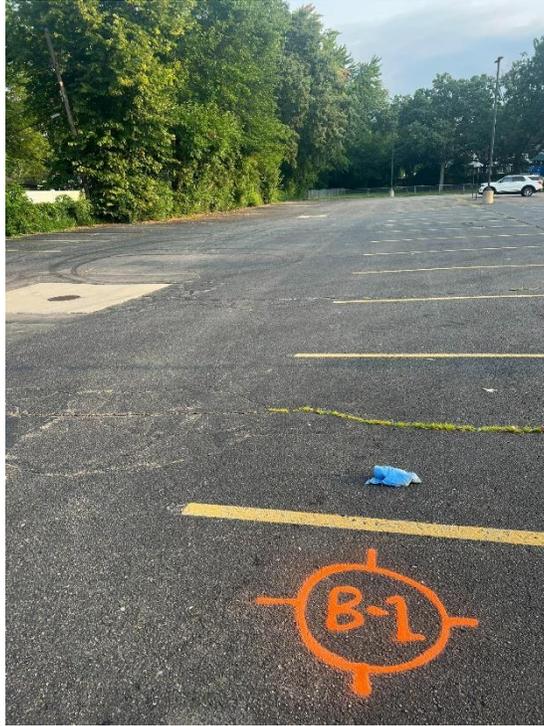
Photograph No. 1: Looking north, low to moderate severity block, joint, and fatigue cracking. Concrete collar around basin.

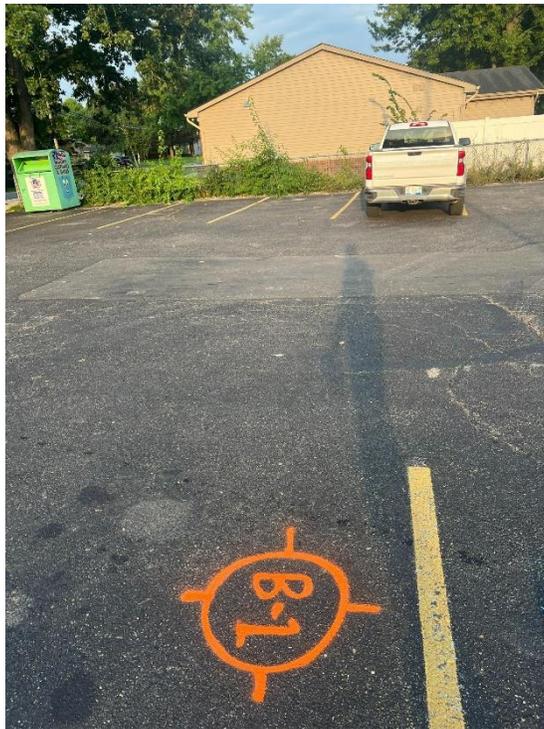
Photograph No. 2: Low to moderate severity fatigue cracking. Note previous patch.

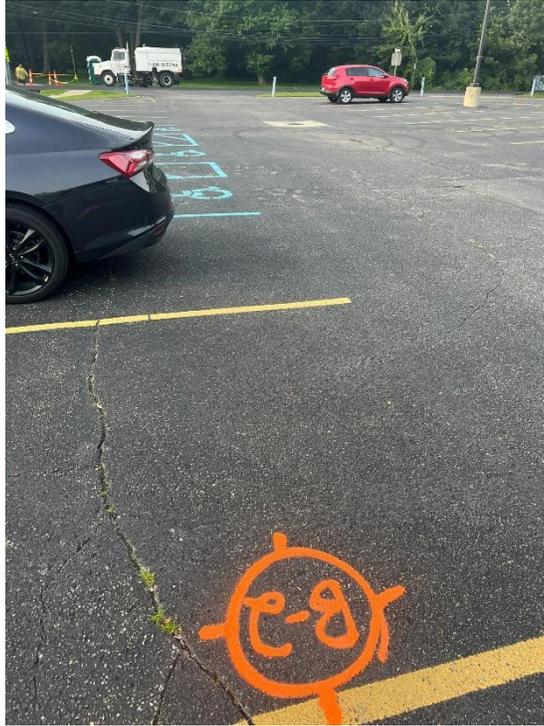
Photograph No. 3: Looking south, low to moderate severity block and fatigue cracking.

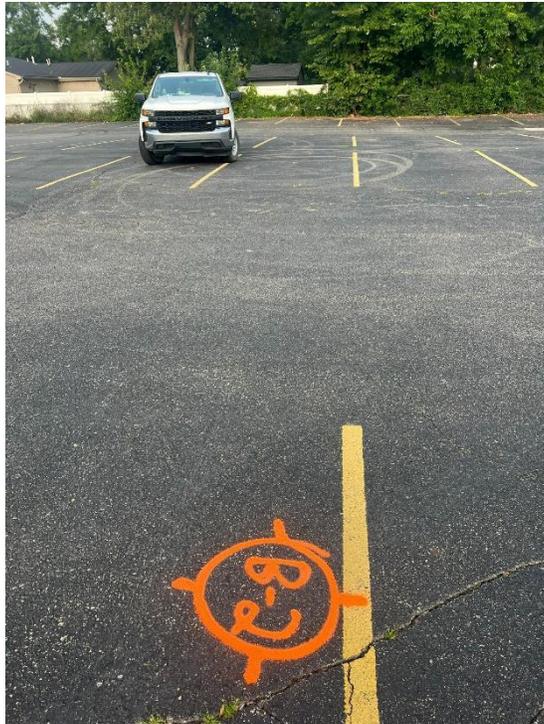
Photograph No. 4: Low to moderate severity block and fatigue cracking.

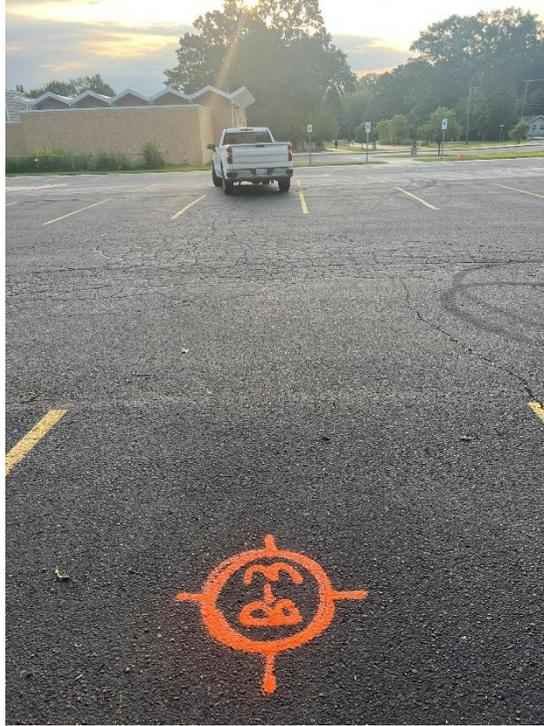
Photograph No. 5: Moderate to high severity fatigue cracking through center of drive lane, looking east.

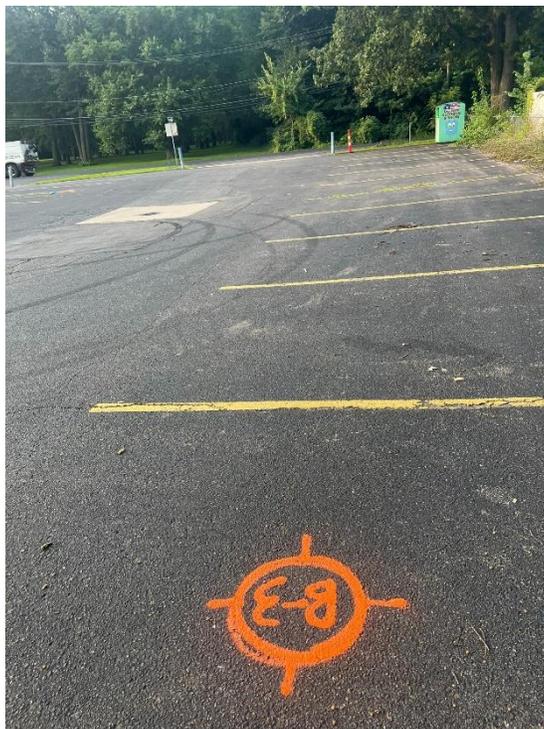
Photograph No. 6: Looking south toward entrance, erosion from west edge of pavement indicating sheet draining to lot.

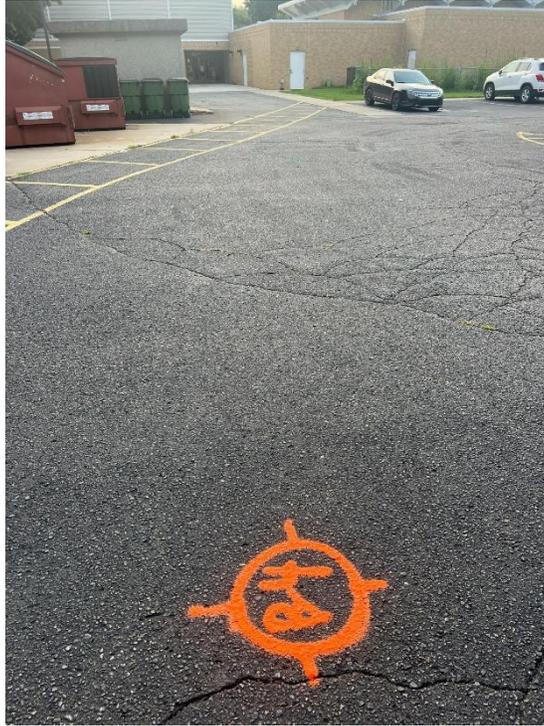
Photograph No. 7: Moderate severity fatigue cracking looking east.

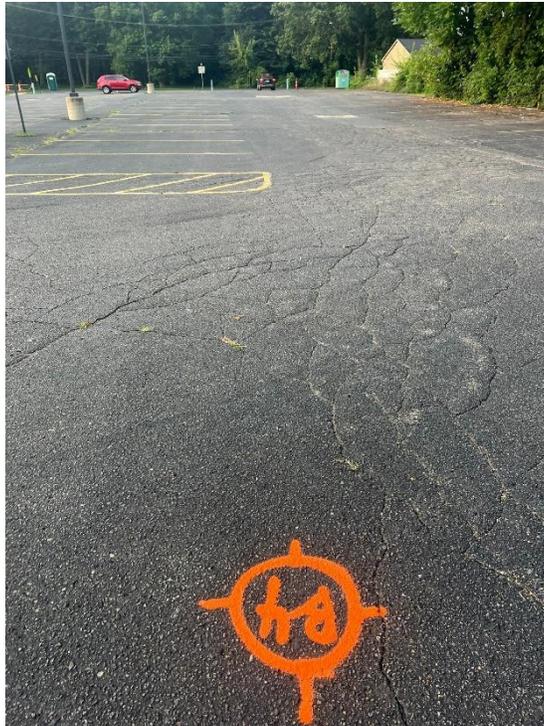
Photograph No. 8: Moderate to high severity fatigue cracking looking south.

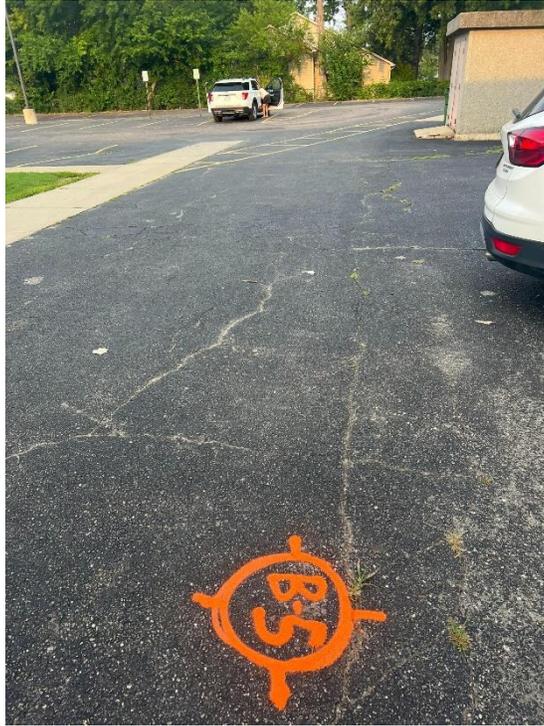
Photograph No. 9: Low to moderate severity fatigue cracking looking west.

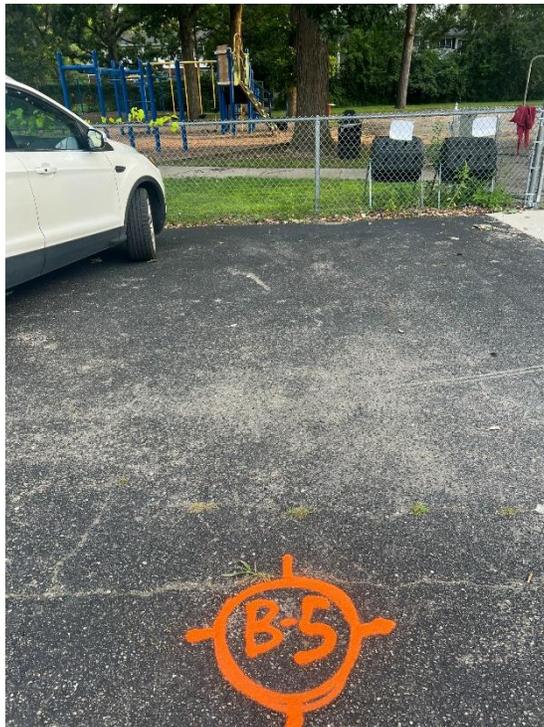
Photograph No. 10: Low severity fatigue cracking looking north playground.
New concrete to the east adjacent to the school.

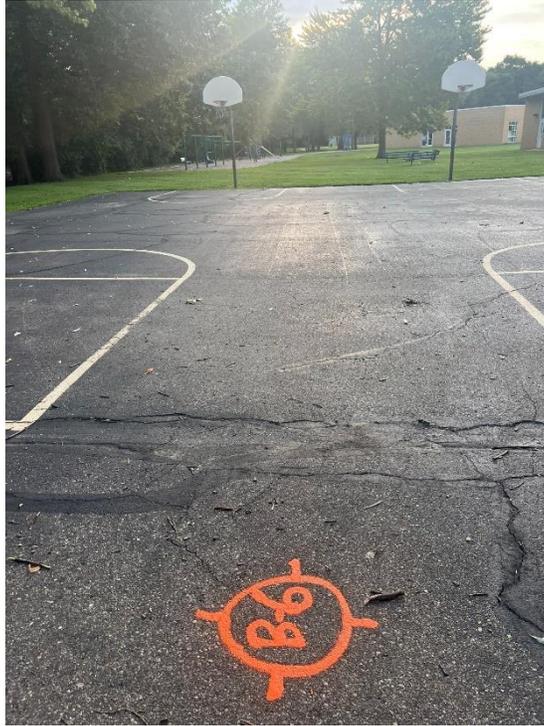
Photograph No. 11: Moderate to high severity fatigue cracking and settlement evident.

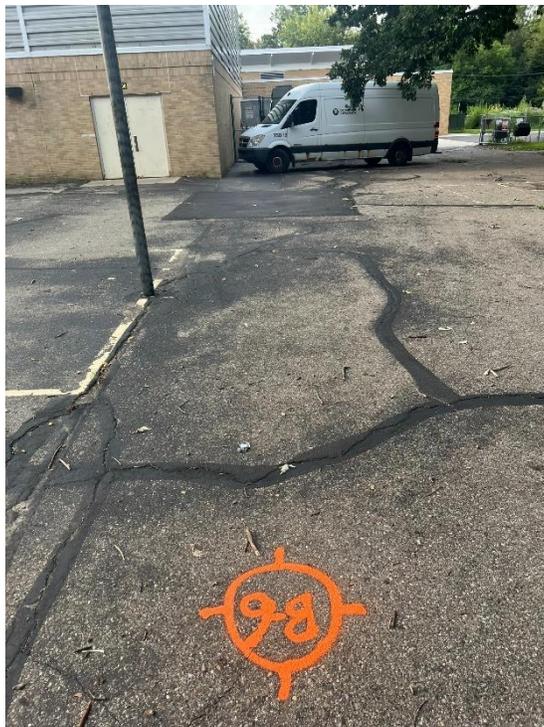
Photograph No. 12: Looking south. Pavement is flush to building.
Previous patch and crack sealing visible.

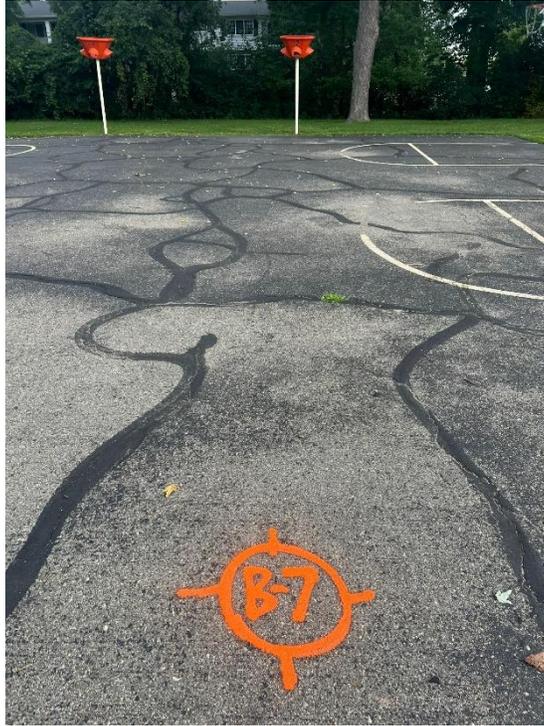
Photograph No. 13: Moderate severity cracking with previous crack sealing.

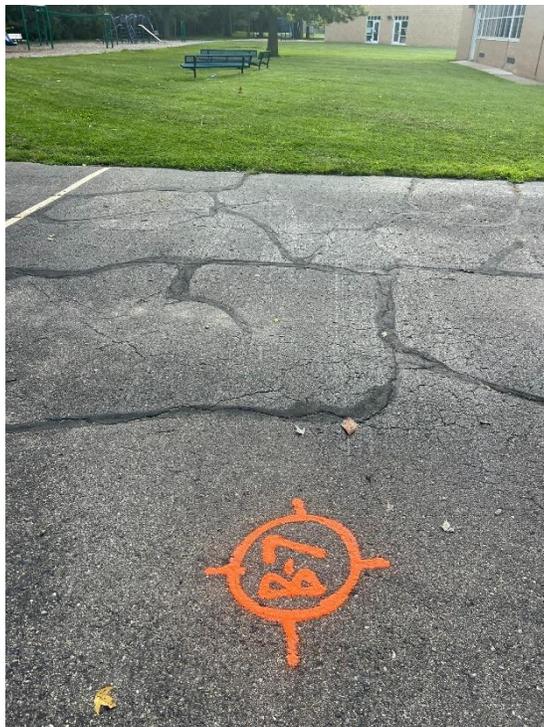
Photograph No. 14: Pavement flush to grass looking east.

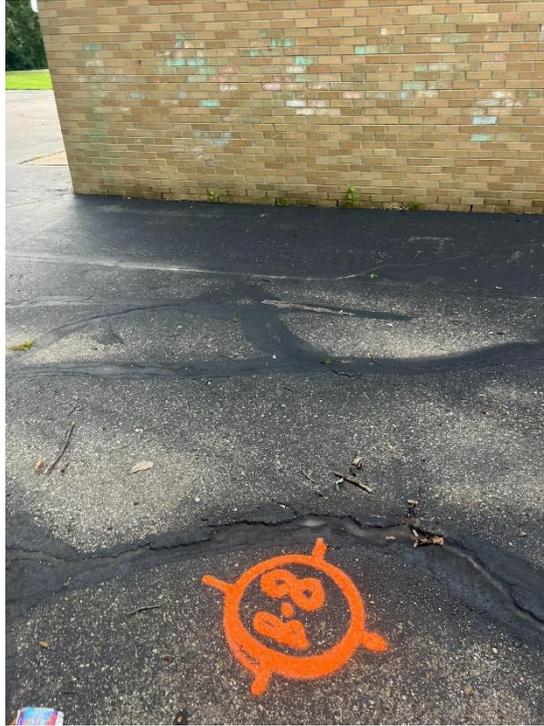
Photograph No. 15: Pavement flush to building. Moderate to high severity cracking.

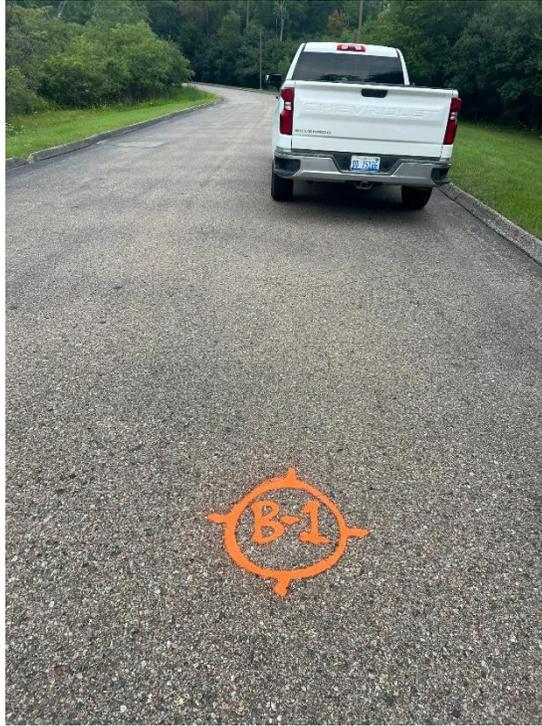
Photograph No. 1: Looking west. Low to moderate severity fatigue and edge cracking. Broken curb line.

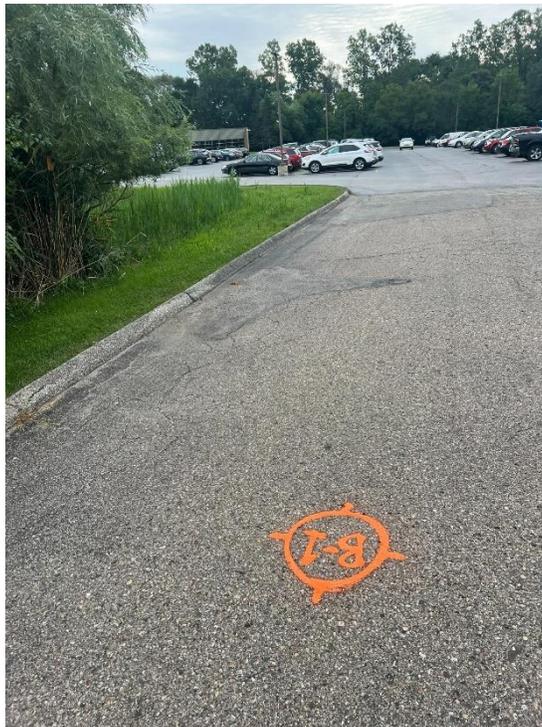
Photograph No. 2: Moderate severity edge cracking and previous patching along bituminous curb. Looking east.

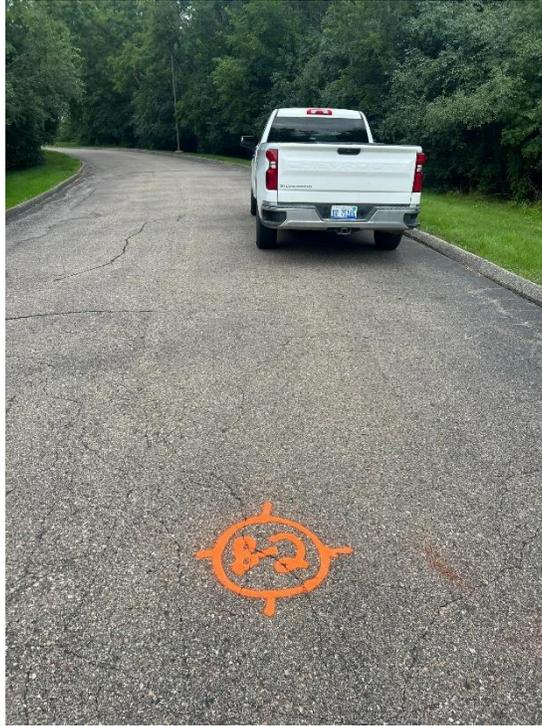
Photograph No. 3: Looking west. Low to moderate severity fatigue and edge cracking. Evidence of ponding along south curb line.

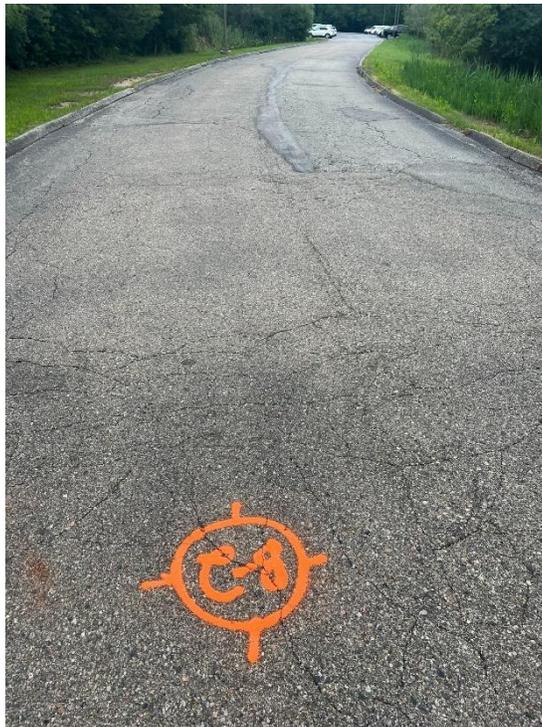
Photograph No. 4: Moderate severity fatigue cracking looking east toward B-2. Previous patching along curb line and center.

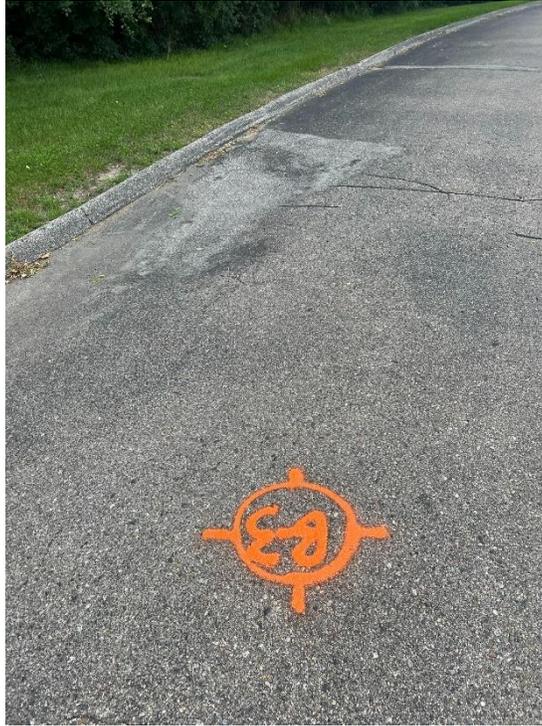
Photograph No. 5: Moderate severity fatigue cracking and patch along north curb line, looking east toward B-3.

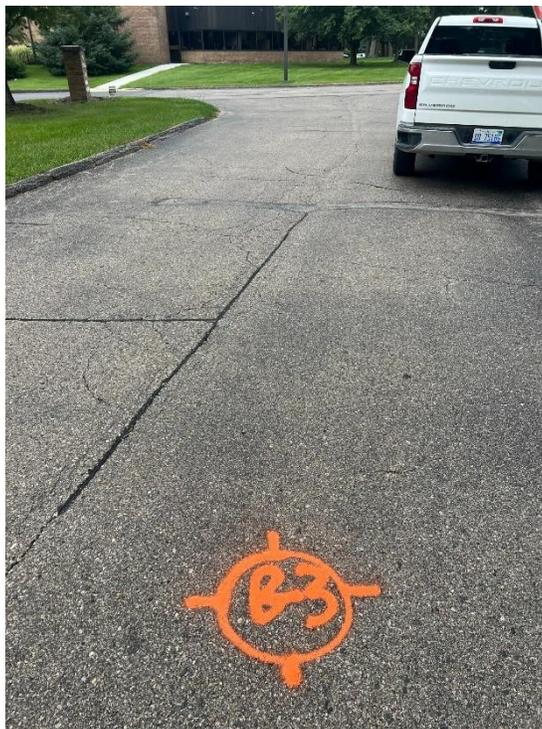
Photograph No. 6: Moderate severity block, joint, and fatigue cracking looking west toward drive entrance.

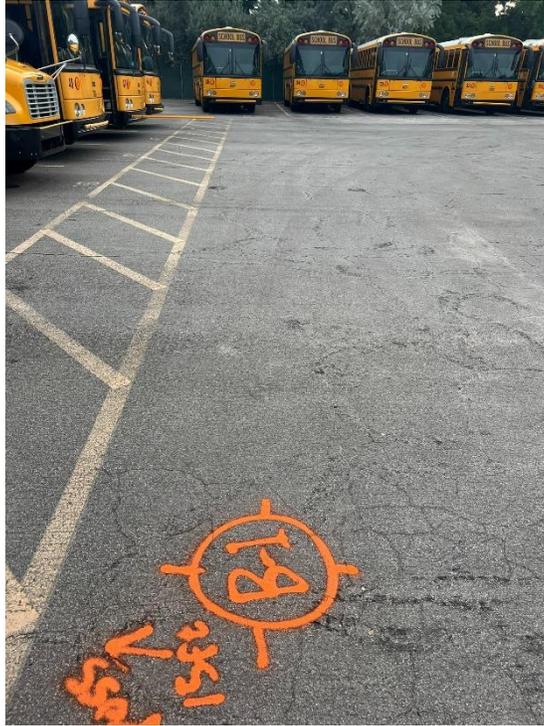
Photograph No. 1: Moderate severity fatigue and block cracking looking east.

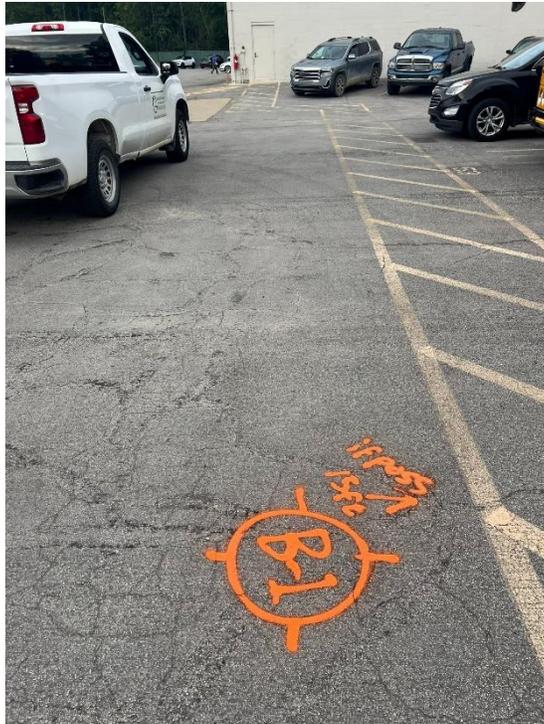
Photograph No. 2: Moderate severity fatigue cracking looking west.
Pavement surface showing weathering.

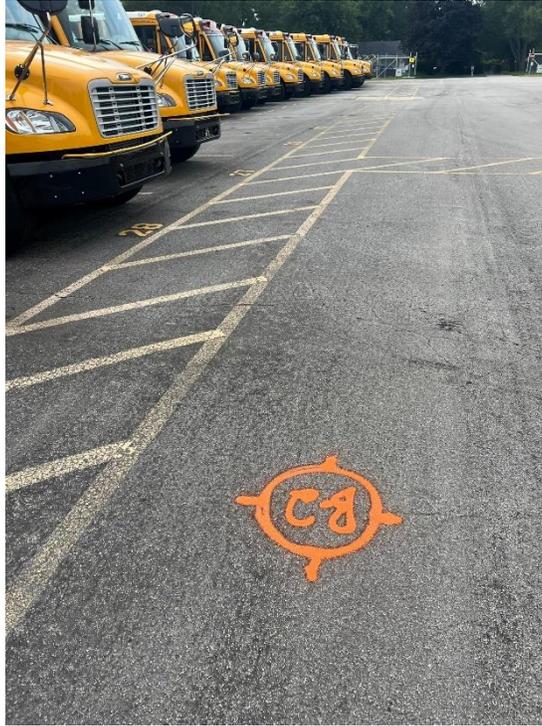
Photograph No. 3: Low severity fatigue along east extent of lot looking south.

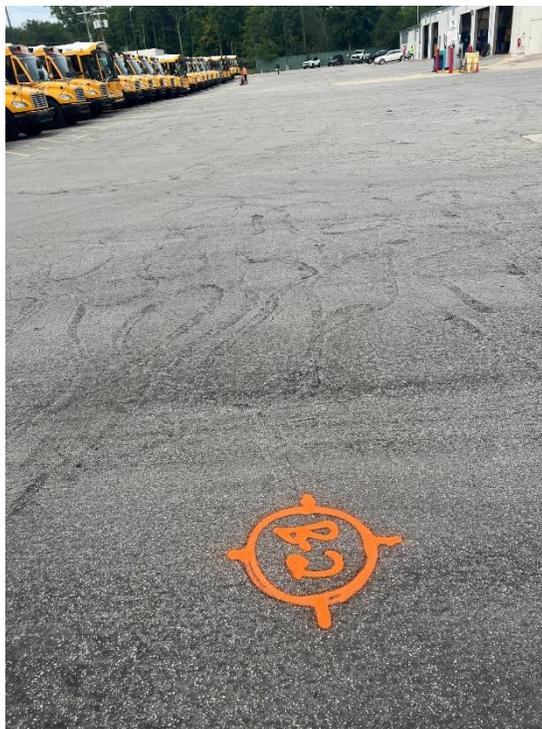
Photograph No. 4: Moderate severity fatigue cracking looking west toward B-2.

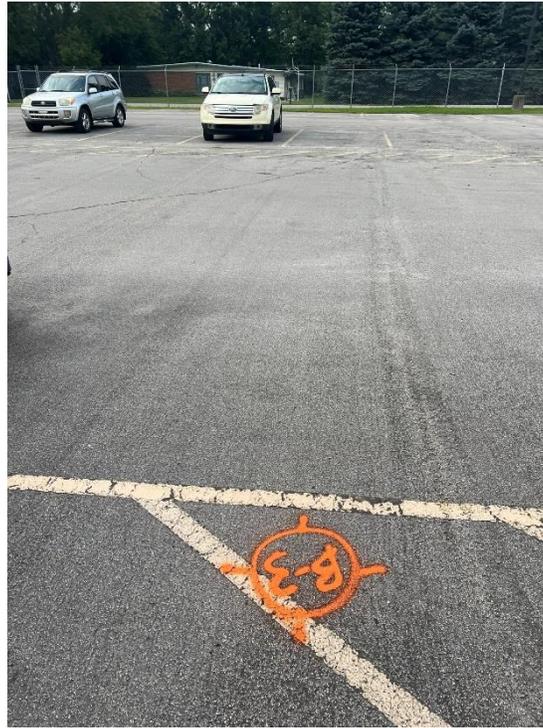
Photograph No. 5: Moderate severity cracking.

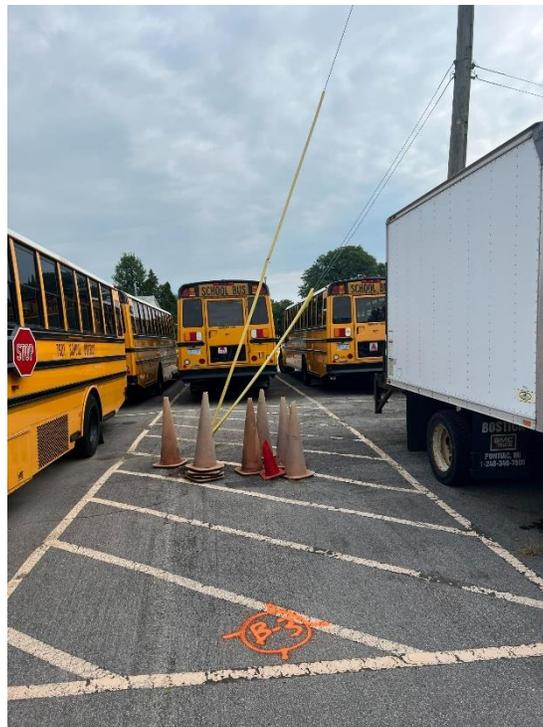
Photograph No. 6: Low severity fatigue cracking. Evidence of ponding near wheel load indicating potential settlement.

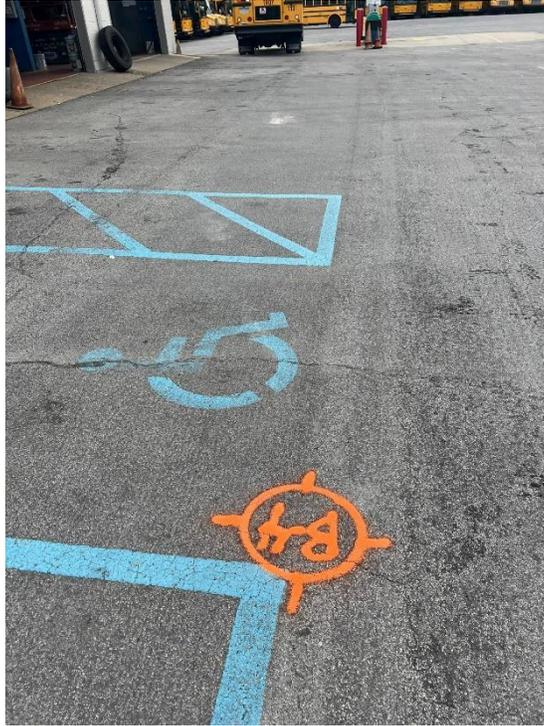
Photograph No. 7: Low severity block cracking near building.

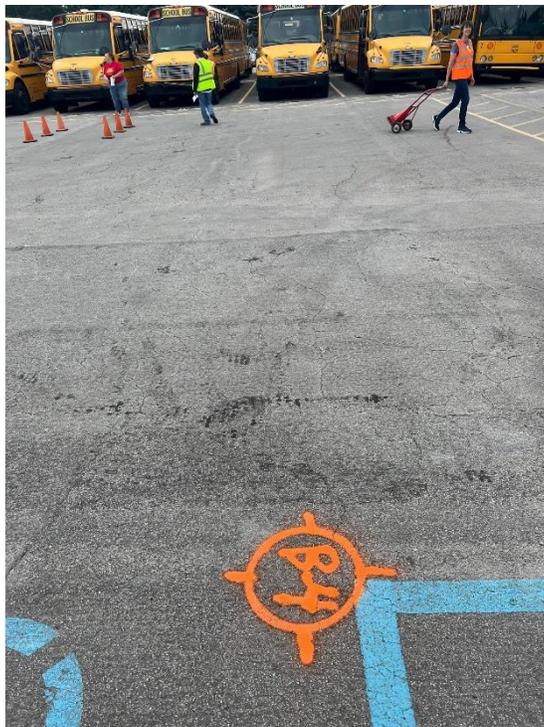
Photograph No. 8: Moderate severity fatigue cracking near bus garage.

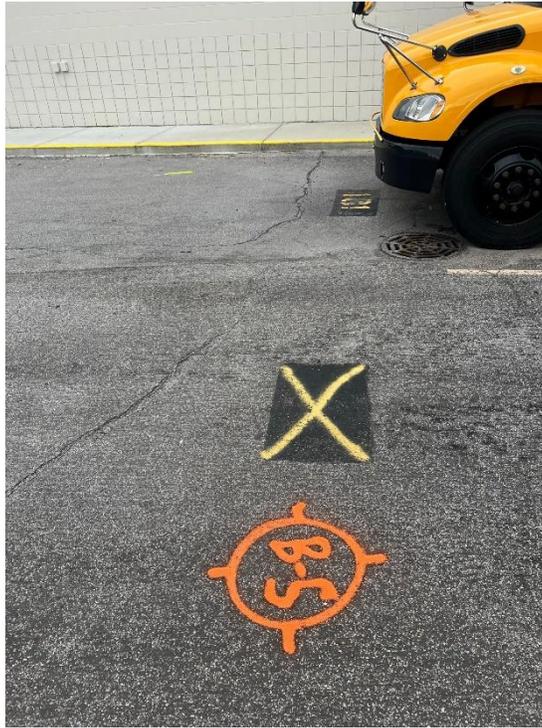
Photograph No. 9: Catch basin adjacent to the car wash building.

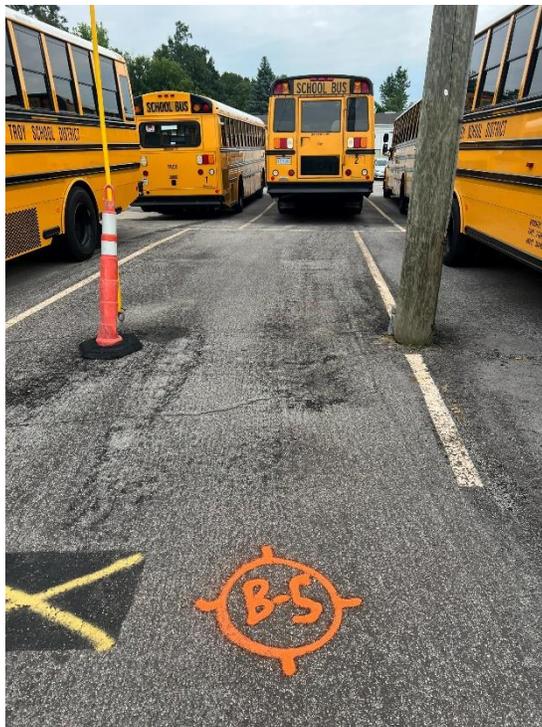
Photograph No. 10: Low severity transverse cracking.

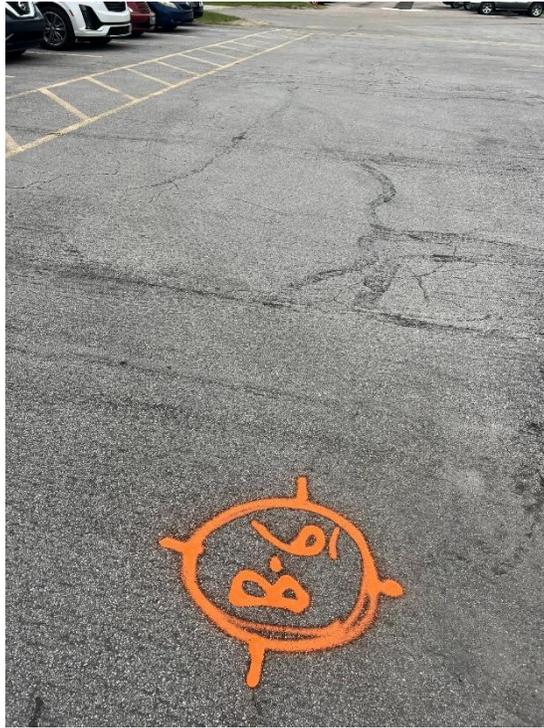
Photograph No. 11: Moderate severity block and fatigue cracking looking west toward west entrance.

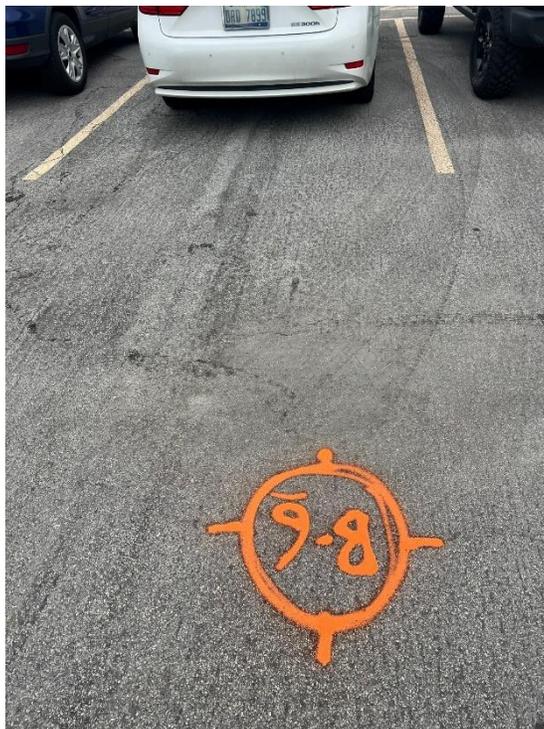
Photograph No. 12: Looking north toward parking stalls, no significant distress.
