Addendum 1

Project: **BRFP NUMBER 2324-03 – TROY SCHOOL DISTRICT 2024 SITE IMPROVEMENTS PAVING PROJECTS**

Report on Geotechnical
Pavement Investigation

**Baker Middle School
1359 Torpey Road
Troy, Michigan 48083**

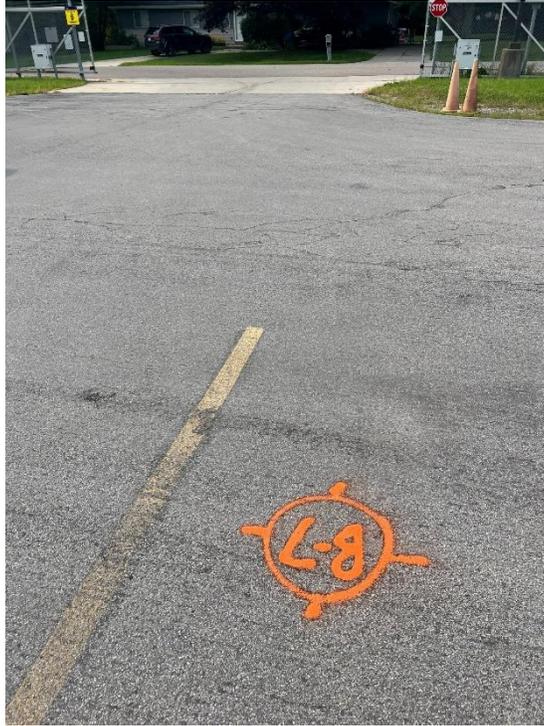
Photograph No. 13: Moderate severity block and fatigue cracking looking south at east entrance.

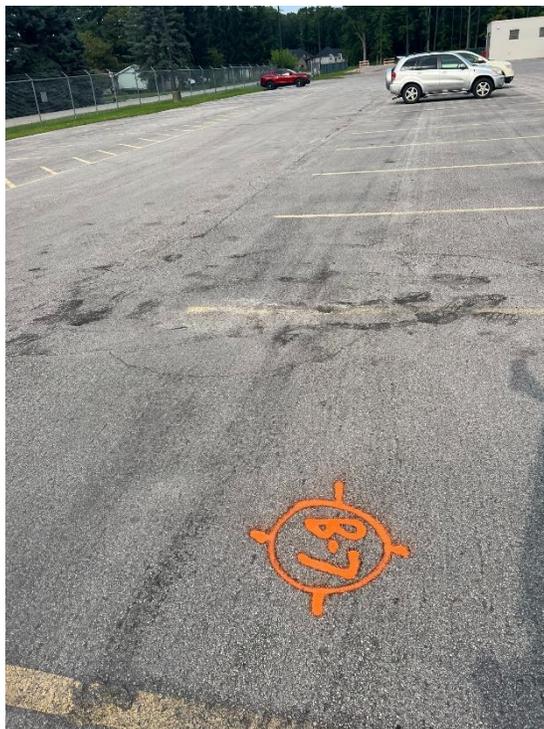
Photograph No. 14: Low to moderate severity joint and fatigue cracking looking west along south side of lot.

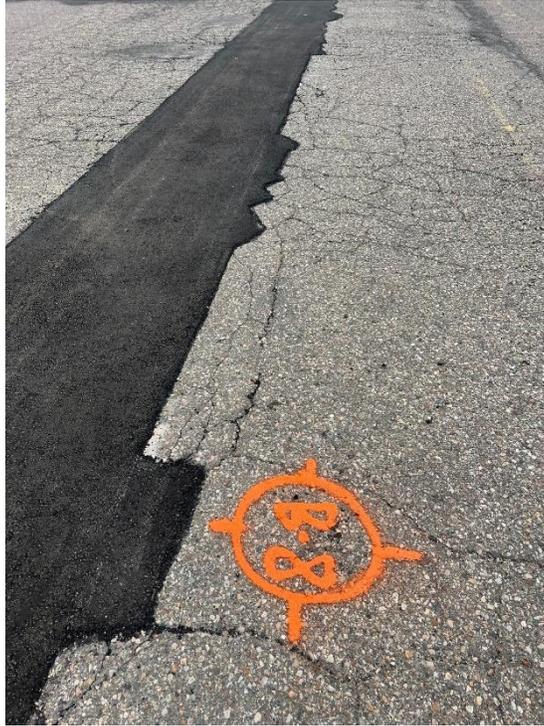
Photograph No. 15: Previous patch near B-8.

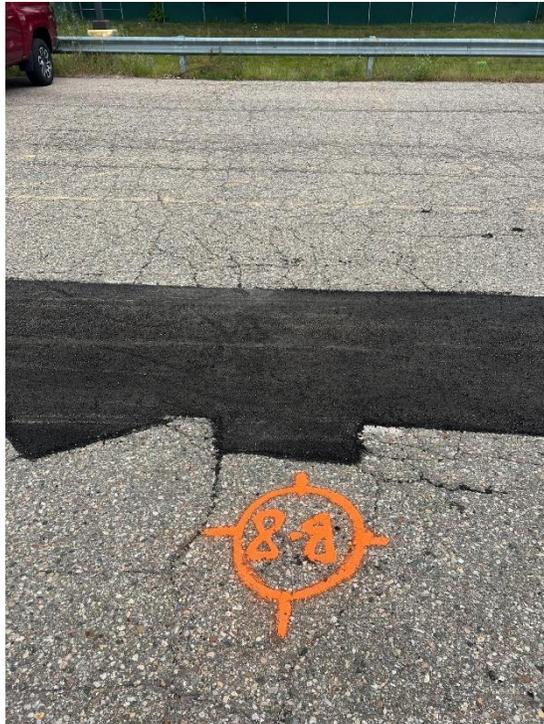
Photograph No. 16: High severity fatigue cracking in parking stalls.

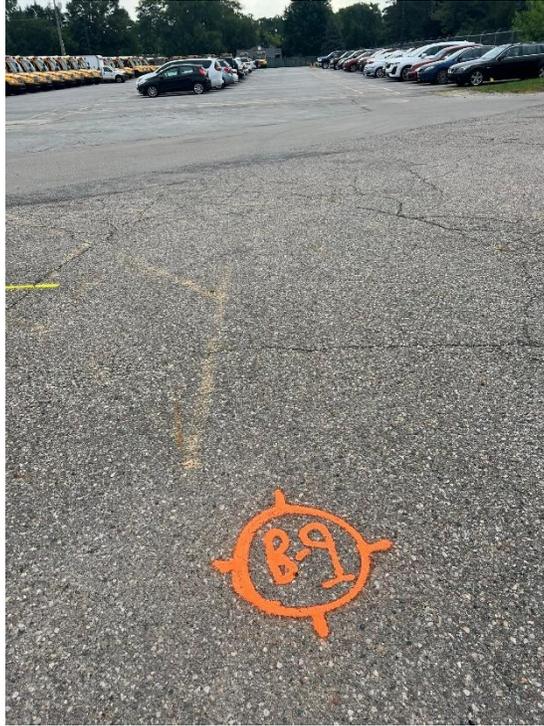
Photograph No. 17: Low severity fatigue cracking looking east along south side of the property. Previous patch crossing west entrance drive.

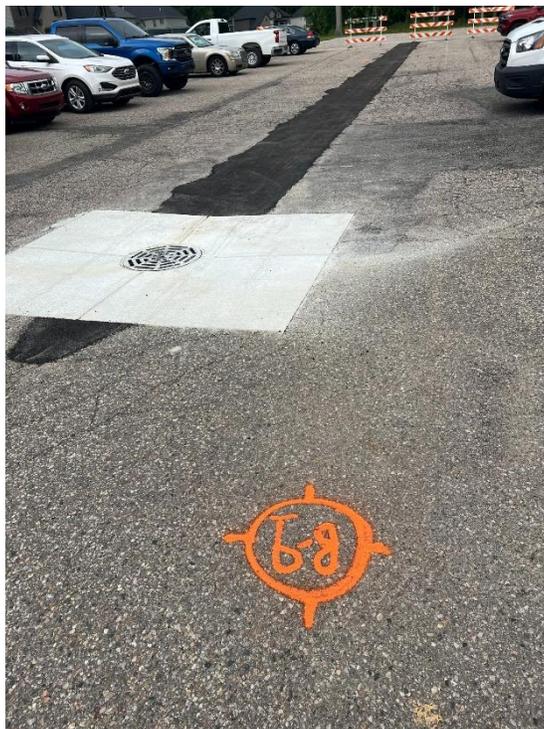
Photograph No. 18: Previous bituminous patch and new concrete collar around basin looking west.

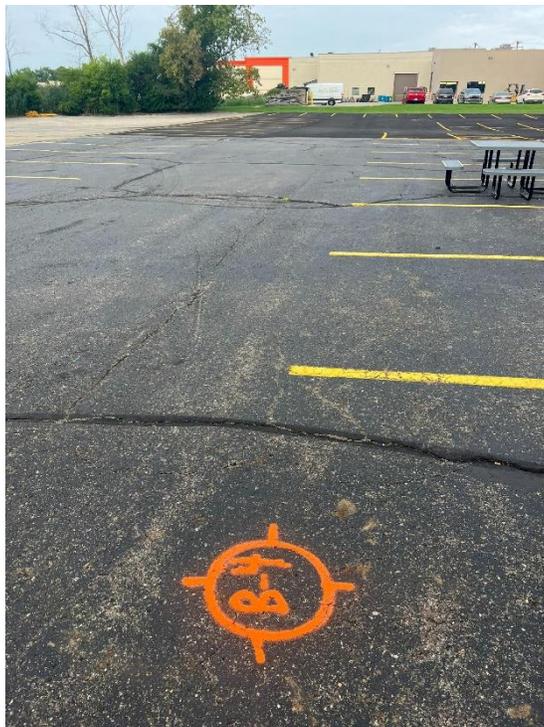
Photograph No. 8: Looking west, note the concrete pavement on the south side of the lot and newer pavement on west lot. Moderate to high severity block cracking.

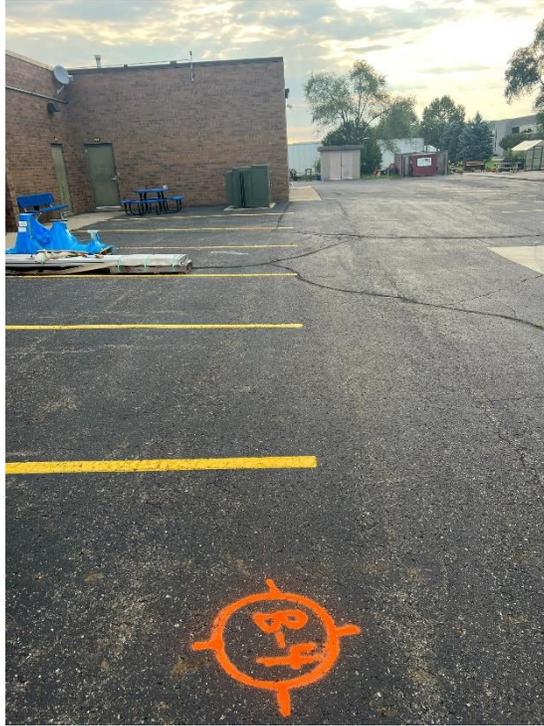
Photograph No. 9: Moderate severity block and fatigue cracking looking east.
Concrete color around catch basin. Pavement flush with building.

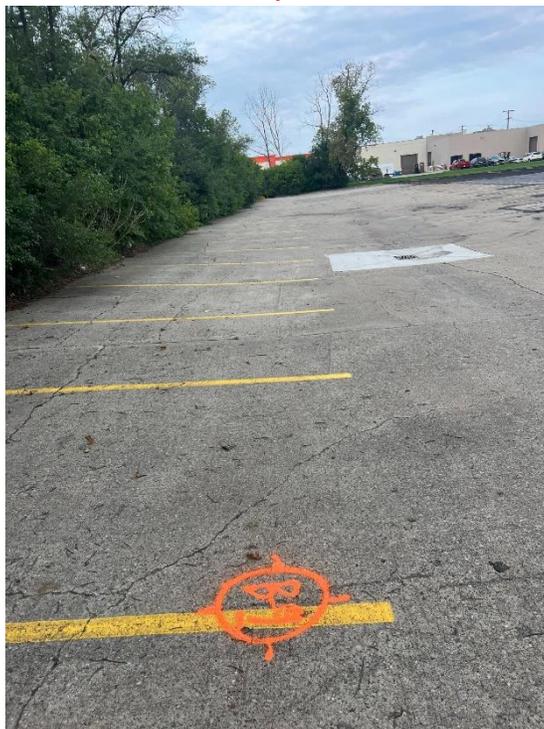
Photograph No. 10: Concrete pavement at south side of lot.
Moderate severity fatigue cracking.

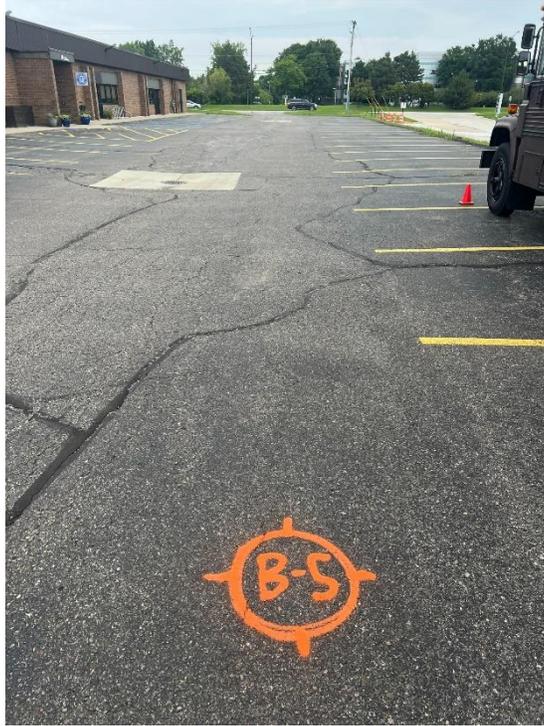
Photograph No. 11: Moderate severity block cracking with moderate to high severity fatigue cracking propagating outward, looking north along east lot.

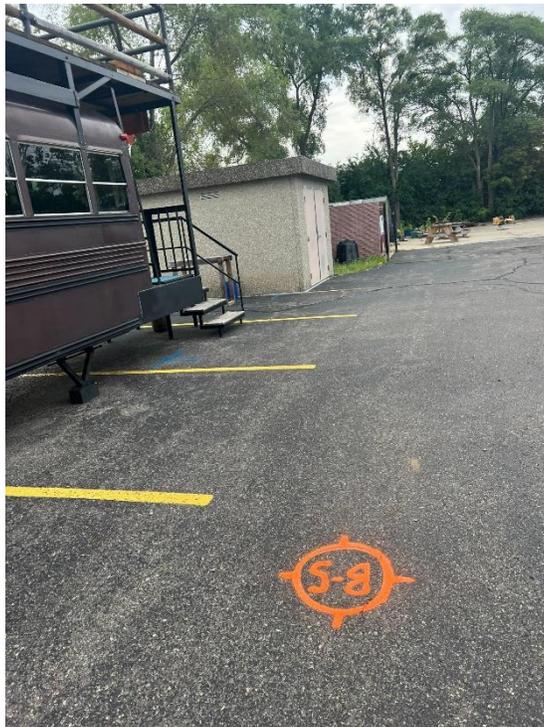
Photograph No. 12: Moderate severity block and fatigue cracking looking south.

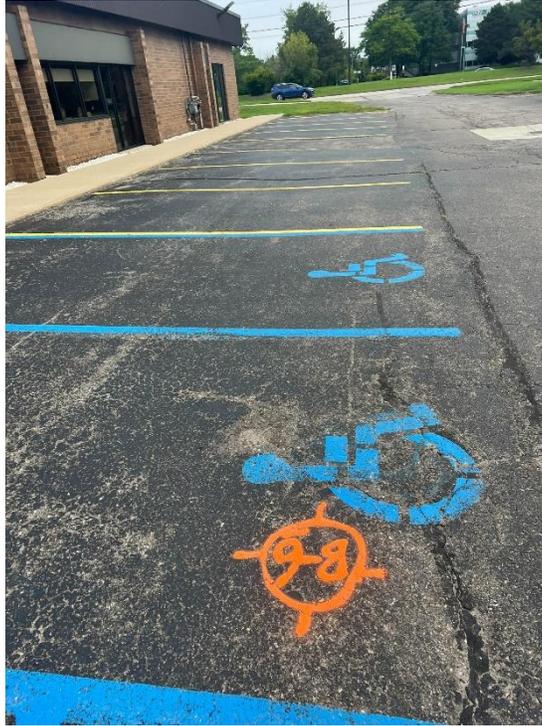
Photograph No. 13: Moderate to high severity block and joint cracking with secondary fatigue cracking looking north toward drive entrance.

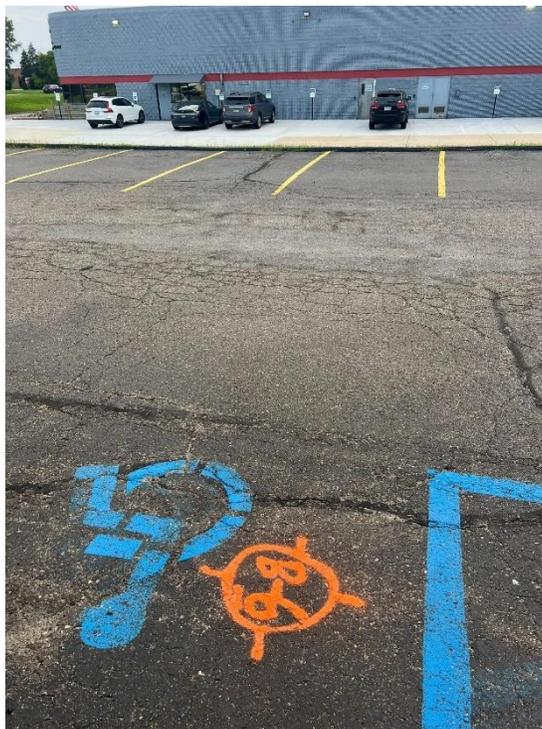
Photograph No. 14: High severity fatigue cracking and settlement evident. Previous patch constructed.

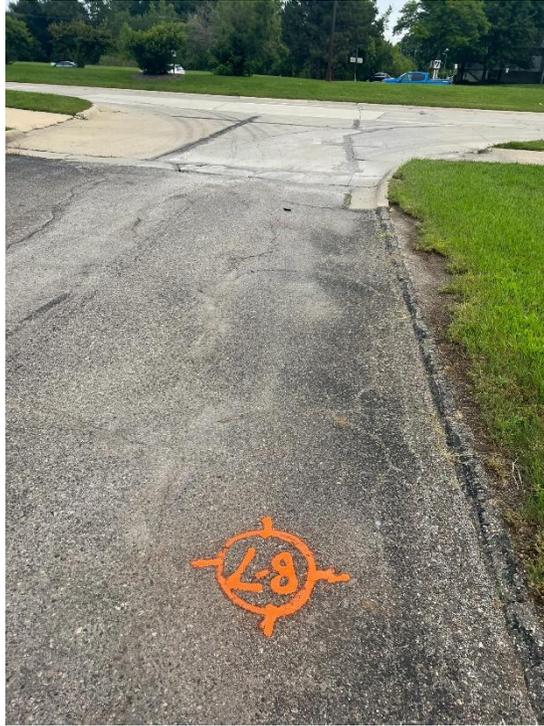
Photograph No. 15: Moderate fatigue cracking at east entrance. Note asphalt curb.

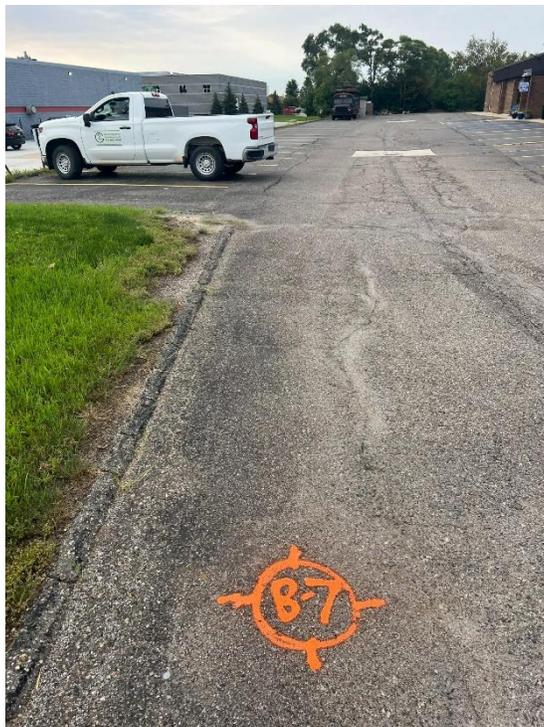
Photograph No. 16: High severity fatigue cracking at center of lot looking south from access drive.

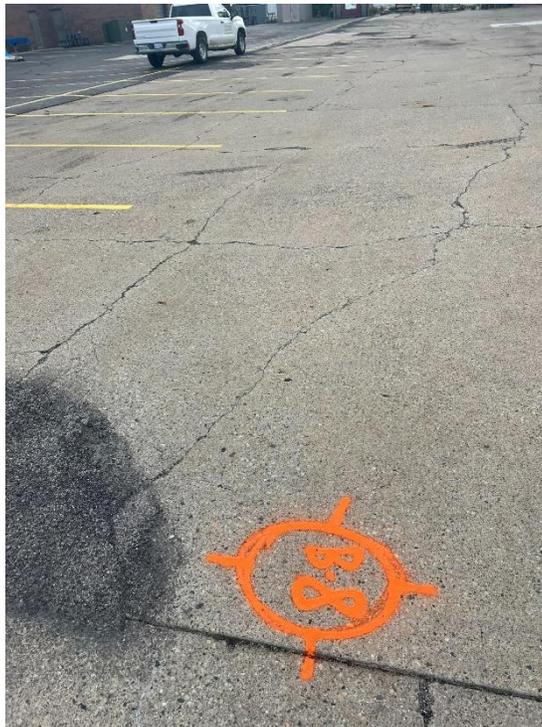
Photograph No. 18: Moderate to high severity longitudinal and transverse cracking, looking east along concrete lot.

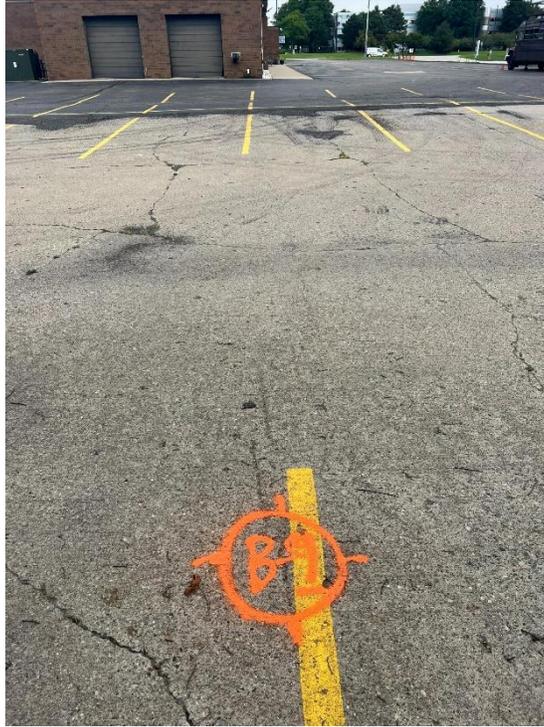
Photograph No. 19: Moderate to high severity longitudinal and transverse cracking, looking north along concrete lot.

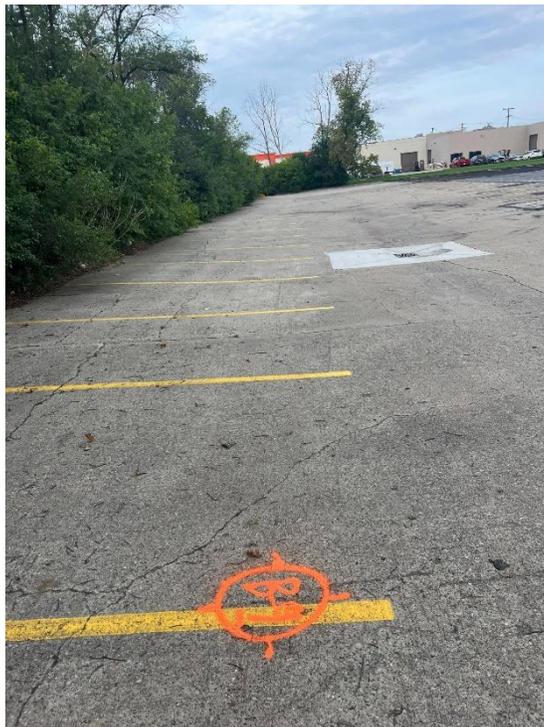
Photograph No. 20: Moderate to high severity longitudinal and transverse cracking, looking west along concrete lot.
