FACILITY CONDITION ASSESSMENT

Business Office | November 2020

Business Office, located at 4701 Col. Vickrey in Vancleave, Mississippi, oldest building is 25 years old (at time of 2020 assessment). It comprises 1,600 gross square feet.

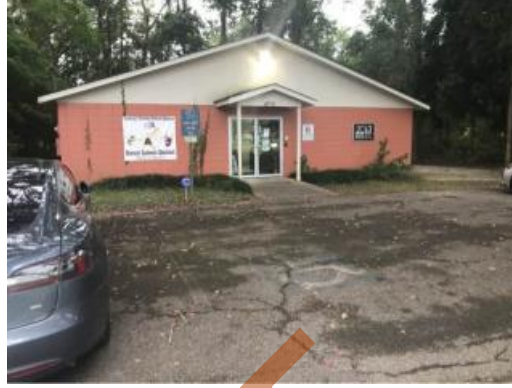
Deficiency	Category	Qty	UoM	Priority	Repair Cost	ID
Car Accessible Parking Spaces Restriping	ADA Compliance	1	Ea.	3	\$101	4
The Van Accessible Parking Spaces Do Not Meet ADA Requirements	ADA Compliance	1	Ea.	3	\$697	5
Note: Sign not legible Location: Main entry						
Paving Restriping	Deferred Maintenance	11	CAR	5	\$326	3
Location: Parking spaces site wide						
Sub Total for System		3 items			\$1,124	
Sub Total for School and Site Level		3 items			\$1,124

ADA signage and parking space Restripe

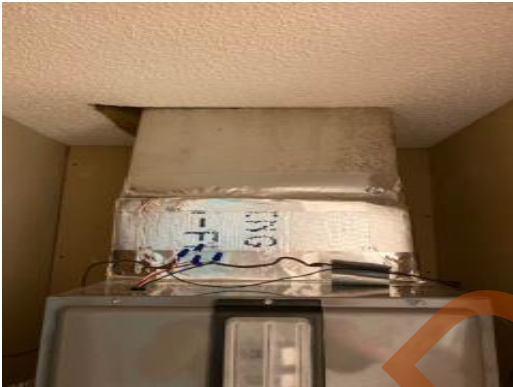
Deficiency	Category	Qty	UoM	Priority	Repair Cost	ID
HVAC Study Recommended	Functional Deficiency	1	LS	3	\$5,760	1
Note: Owner mentioned when new split system was installed contractor used original line-sets. Line-sites could potentially be incorrect sizes. Verify correct line-set installed. Repair/replace as necessary (20 LF)						
Location: Building wide						
Duct Cleaning	Deferred Maintenance	1,600	SF	5	\$1,624	2
Note: Suspect materials, clean ducts Location: Building wide						
Sub Total for System		2 items			\$7,384

Ductwork to the air handler

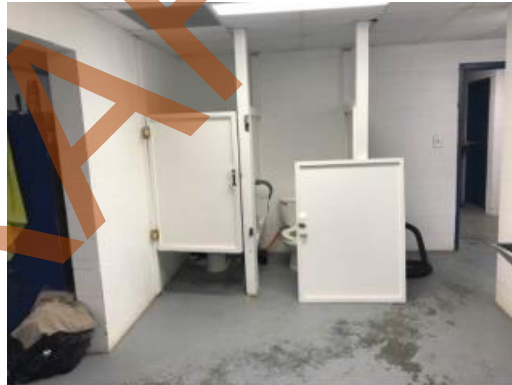
Boys locker room, replace Restroom partitions
