FACILITY CONDITION ASSESSMENT

GED Building | November 2020

GED Building, located at 12513 Hwy 57 in Vancleave, Mississippi, oldest building is 28 years old (at time of 2020 assessment). It comprises 1,900 gross square feet.

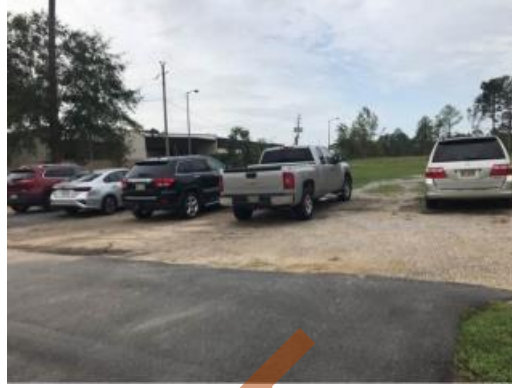
Gravel parking

Deficiency	Category	Qty	UoM	Priority	Repair Cost	ID
Asphalt Driveway Replacement	Capital Renewal	4,000	SF	3	\$22,952	716
Car Accessible Parking Spaces Do Not Meet ADA Requirements	ADA Compliance	10	Ea.	3	\$6,967	708
Note: Construct a paved parking lot, ADA compliant. Stripe for 10 cars, add complaint space						
Exterior Entry Signage At The Building Entry Does Not Meet ADA Requirements	ADA Compliance	1	Ea.	3	\$120	709
Location: Main Entry						
Asphalt Paving Replacement	Capital Renewal	10	CAR	4	\$12,946	715
		Sub Total for System		4 items	\$42,984	
		Sub Total for School and Site Level		4 items	\$42,984

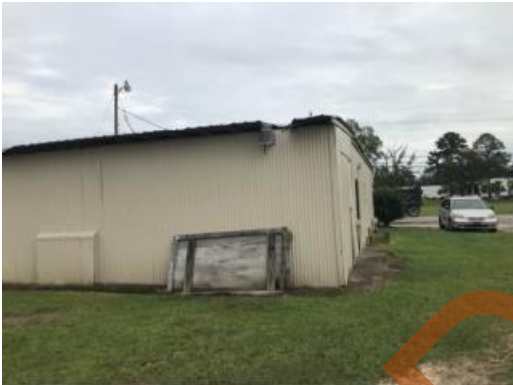
Roof damage

Deficiency	Category	Qty	UoM	Priority	Repair Cost	ID
Metal Roof Architectural Roof Covering Replacement	Capital Renewal	100	SF	2	\$3,559	706
Note: Damaged						
		Sub Total for System		1 items	\$3,559

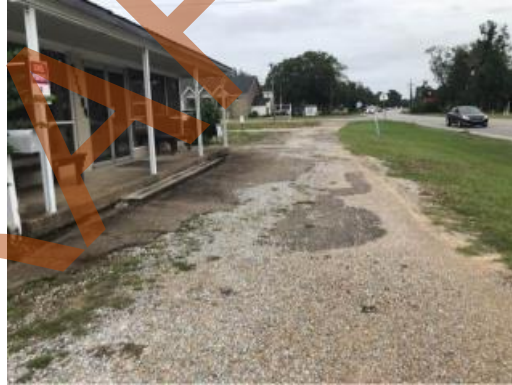
Gravel drive

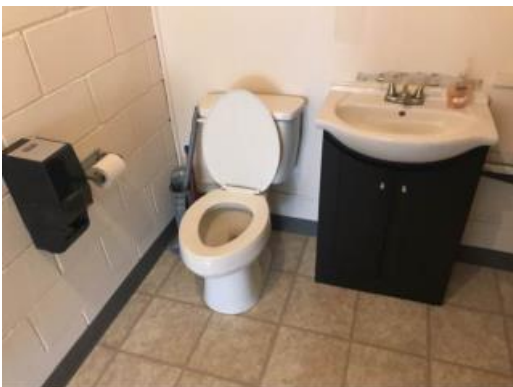
Restroom fixtures and finishes

Deficiency	Category	Qty	UoM	Priority	Repair Cost	ID
Restroom Is Not ADA Compliant	ADA Compliance	200	SF	3	\$18,839	713
Note: Construct ADA Restroom						
		Sub Total for System		1 items	\$18,839	
		Sub Total for Building 01 - GED Building		5 items	\$40,610	
		Total for Campus		9 items	\$83,595

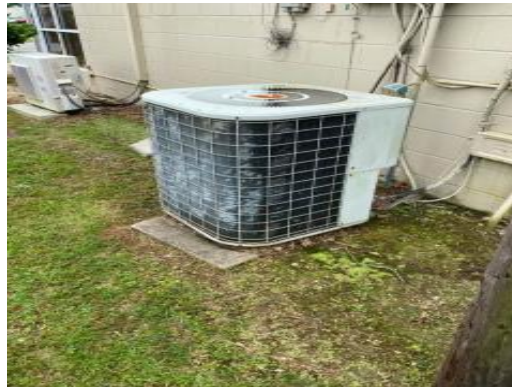
Abandoned equipment

Deficiency	Category	Qty	UoM	Priority	Repair Cost	ID
Remove Abandoned Equipment	Deferred Maintenance	1	Ea.	5	\$1,106	705
Note: Fan coil/heat pump (4.0 Ton)						
		Sub Total for System		1 items	\$1,106
