FACILITY CONDITION ASSESSMENT

East Central High School | November 2020

Executive Summary

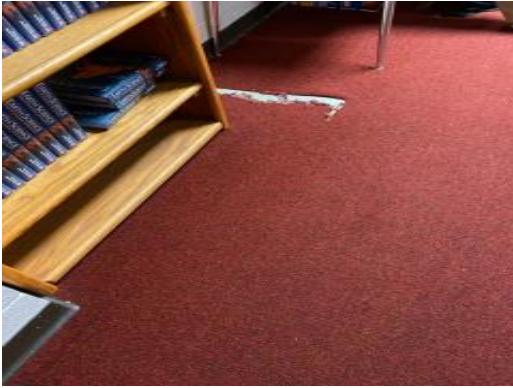
Worn carpet

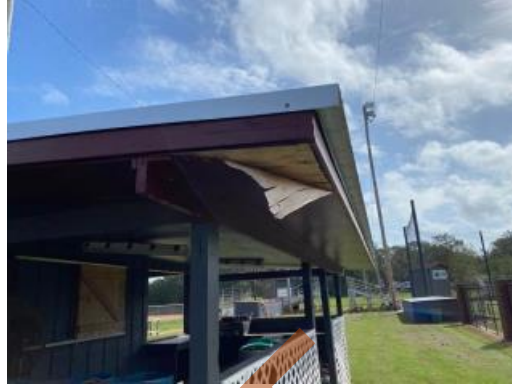
Deficiency	Category	Qty	UoM	Priority	Repair Cost	ID
Awning Or Canopy Metal Roofing System Replacement	Capital Renewal	5	SF	3	\$181	435
Note: Plywood soffit underneath extended metal roof overhang is rotting/deteriorating.						
Location: Northwest corner						
Sub Total for System		1	items		\$181

Deteriorated plywood soffit

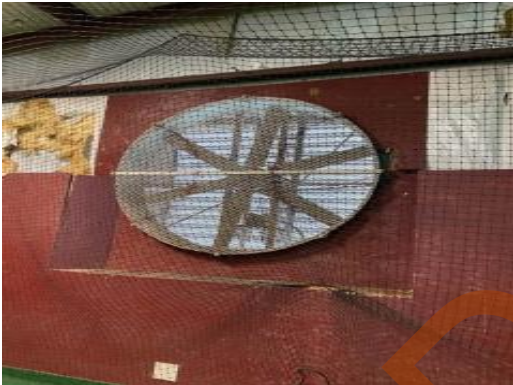
Deficiency	Category	Qty	UoM	Priority	Repair Cost	ID
Wall Exhaust Fan Ventilation Replacement	Capital Renewal	1	Ea.	4	\$4,222	442
Note: Exhaust fan is making excessive noise and is barely working.						
Sub Total for System		1	items		\$4,222

Noisy wall exhaust fan

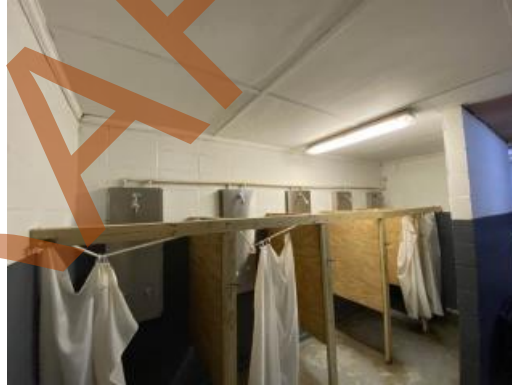
Showers

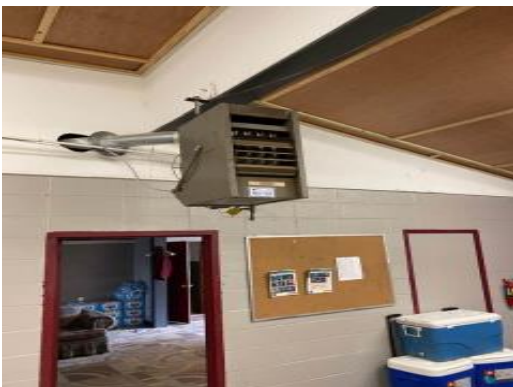
Aged heater

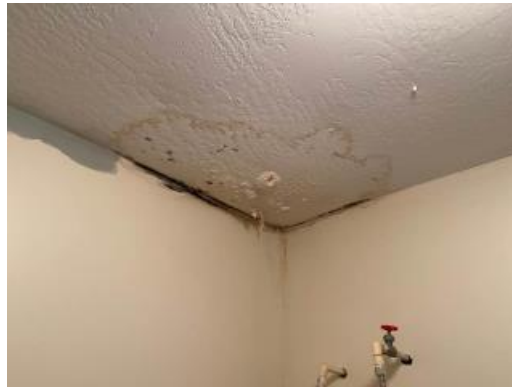
Water damaged ceiling

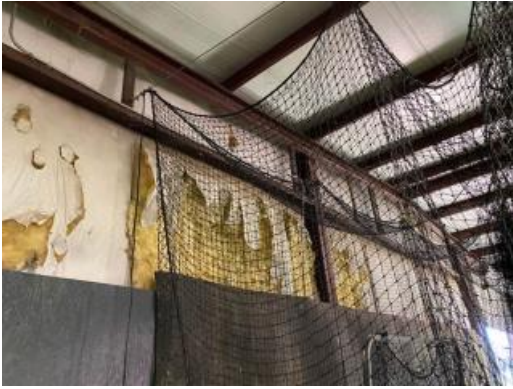
Multiple holes and tears in insulation

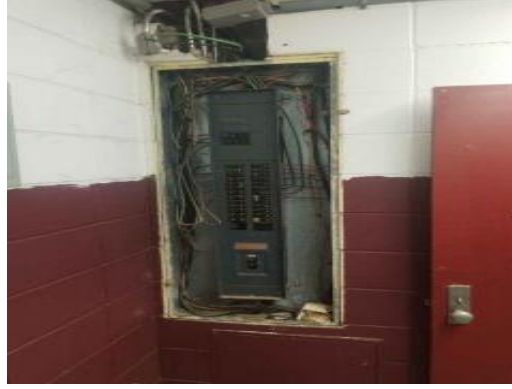
Deadfront and panel cover missing

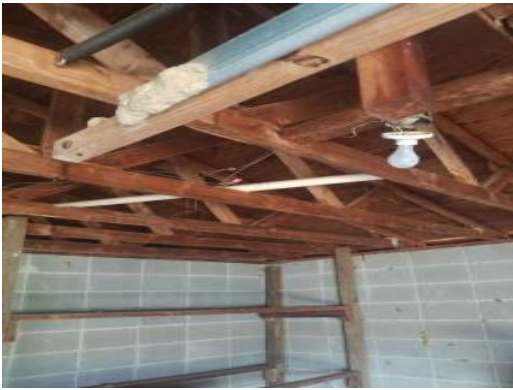
Exposed wiring

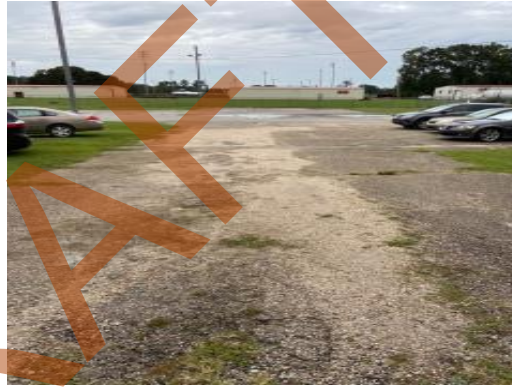
Asphalt failure north of cafeteria wing

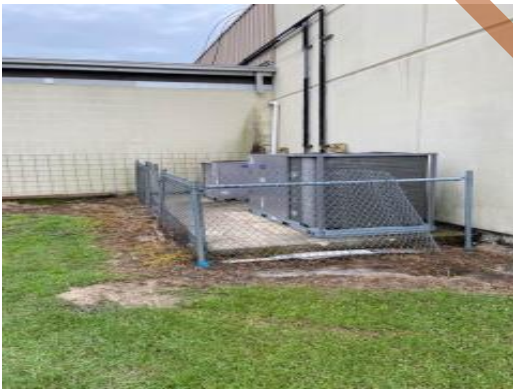
Damaged fencing
