FACILITY CONDITION ASSESSMENT

Vancleave High School | November 2020

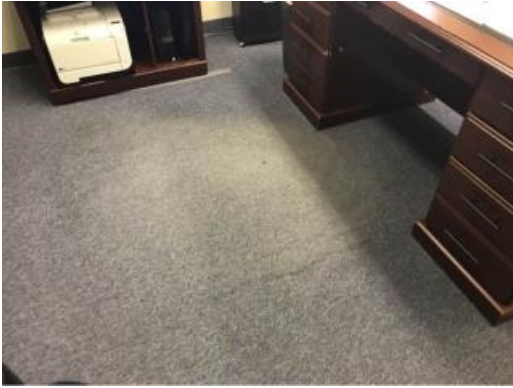
Worn carpet

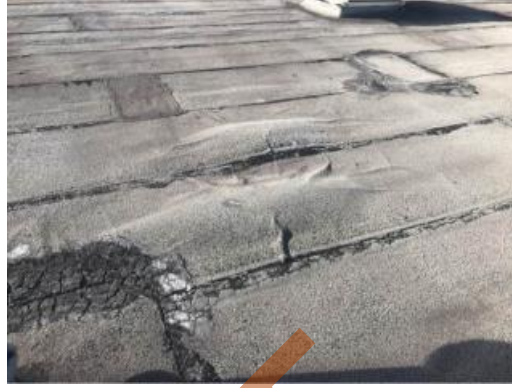
Aged and bubbled roofing

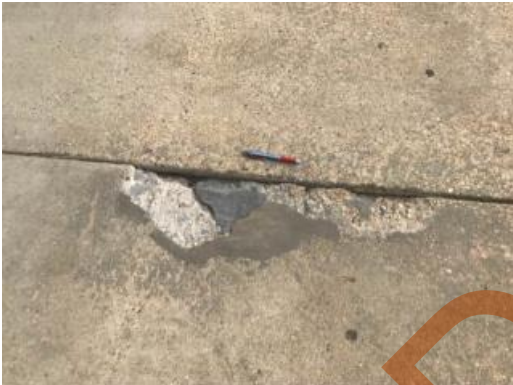
Damaged sidewalk south of gym

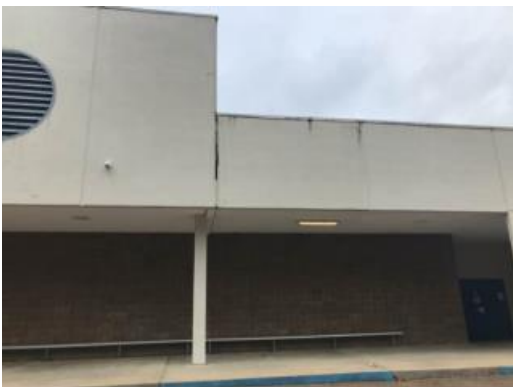
Precast panel joint damage

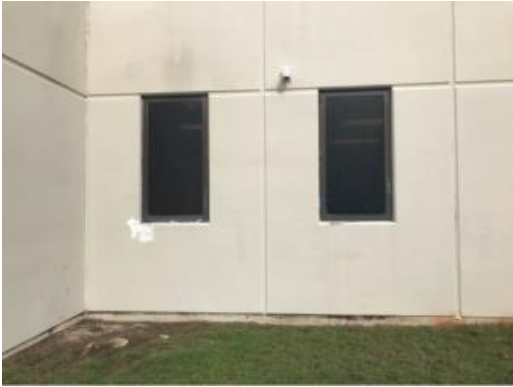
Aged and worn windows

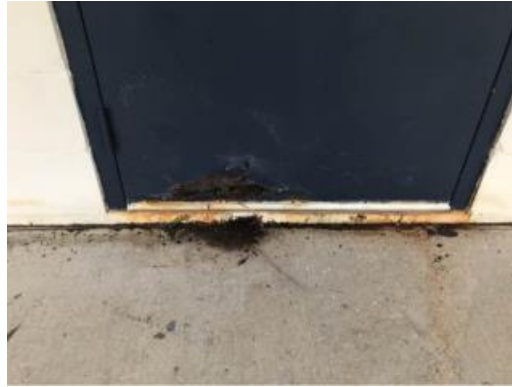
Rusted exterior door

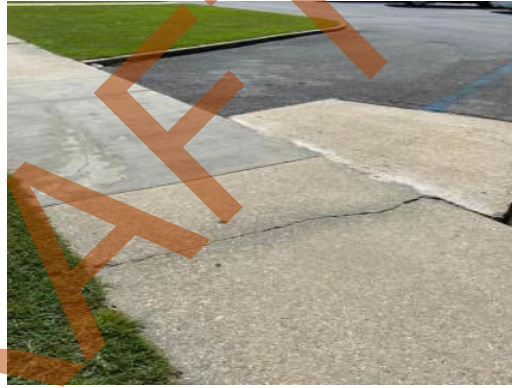
Cracked sidewalk at main entry

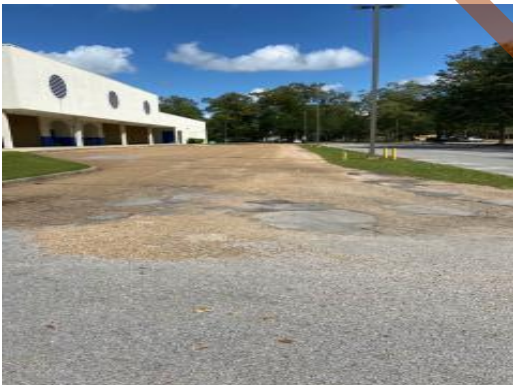
Failing asphalt south of building

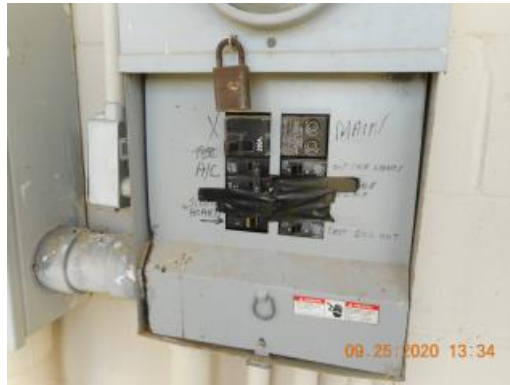
Deficiency	Category	Qty	UoM	Priority	Repair Cost	ID
Panelboard Replacement	Capital Renewal	1	Ea.	2	\$4,907	516
Note: Breakers covered in tape						
Sub Total for System		1	items		\$4,907	
Sub Total for Building 07 - Softball Concession		1	items		\$4,907

Panelboard with tape covering breaker switches
