FACILITY CONDITION ASSESSMENT

St. Martin High School | November 2020

Jackson CS - St. Martin High School

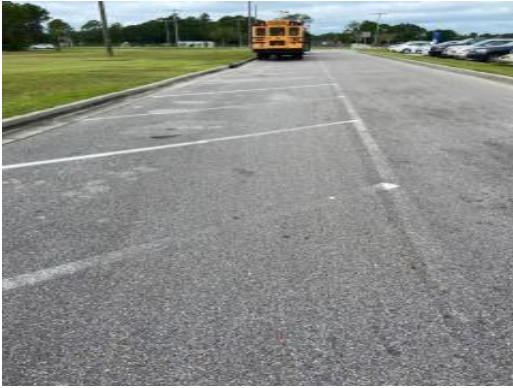
Deficiency	Category	Qty	UoM	Priority	Repair Cost	ID
Concrete Driveways Replacement	Capital Renewal	700	SF	3	\$7,797	338
Concrete Walks Replacement	Capital Renewal	3,000	SF	3	\$30,322	341
Note: Sidewalk damaged outside Northwest corner of the building 8 and circular seating area in the courtyard.						
Site Drainage Regrading	Deferred Maintenance	1,200	SF	4	\$1,540	340
Note: Area to the East of propane tanks to be regraded to alleviate standing water						
Bollard Replacement	Deferred Maintenance	2	Ea.	5	\$2,220	342
Note: Northeast corner of the parking lot						
Paving Restriping	Deferred Maintenance	884	CAR	5	\$26,232	339
Note: Faded throughout site. Crosshatch pavement striping needs to be redone.						
Sub Total for System		5 items			\$68,111

Faded parking striping on the south drive

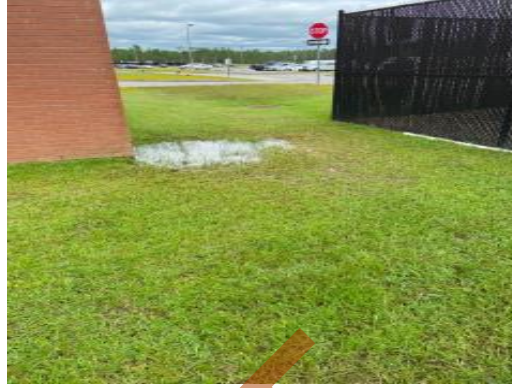
Area on southeast corner holding water

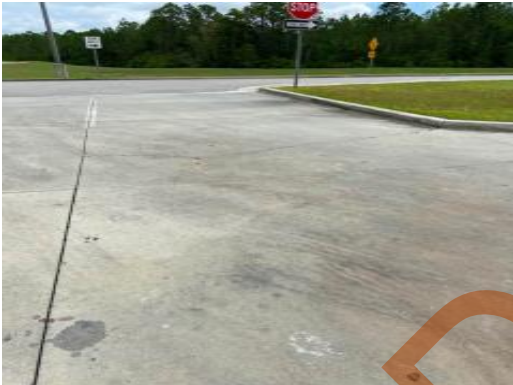
Concrete drive in southeast corner

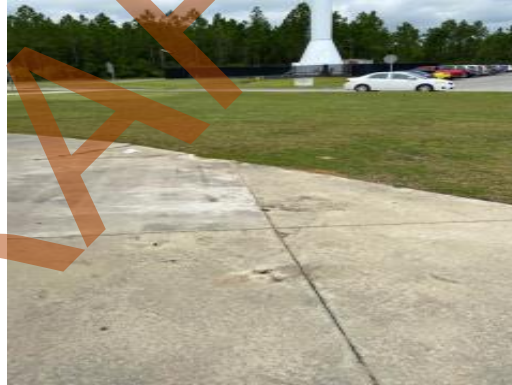
Sidewalk at northwest building corner

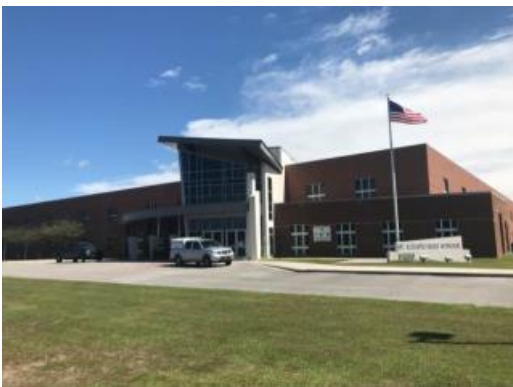
Main entrance

Deficiency	Category	Qty	UoM	Priority	Repair Cost	ID
Entry Door Does Not Have Power Assist Device	ADA Compliance	1	Ea.	3	\$14,134	750
Location: main entrance						
Sub Total for System		1 items			\$14,134

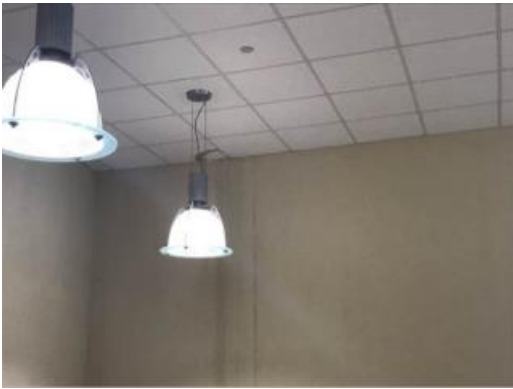
Deficiency	Category	Qty	UoM	Priority	Repair Cost	ID
Single-Ply Membrane Roof Covering Replacement	Capital Renewal	100	SF	2	\$3,000	953
Note: Roof leak in north stairwell.						
Sub Total for System		1 items			\$3,000

Roof leak north stairwell

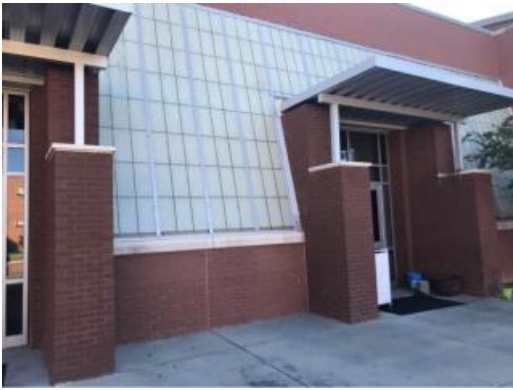
Art rooms light wall

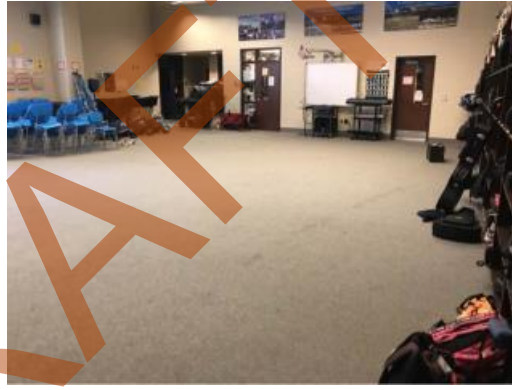
Deficiency	Category	Qty	UoM	Priority	Repair Cost	ID
Carpet Flooring Replacement	Capital Renewal	1,000	SF	4	\$11,297	784
Location: band room						
Vinyl Composition Tile Replacement	Capital Renewal	1,520	SF	4	\$11,092	785
Note: Sheet vinyl						
Location: main entry and hallway						
Sub Total for System		2	items		\$22,388

Worn band hall carpet

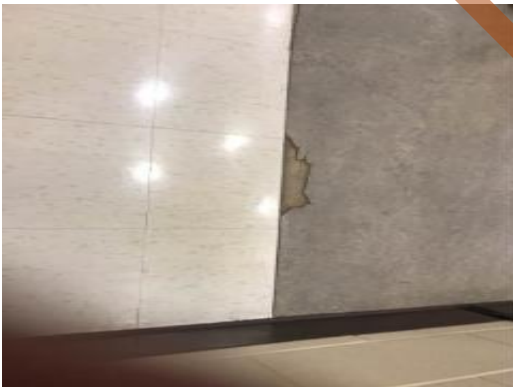
Worn hallway floor
