FACILITY CONDITION ASSESSMENT

St. Martin Middle School | November 2020

Jackson CS - St. Martin Middle School

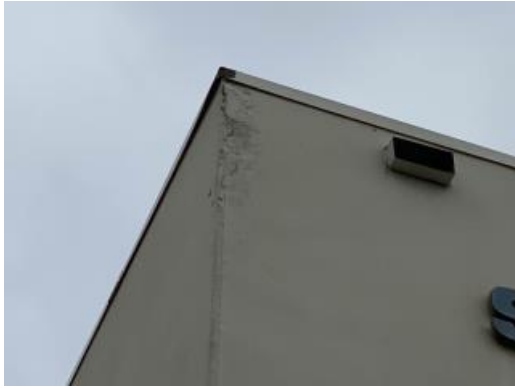
Deteriorating precast panel on west side of building

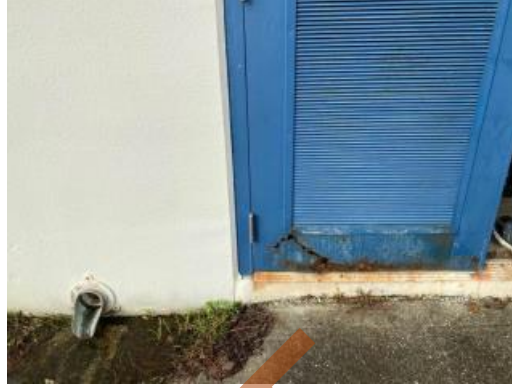
Rusted exterior metal door

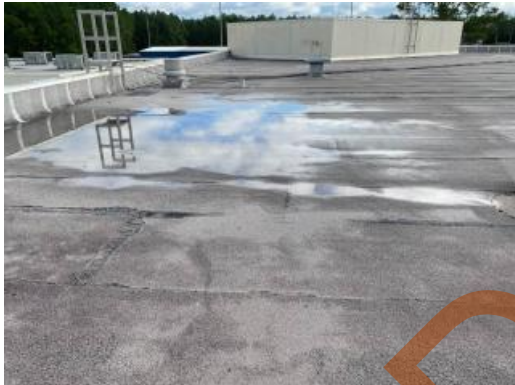
Deficiency	Category	Qty	UoM	Priority	Repair Cost	ID
Modified Roof Covering Replacement Note: Across entire portion of the original building area roof, the top layer is scraping off. There are areas of severe ponding, bubbling, and blistering. Location: Original roof area	Capital Renewal	96,200	SF	2	\$2,958,553	108

Ponding on roof

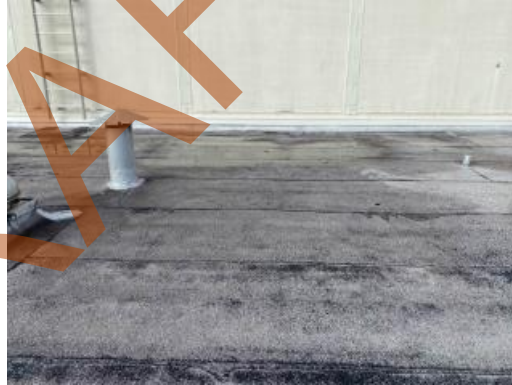
Bubbled and blistered roof

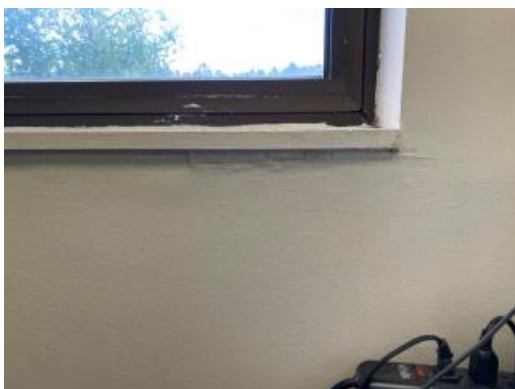
Deficiency	Category	Qty	UoM	Priority	Repair Cost	ID
Aluminum Window Replacement	Capital Renewal	540	SF	2	\$48,053	157
Note: 30 @ 3x6 - all original windows need to be replaced due to leaking and being unable to properly close.						
Concrete Pre-Cast Panel Replacement (Bldg SF)	Capital Renewal	350	SF	2	\$5,857	206
Note: Pre-cast panel has been patched in various locations and is deteriorating.						
Location: West side of entry, area around signage, exterior courtyard wall on west side of building						
Metal Exterior Door Replacement	Capital Renewal	33	Door	2	\$109,157	158
Note: Original metal doors should be replaced due to rust, extensive wear and tear, and inability to close properly.						
Concrete/CMU Exterior Repair	Deferred Maintenance	60	LF	4	\$792	205
Note: There is cracking and damage to pre-cast panels at corner joints and expansion joints.						
Exterior Painting (Bldg SF)	Capital Renewal	101,250	SF	4	\$158,172	155

Water damage at leaking window

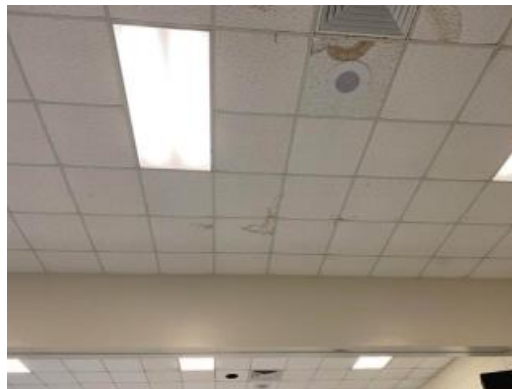
Water damaged ceiling tiles

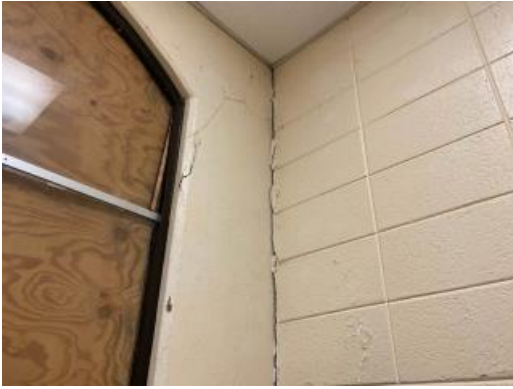
Crack at ticket booth area

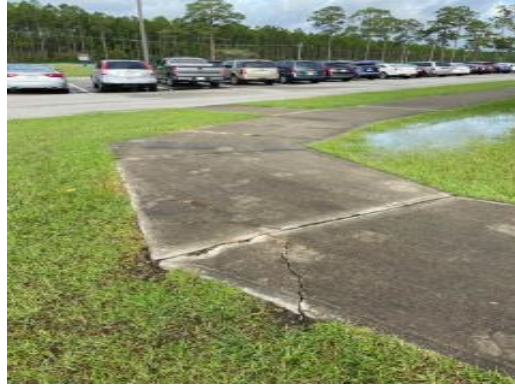
Damaged south sidewalk

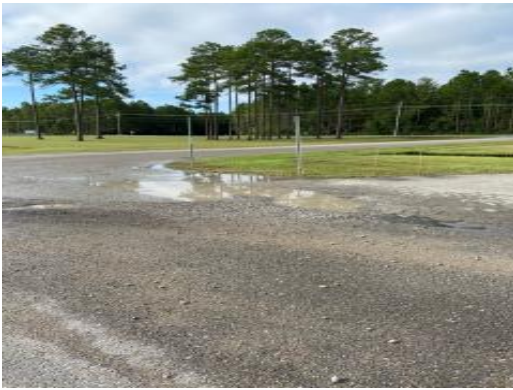
Deficiency	Category	Qty	UoM	Priority	Repair Cost	ID
Asphalt Driveway Replacement Note: Southwest corner of west parking lot (4,000 SF). Asphalt drive to the east of the cafeteria wing (2,000 SF). South of the cafeteria wing (9,000 SF).	Capital Renewal	15,000	SF	3	\$86,069	787
Asphalt Driveway Replacement Note: Asphalt drive to the southwest of the new fieldhouse is failing and holding water. Location: Football fieldhouses	Capital Renewal	3,500	SF	3	\$20,083	836
Asphalt Driveway Replacement Note: Low spot in asphalt holding water SW of building. Location: Baseball fieldhouse	Capital Renewal	5,000	SF	3	\$28,690	840
Asphalt Walks Replacement Note: Asphalt sidewalk to be replaced due to grass growing through and causing sidewalk to fail. Location: SE of new fieldhouse	Capital Renewal	2,000	SF	3	\$10,336	838
Concrete Walks Replacement Note: Cracked along the south building line	Capital Renewal	200	SF	3	\$2,021	791

Failing asphalt at southwest corner of west parking lot

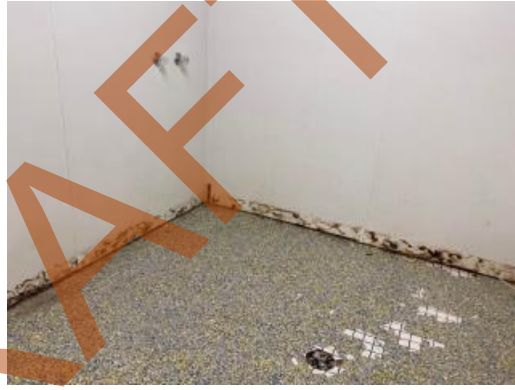
Damaged wall in group shower area

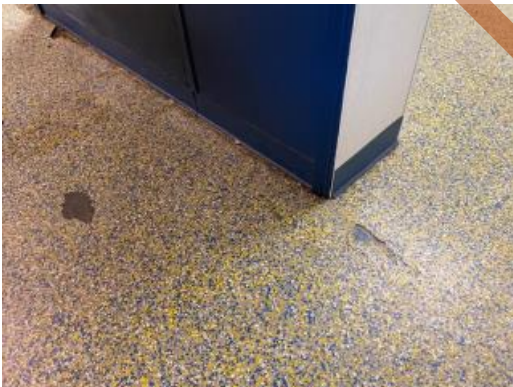
Peeling epoxy flooring
