FACILITY CONDITION ASSESSMENT

St. Martin Upper Elementary | November 2020

Jackson CS - St. Martin Upper Elementary

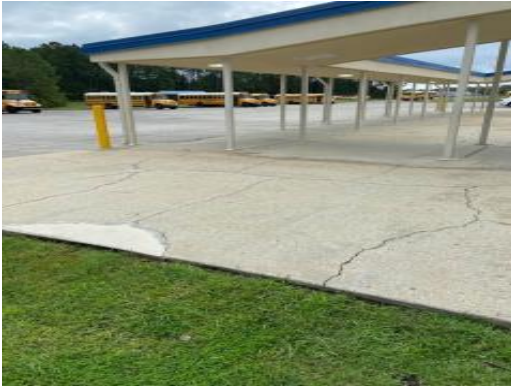
Cracked sidewalks

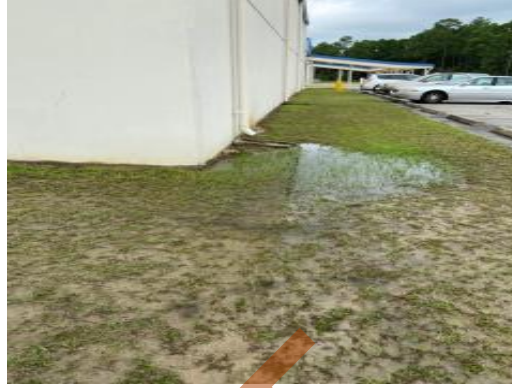
Area around southeast building corner ponding

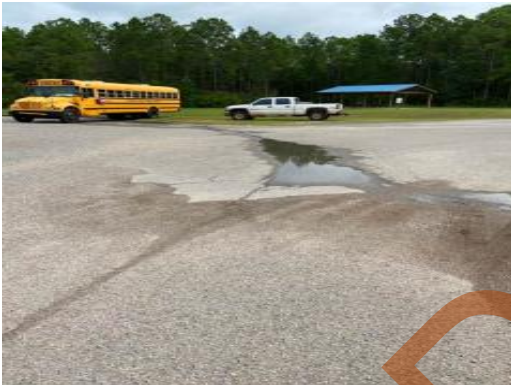
Driveway pavement failure

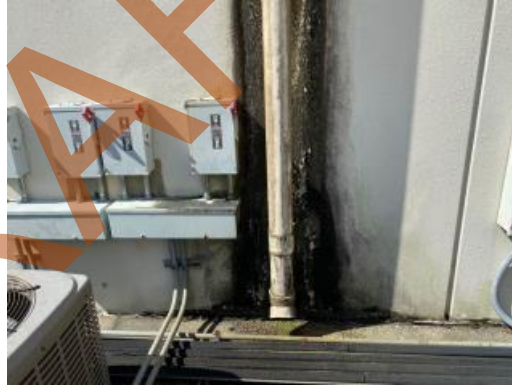
Area around downspout to be cleaned

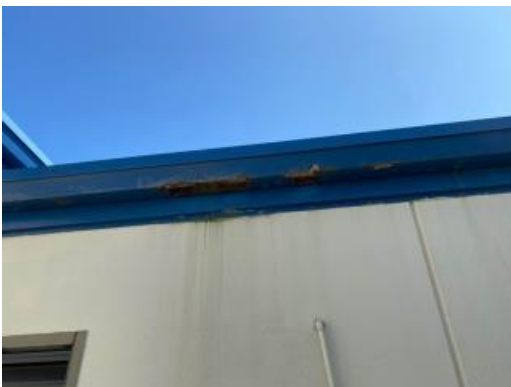
Deficiency	Category	Qty	UoM	Priority	Repair Cost	ID
Gutter Replacement Note: Entire perimeter of gutter needs to be replaced. Gutters are rusted out at every downspout and at every seam/joint.	Deferred Maintenance	1,800	LF	3	\$32,678	64
Sub Total for System		1	items		\$32,678

Rusted out gutters
