FACILITY CONDITION ASSESSMENT

St. Martin East Elementary | November 2020

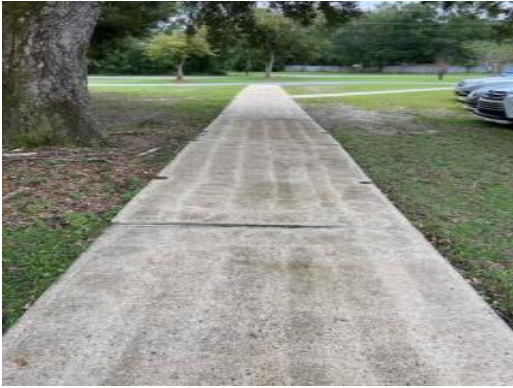
Concrete sidewalk buckling

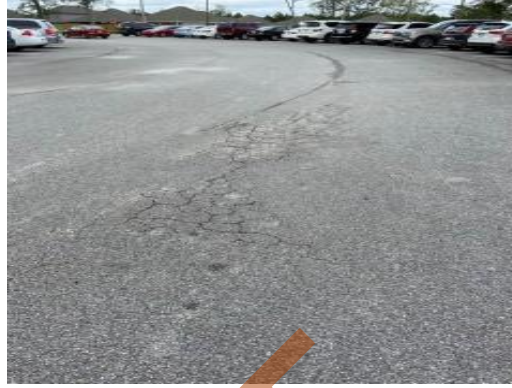
Cracked asphalt pavement

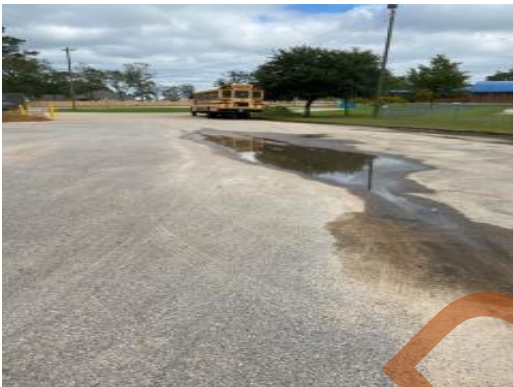
Ponding in east parking lot

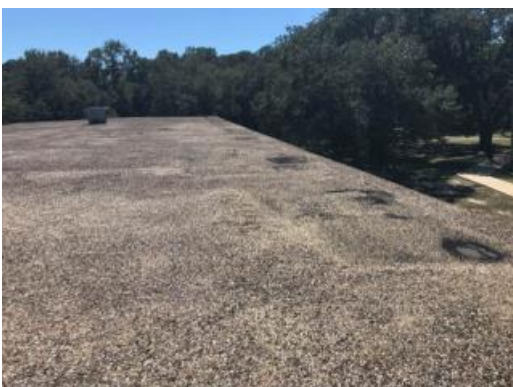
Built up roofing with evidence of leaks

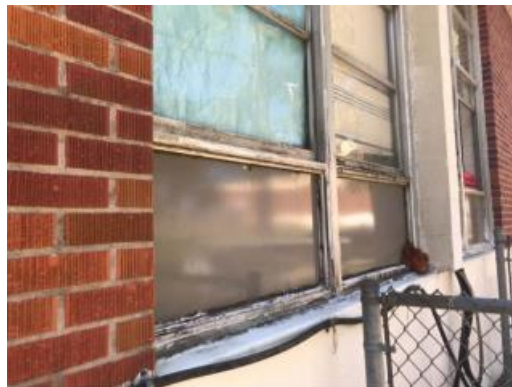
Aged windows

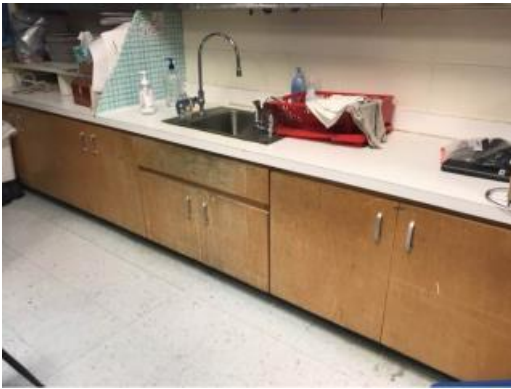
Worn classroom cabinetry

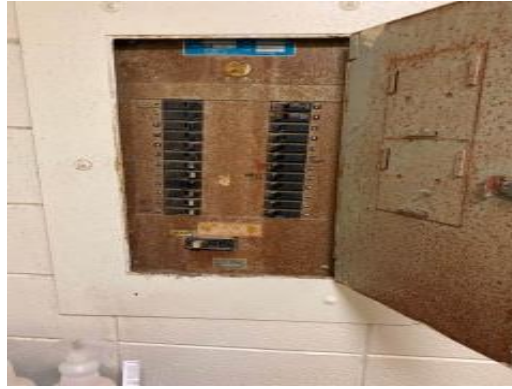
Aged panel

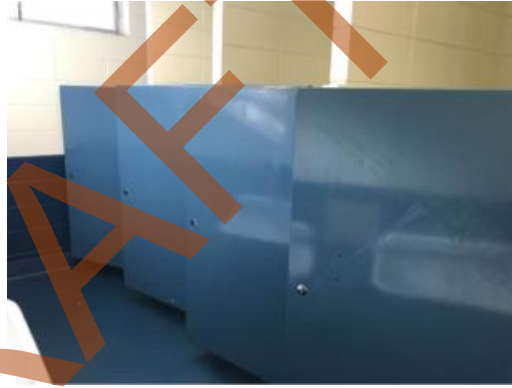
Restroom partitions

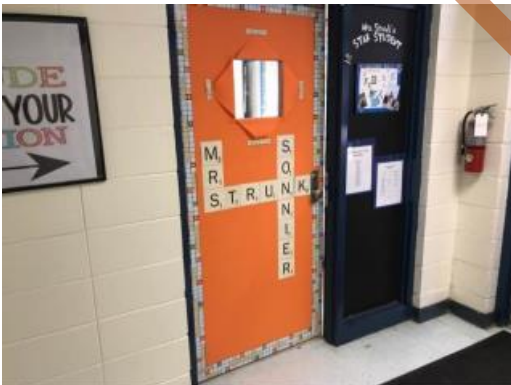
Classroom door hardware not ADA compliant

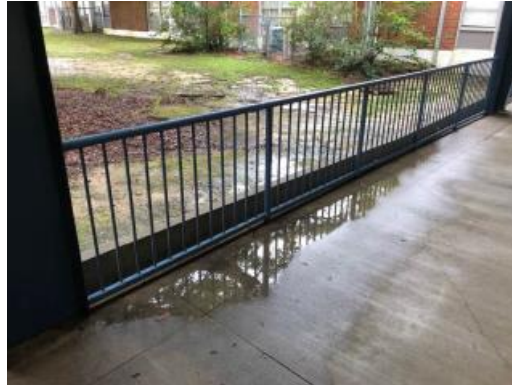
Water ponding north of breezeway
