FACILITY CONDITION ASSESSMENT

St. Martin North Elementary | November 2020

Jackson CS - St. Martin North Elementary

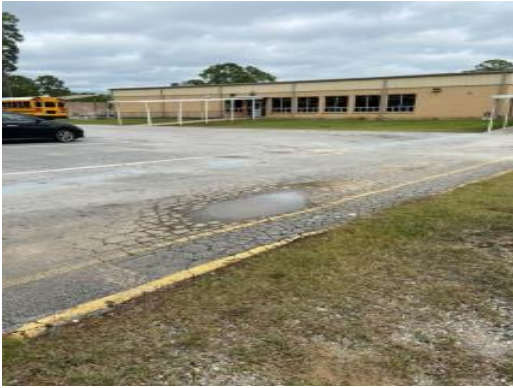
Deficiency	Category	Qty	UoM	Priority	Repair Cost	ID
Asphalt Driveway Replacement Note: Areas throughout the site are failing and should be replaced.	Capital Renewal	21,000	SF	3	\$120,497	772
Concrete Walks Replacement Note: Various areas where concrete sidewalks are cracked and failing. Areas being undermined and could cause sidewalk failure.	Capital Renewal	2,100	SF	3	\$21,226	774
Fencing Replacement (4' Chain Link Fence) Note: 4' chain link has top rail damage throughout playground areas, damaged sections to be removed and replaced.	Capital Renewal	200	LF	4	\$8,423	770
Fencing Replacement (8' - 10' high Chain Link Fence) Note: Fence post and top rail bent need to be replaced. Location: Located along the east fence line south playground	Capital Renewal	30	LF	4	\$2,097	771
Site Drainage Regrading Note: Areas between building wings to be regraded to facilitate drainage away from the buildings.	Deferred Maintenance	8,000	SF	4	\$10,265	773

Failing asphalt in west parking area

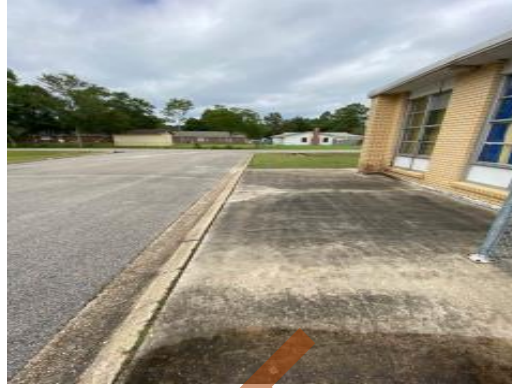
Sidewalk failure to the west of the northeast wing

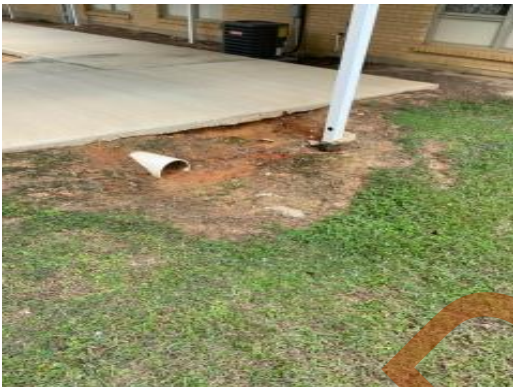
Sidewalk to west parking lot being undermined

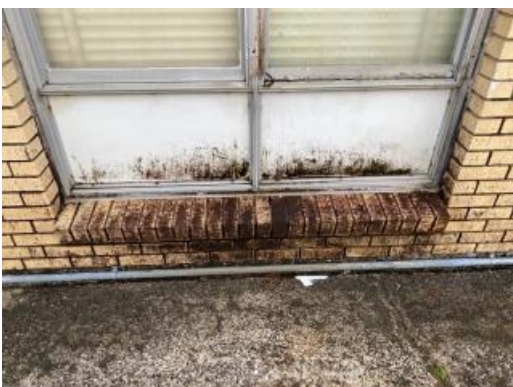
Dirty window sills

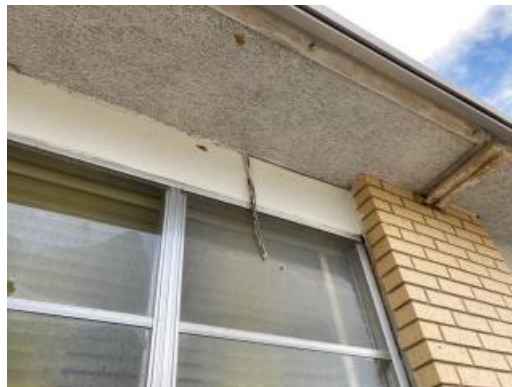
Failing caulk joints

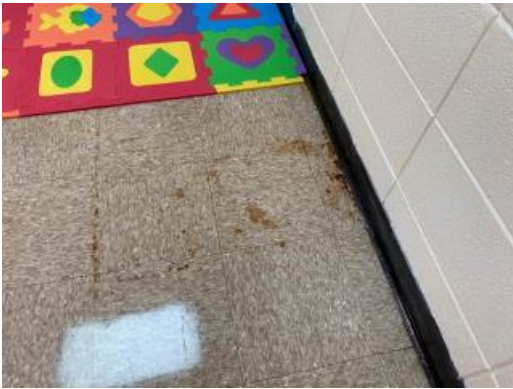
Stained and peeling VCT

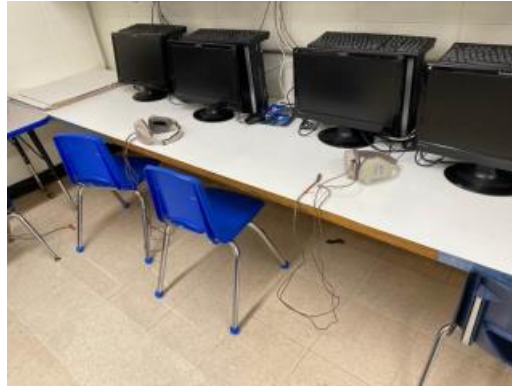
Peeling veneer at classroom casework

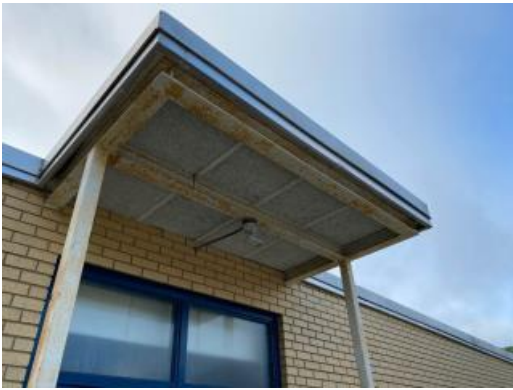
Deficiency	Category	Qty	UoM	Priority	Repair Cost	ID
Gutter Joint Repair Location: west side of building	Deferred Maintenance	1	Ea.	2	\$220	92
Awning Or Canopy Metal Roofing System Replacement Note: Steel canopy structure is rusted including columns.	Capital Renewal	40	SF	3	\$1,447	91
Sub Total for System		2	items		\$1,667

Rusted canopy and structure

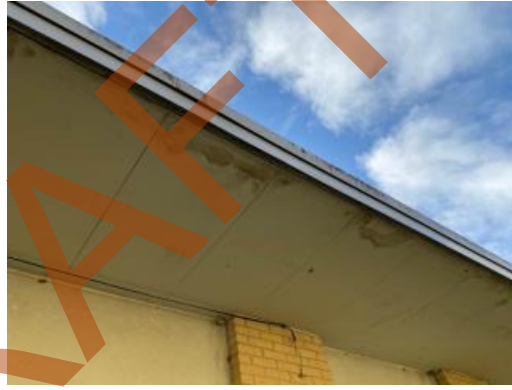
Water damaged soffit paneling

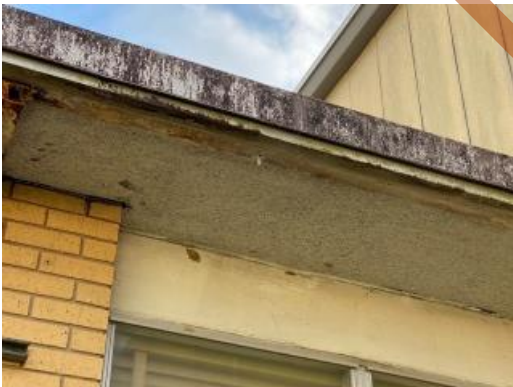
Dirty coping and rusted metal soffit trim
