TOWN OF SUFFIELD

CONDITIONS ASSESSMENT & MASTER PLAN

Draft as submitted August 1, 2022 for review

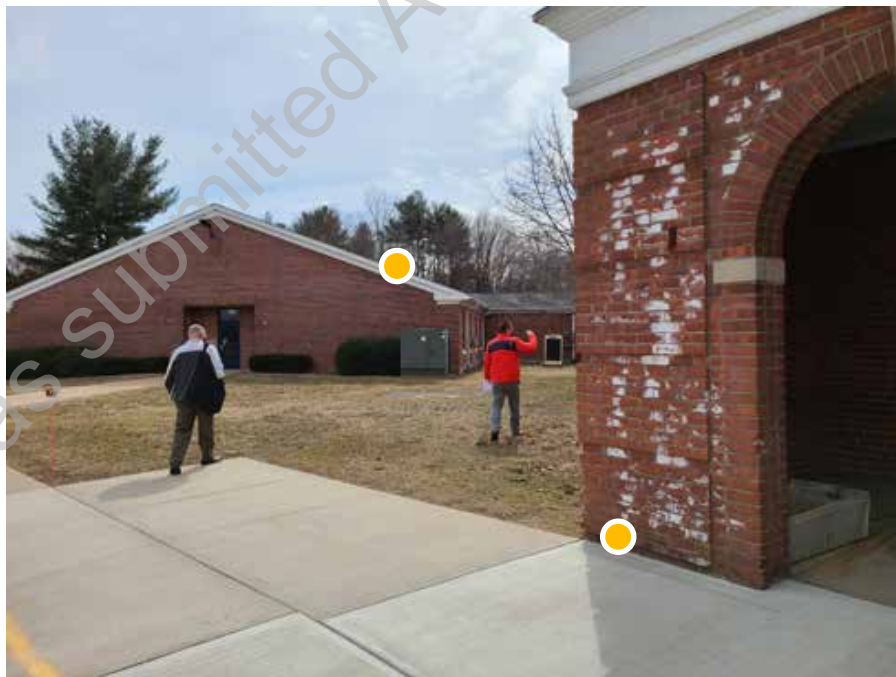
D1. 2: Detail view of the masonry efflorescence (right), view to entry into STEM, art, music, media and specialized education area (left)

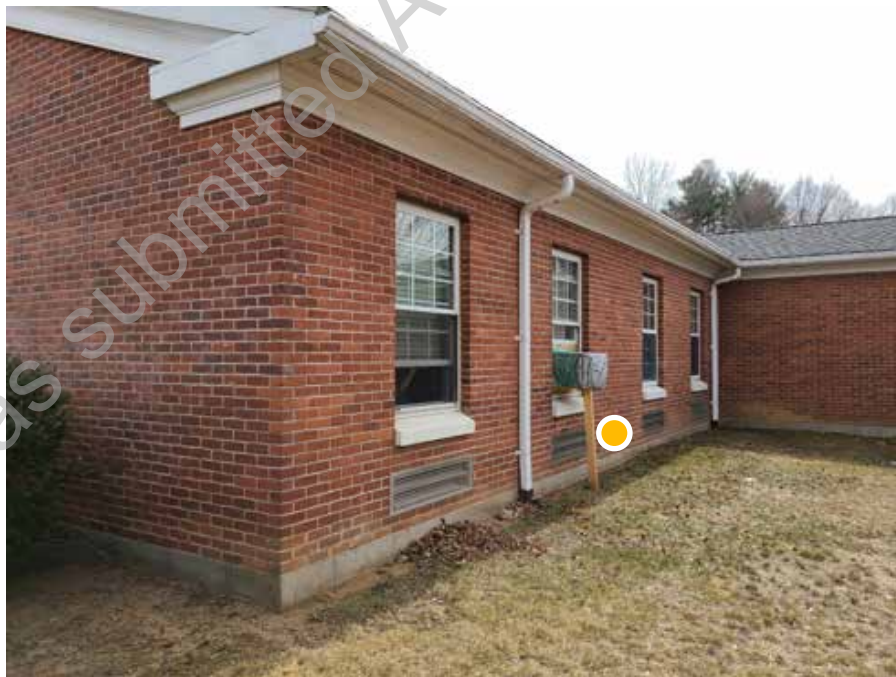
● D1. 6: View of 1988 classroom wing addition, note window air conditioning unit with support post.

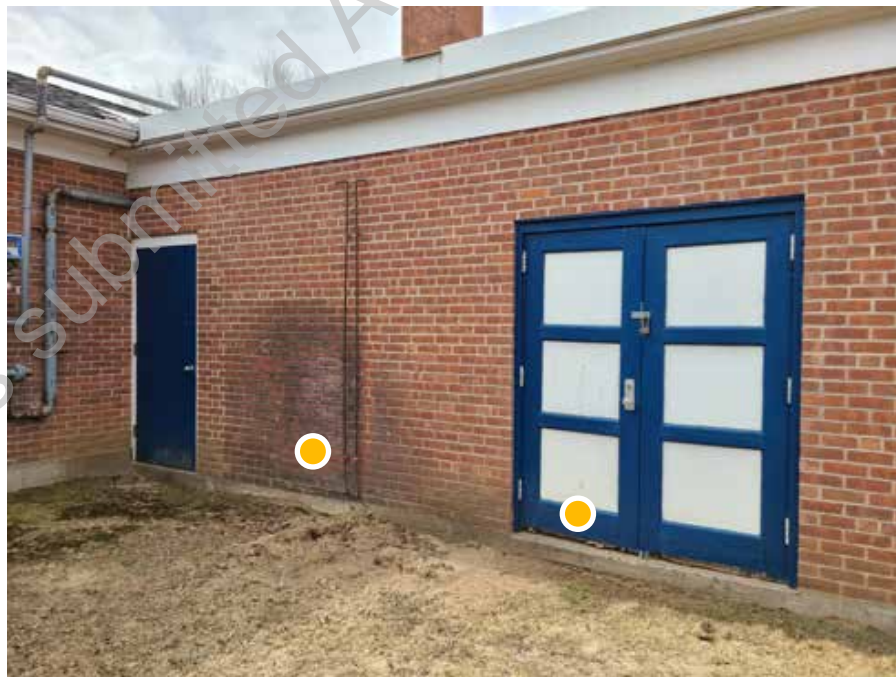
● D1. 8: Detail view of access doors into lower level mechanical room space. Note deterioration at based of wall and doors.

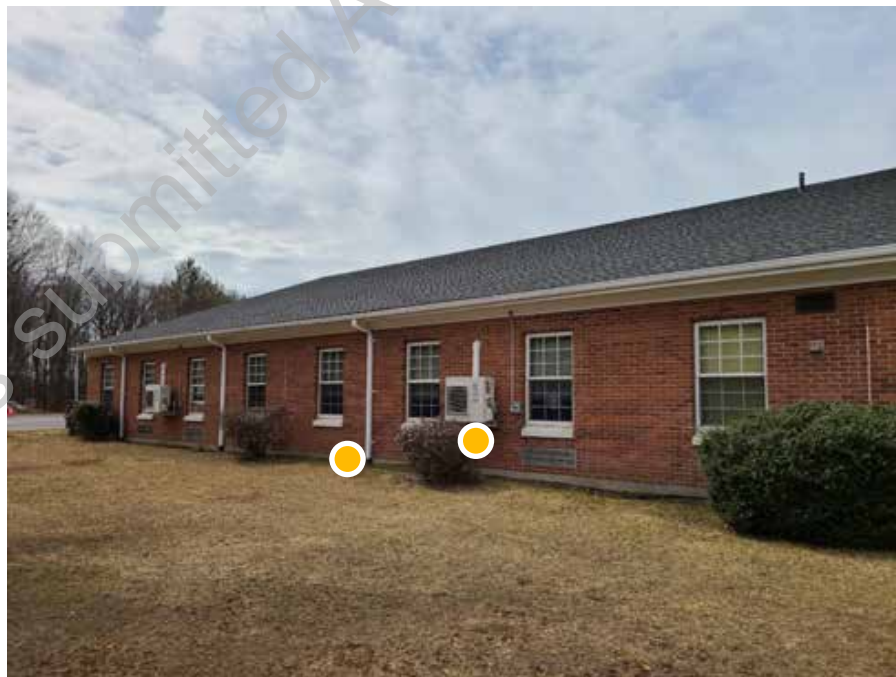
● D1. 12: Overall view of 1988 addition, note rain leaders connected to storm water collection system and retrofit wall mounted air conditioning units.

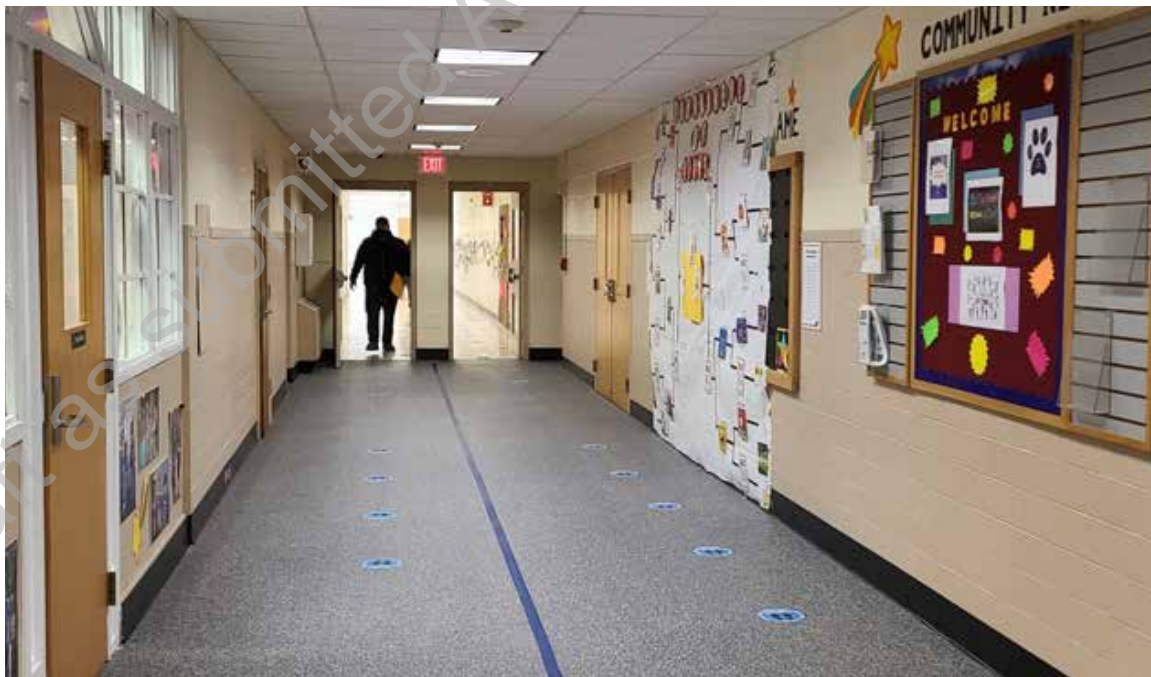
- D1. 28: View of typical main corridor with flooring overlay.

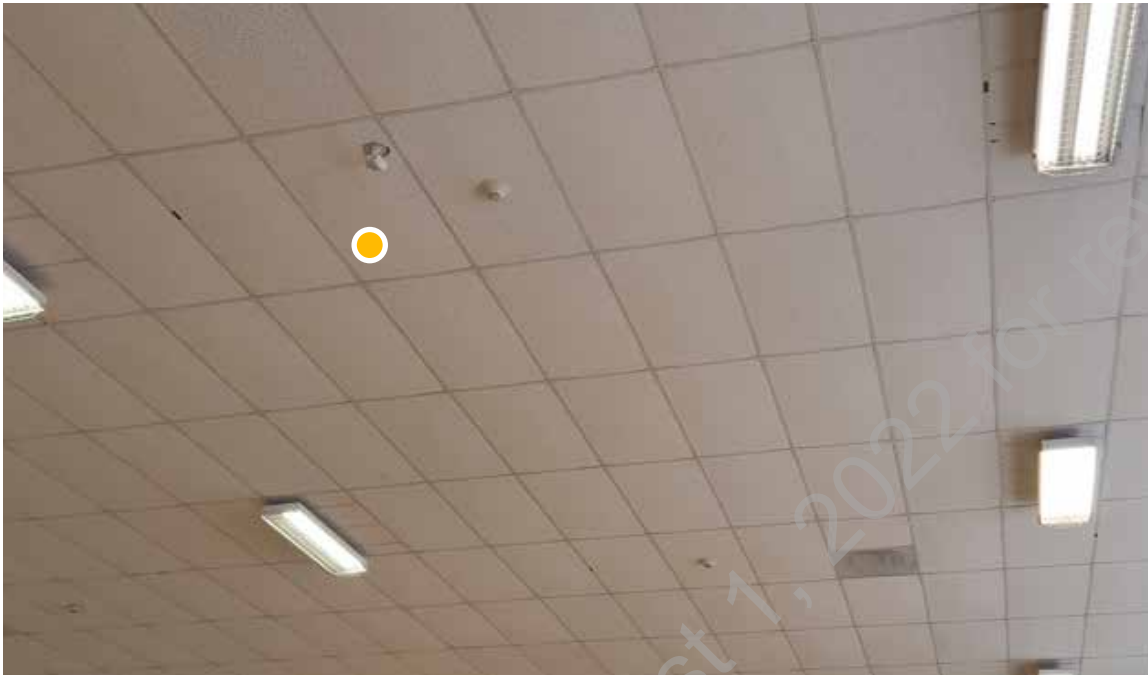
● D1. 49: View of lay in tile ceiling in the gymnasium. Several missing or damaged tile, note the cupping of the tile edges due to possible humidity control.

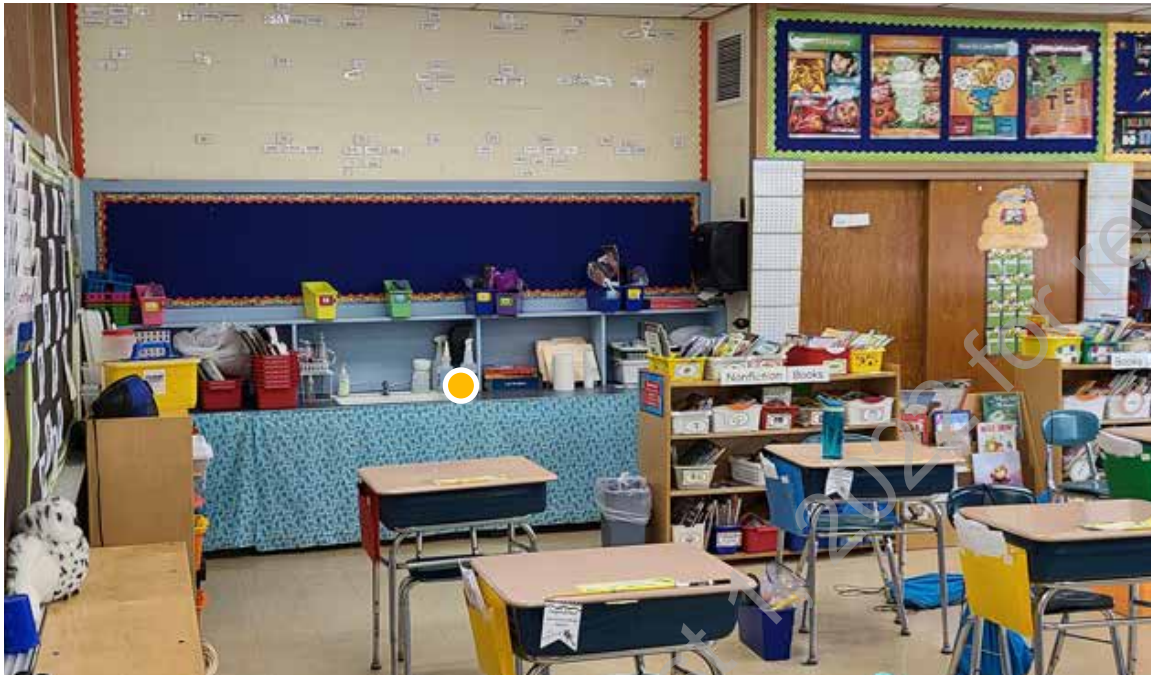
● D1. 53: View of typical classroom with original millwork and cabinets beyond, note non-compliant sink.

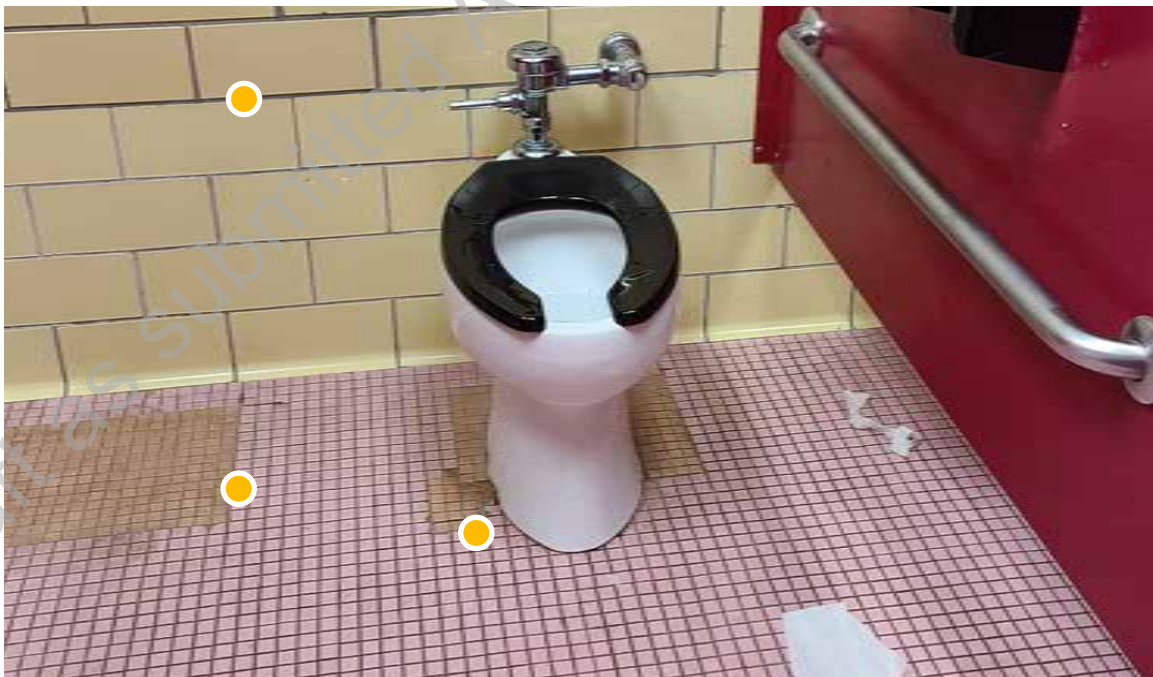
● D1. 56: Typical original bathroom with modified toilet location for ADA accessibility. Missing rear grab bar. Note the patched tile work on both wall and floor.

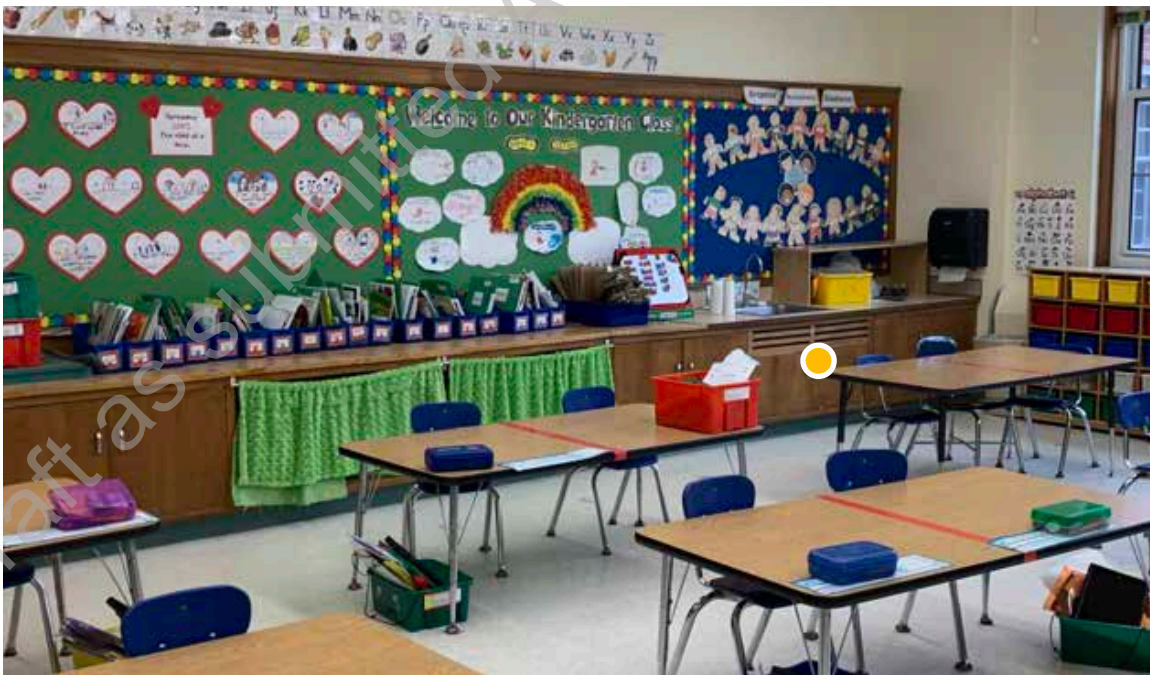
● D1. 58: View of typical classroom with flooring replacement. Note original millwork/cabinetry with inaccessible sink.

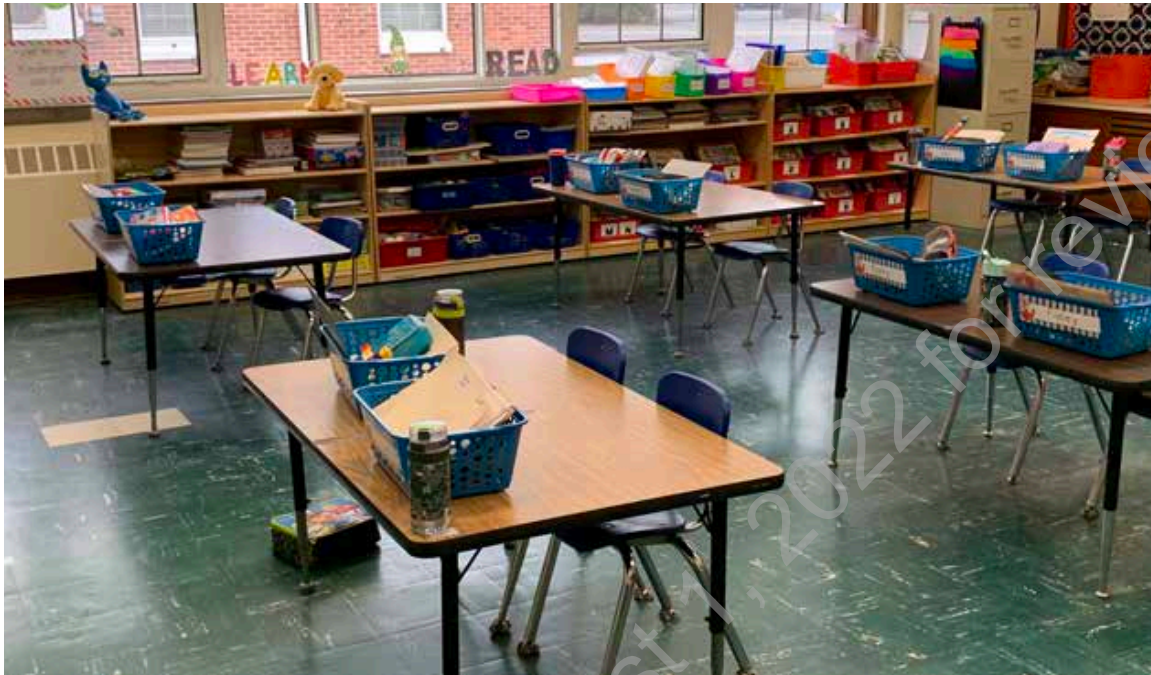
● D1. 59: View of typical classroom with linear shelving in front of perimeter radiation along exterior wall. Note patched VAT (Vinyl asbestos tile) flooring.

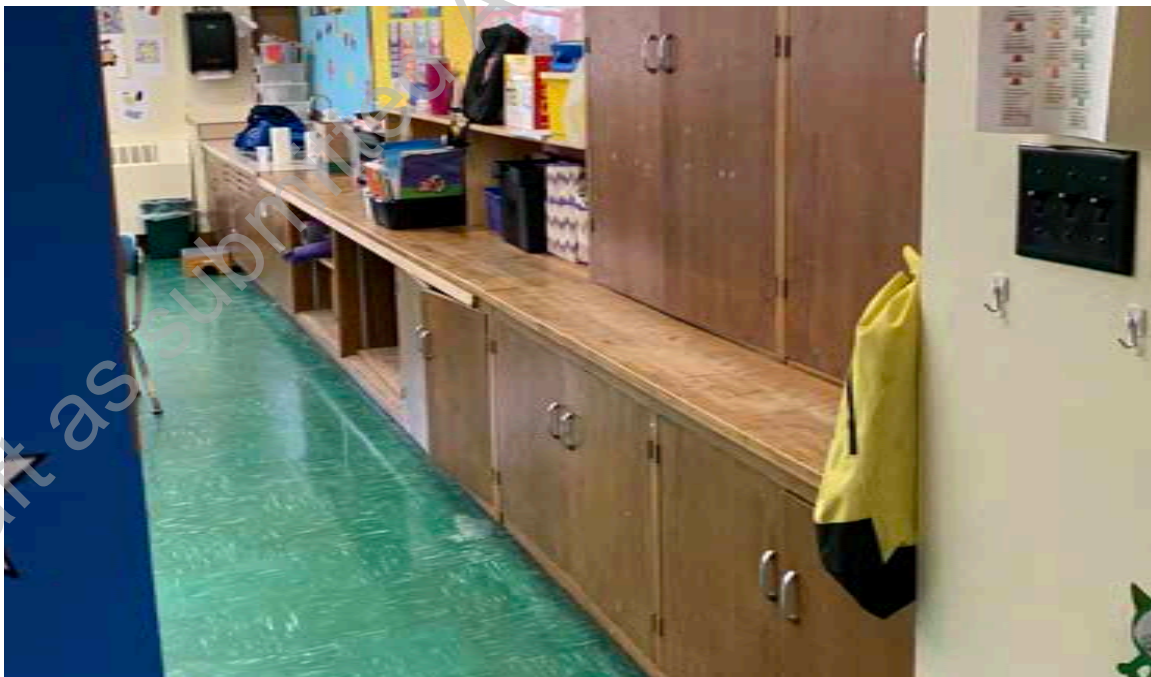
● D1. 60: View of typical classroom with original VAT (Vinyl asbestos tile) and millwork. Note: age and condition of cabinetry.

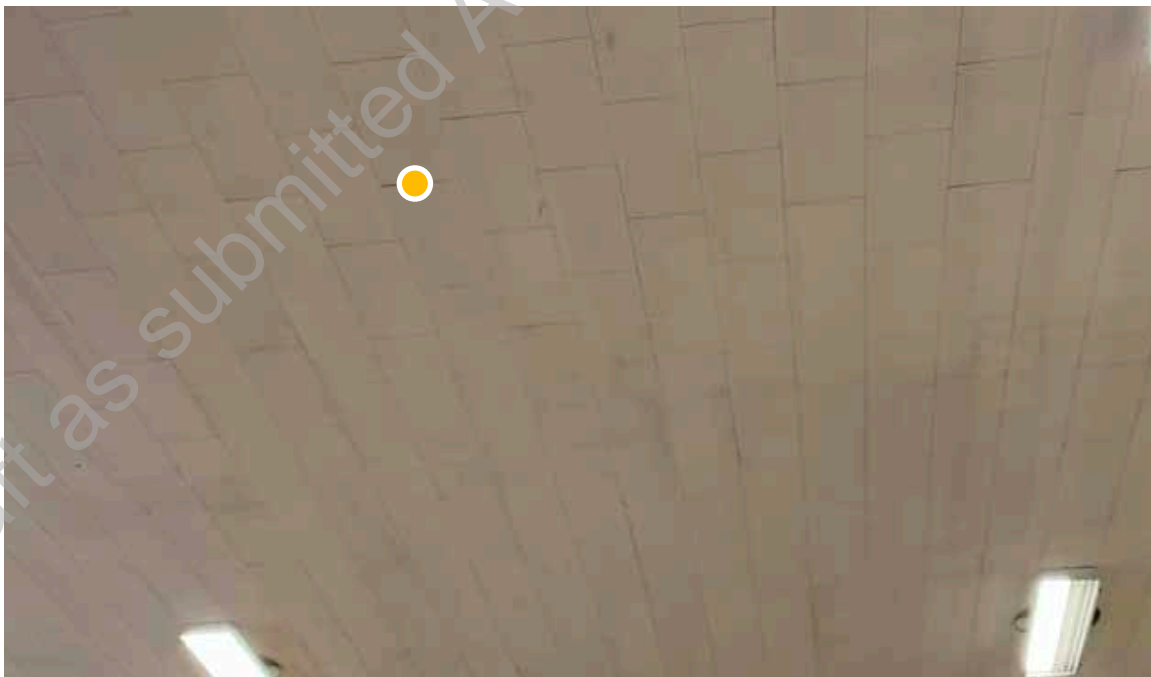
● D1. 64: View of possible ACM (with adhesive hazardous material) ceiling system with surface mounted lighting

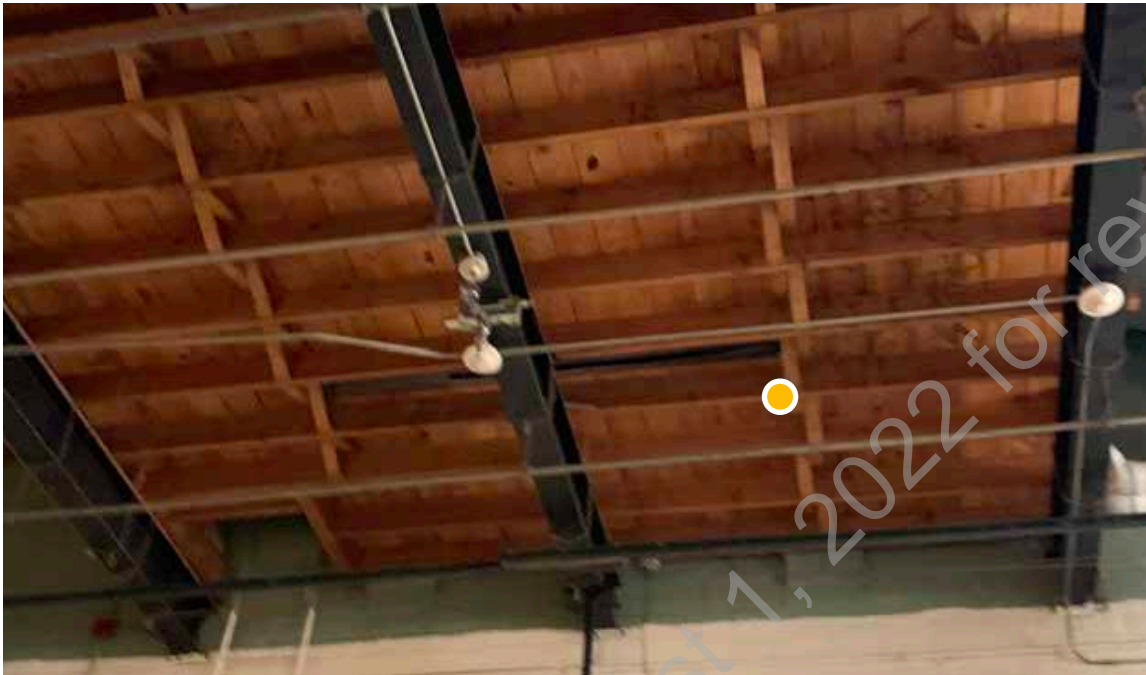
● D1. 65: View of combustible catwalk construction above existing stage.

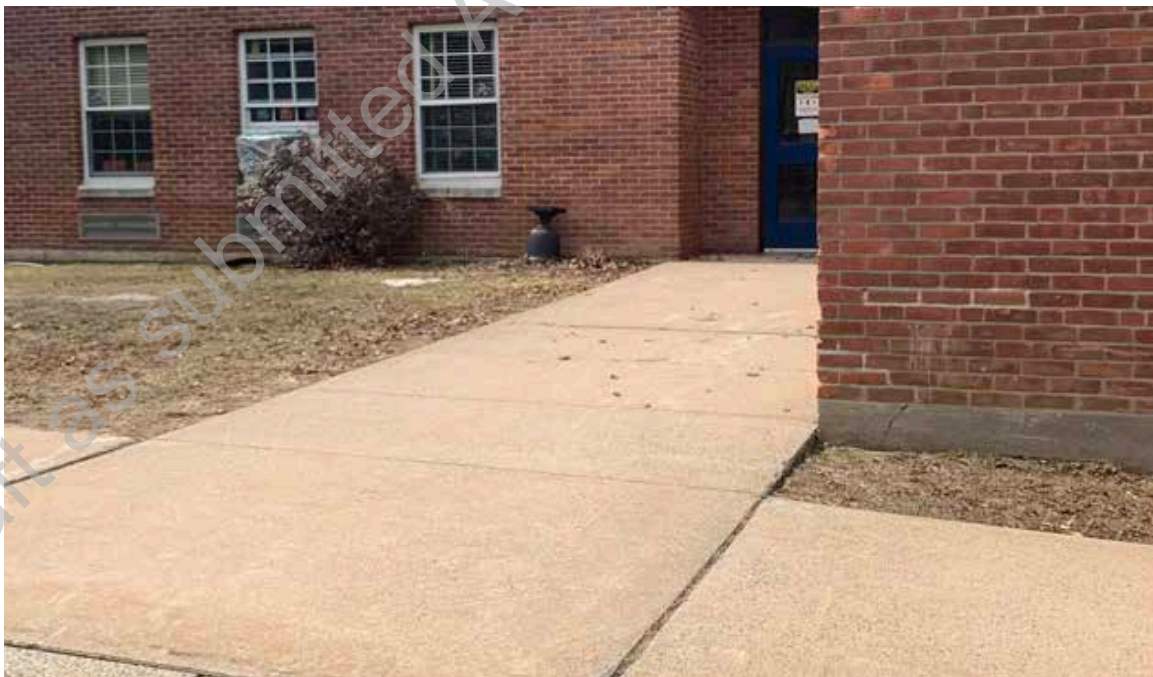
● D3. 10: View of concrete sidewalk to classroom building. Detail view (right) of concrete foundation wall settlement and/or deterioration.

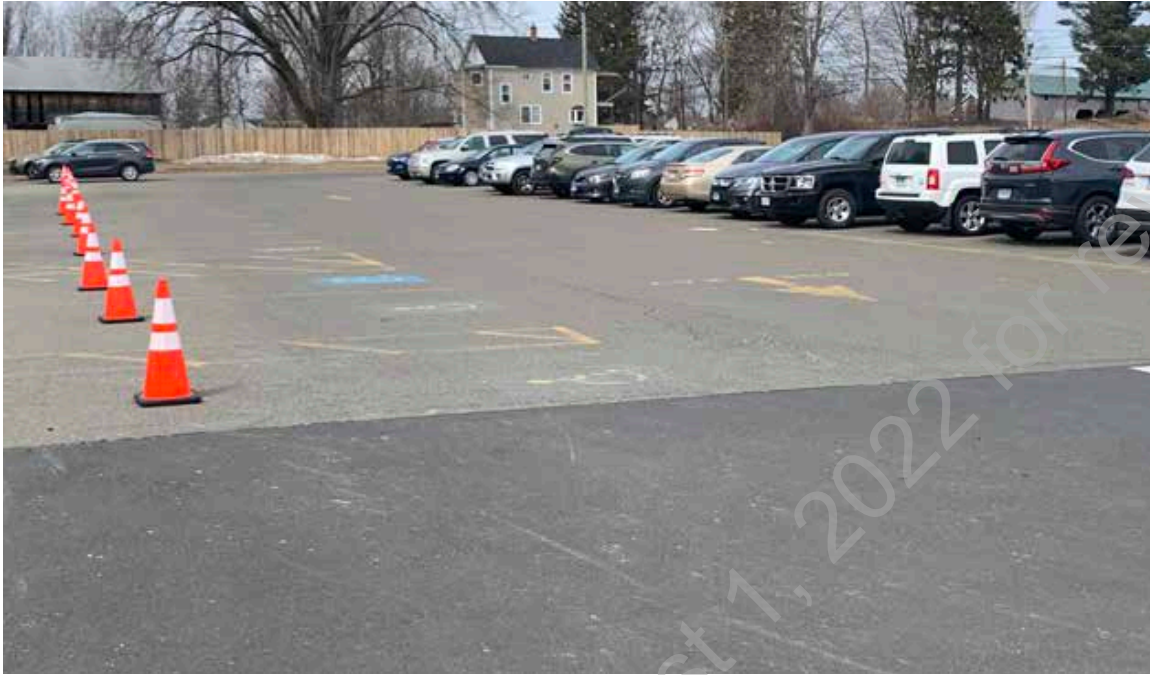
- D3. 15: View of patched and repaired parking lot with limited striping. Accessible parking signage does not currently meet code.

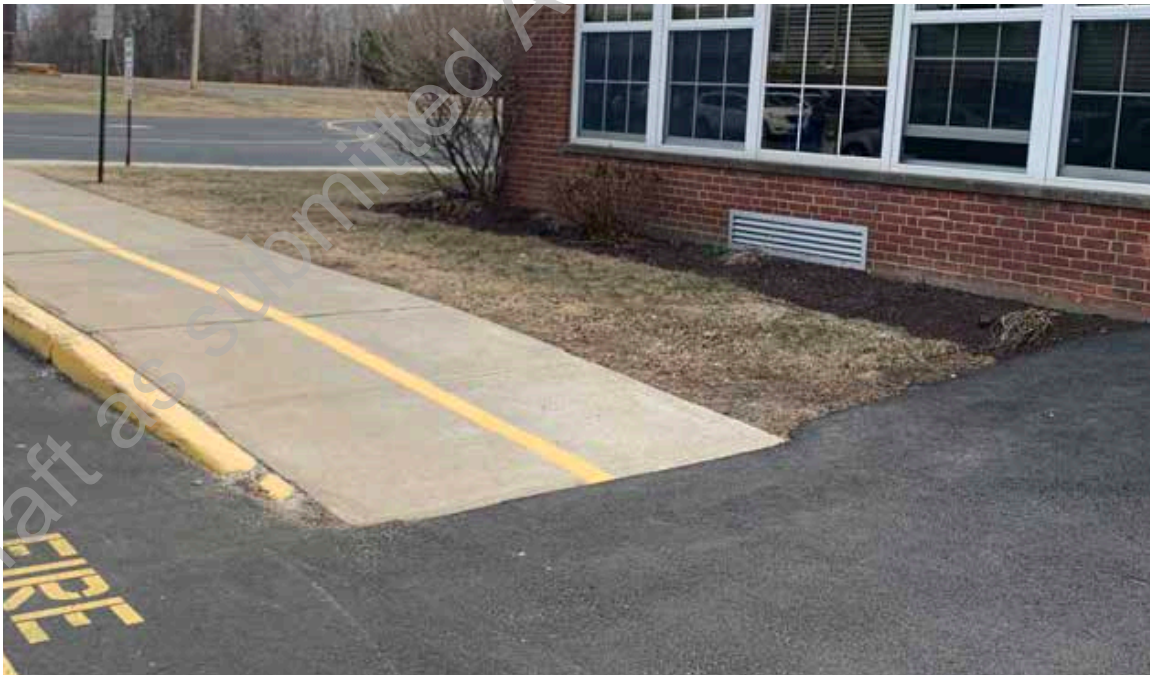
- D3. 16: View of deteriorated cast in place concrete curb, no ADA tactile warning strip at transition in grade/materials.

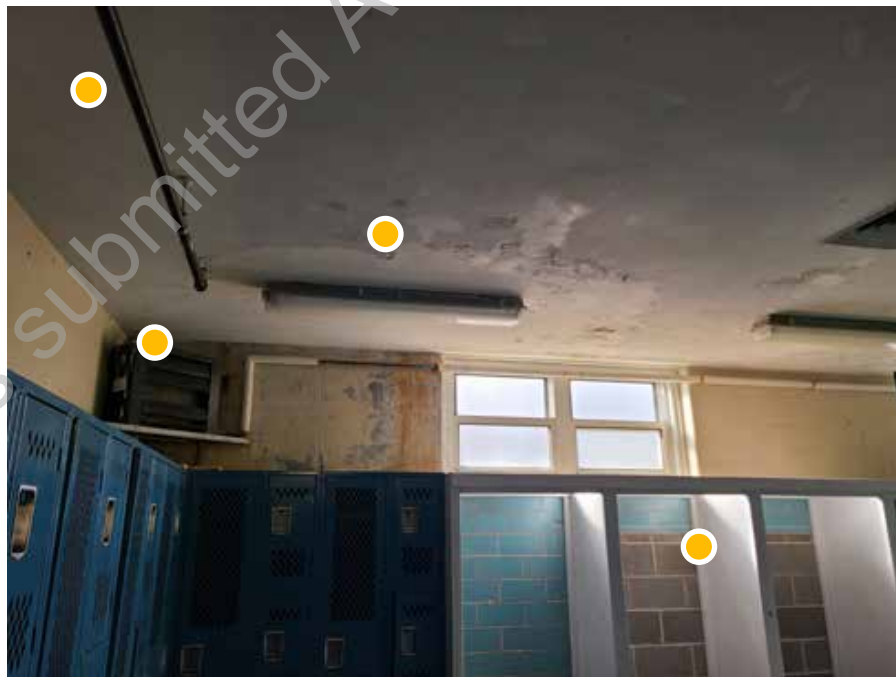
● D1. 40: Detail view of changing area retrofit in boys locker room, note poor condition of walls, ceilings, and exposed equipment and piping (original to the building).

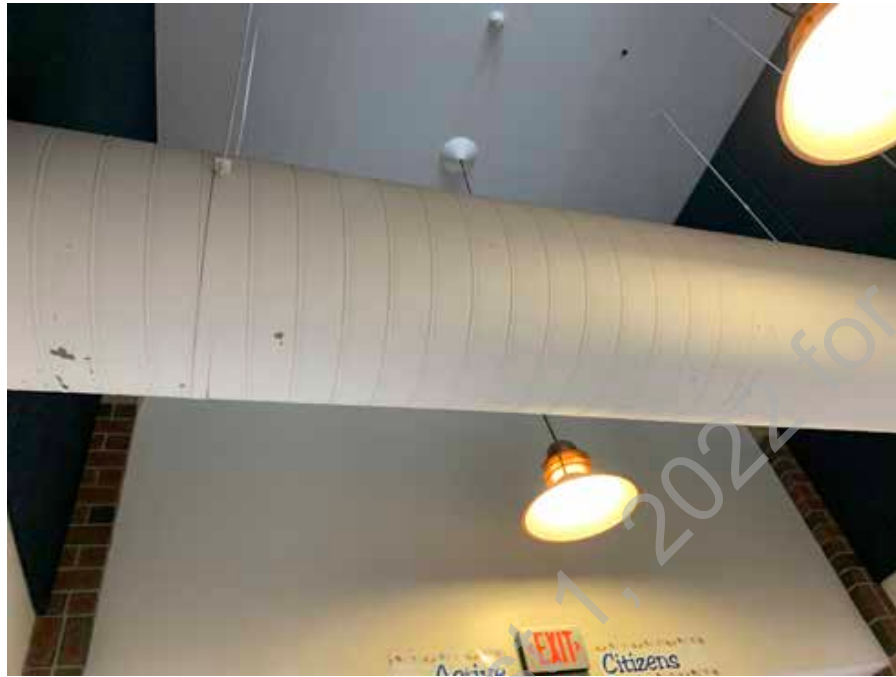
● D1. 47: Detail view of exposed spiral ductwork, note deterioration of paint finish

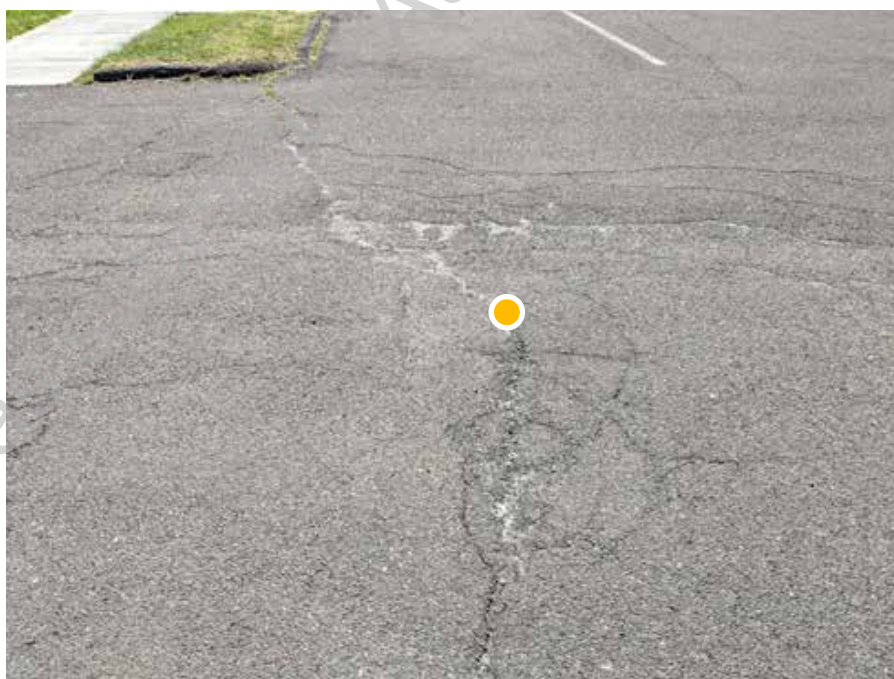
● D3. 2: Cracking pavement throughout parking areas and drive aisles

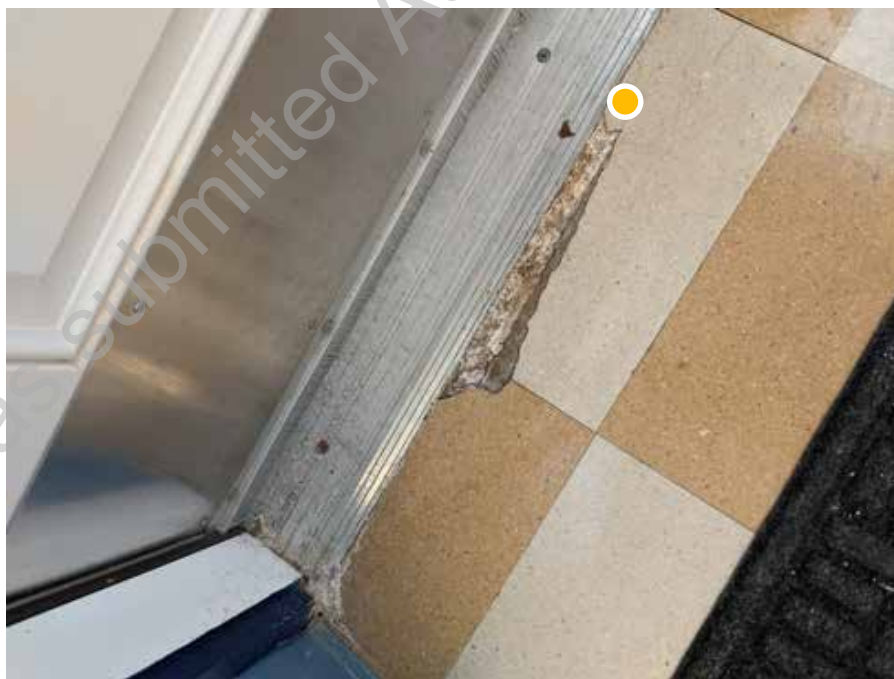
● D1. 42: Damaged vinyl tile flooring at Youth Services entry

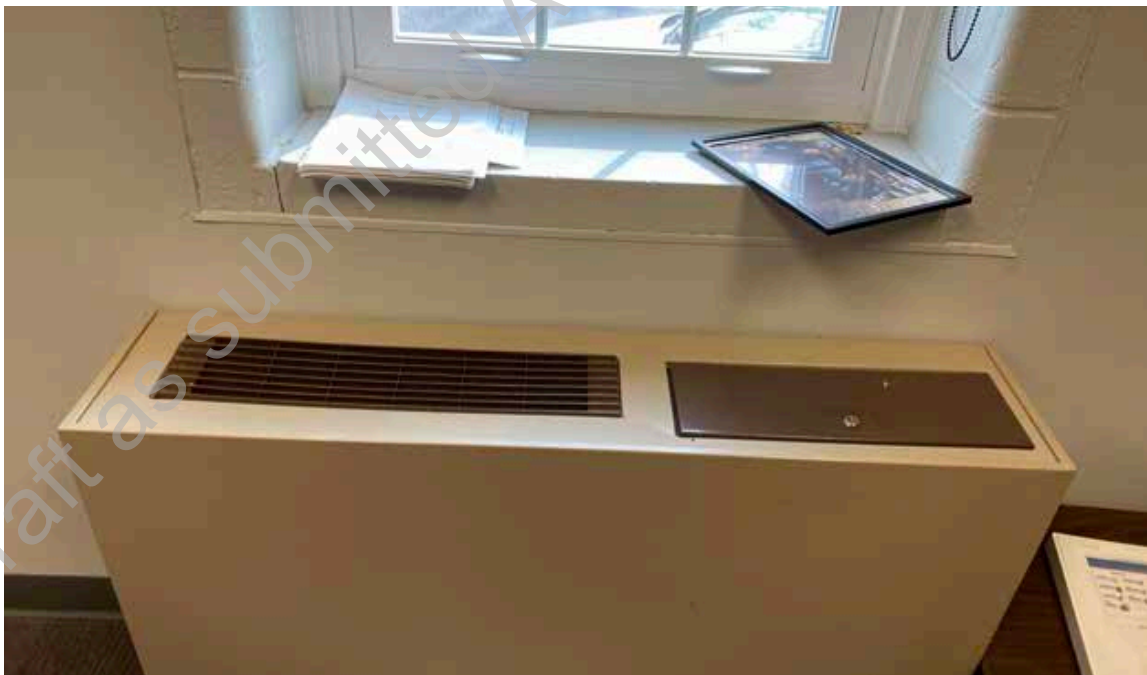
● D2. 24: PTAC Unit Needs Replacement
