FACILITY CONDITION ASSESSMENT

Alexandria City Public Schools
2000 North Beauregard Street
Alexandria, Virginia 22311
John Finnigan

1703 North Beauregard Street
Alexandria, Virginia 22311

November 22, 2021

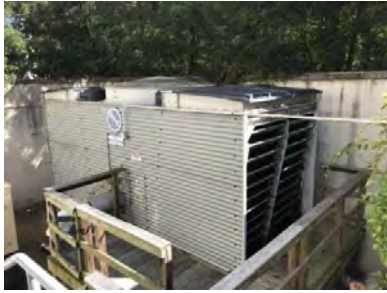
**Chiller in Poor condition.**

Air-Cooled
1703 North Beauregard Street Site

The chiller looks and sound old and should be considered for replacement soon - AssetCALC ID: 3443879

Uniformat Code: D3031
Recommendation: **Replace in 2022**

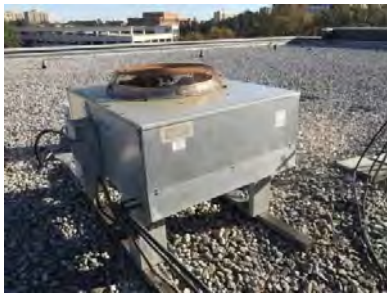
**Split System in Poor condition.**

Condensing Unit/Heat Pump
1703 North Beauregard Street Roof

Uniformat Code: D3037
Recommendation: **Replace in 2022**
