# **FACILITY CONDITION ASSESSMENT**

## Alexandria City Public Schools 2000 North Beauregard Street Alexandria, Virginia 22311 John Finnigan

Charles Barrett Elementary 1115 Martha Custis Drive Alexandria, Virginia 22302

DATE OF REPORT: December 14, 2021

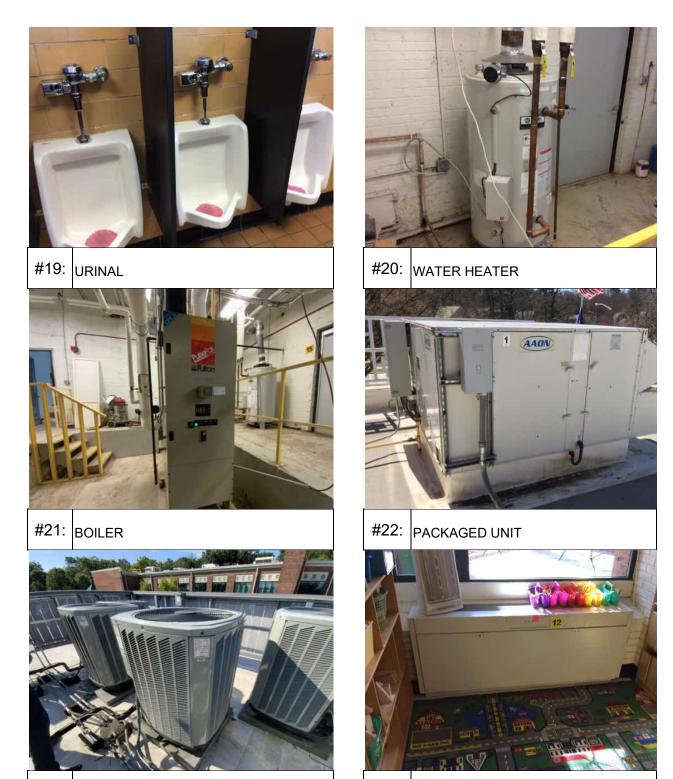
#23: SPLIT SYSTEMS

#24: UNIT VENTILATOR
