FACILITY CONDITION ASSESSMENT

Dee Campbell Rowing Center
1 Madison Street
Alexandria, Virginia 22302

148303.21R000-017.354

December 21, 2021

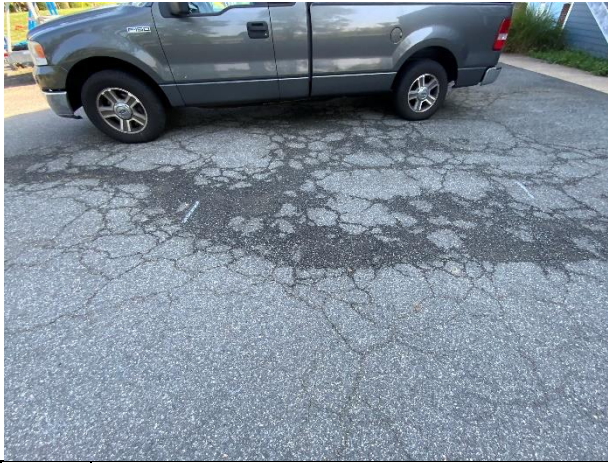
#19:	ASPHALT DRIVEWAY
------	------------------

Site Development	Property entrance signage; chain-link fence.	Fair
Landscaping and Topography	Limited landscaping features Irrigation not present	Fair
Utilities	Municipal water and sewer Local utility-provided electric	Good
Site Lighting	Building-mounted: LED	Fair
Ancillary Structures	None	--
Key Issues and Findings	Recommended driveway cut and patch with seal and stripe.

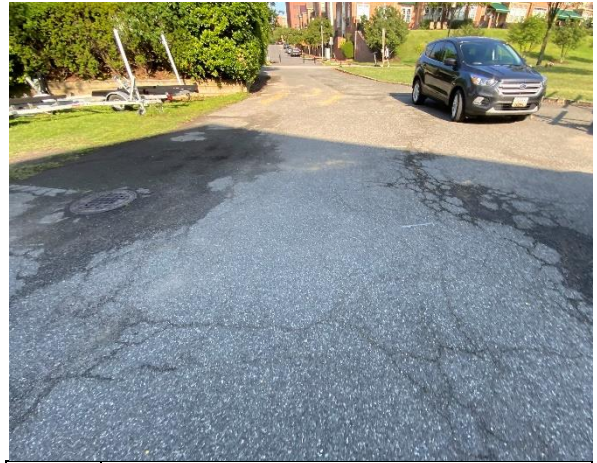
#20:	ASPHALT DRIVEWAY
------	------------------
