FACILITY CONDITION ASSESSMENT

George Mason Elementary
2601 Cameron Mills Road
Alexandria, Virginia 22302

148303.21R000-007.354

December 15, 2021

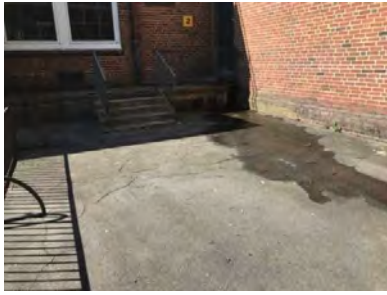
Exterior Walls in Poor condition.

Brick or Brick Veneer, 1-2 Story Building
George Mason Elementary School Campus
Exterior wall

Sections of the exterior walls were observed to be in poor condition. Many areas have experienced damage and there are holes within the facade which allow water infiltration. The property has experienced problems with rodent infestation through the facade. The brick veneer will require repair during the reserve term. - AssetCALC ID: 3046374

Recommendation: **Repair/Repoint in 2021**

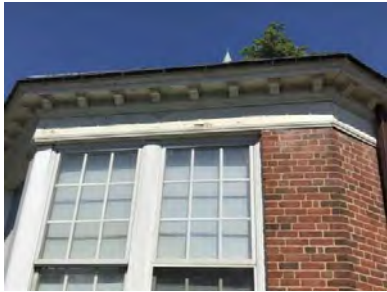
Exterior Walls in Poor condition.

Any painted surface, 1-2 Story Building
George Mason Elementary School Campus
Building exterior

The painted finish on the wood trim was observed to be in poor condition. The fascia and soffits have experienced a significant amount of damage. the damaged wooden trim is believed to contribute to the water infiltration within the building. The wood trim will require replacement during the reserve term. - AssetCALC ID: 3046348

Recommendation: **Prep & Paint in 2023**

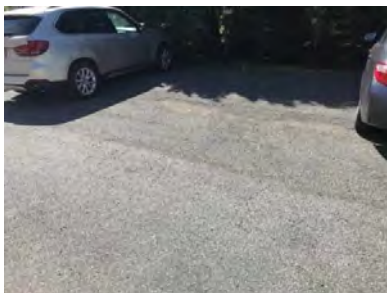
Parking Lots in Failed condition.

Pavement, Asphalt
George Mason Elementary School Campus
Parking lot

Recommendation: **Seal & Stripe in 2021**

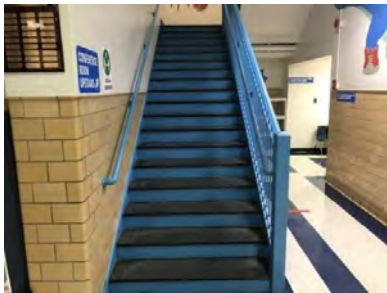
Stair Treads in Failed condition.

Raised Rubber Tile
George Mason Elementary School Campus
Front stairs

The front two sets of stairs have a polished surface which is likely slippery when wet. Rubber treads or tape should be installed to ensure safe footing. - AssetCALC ID: 3046432

Uniformat Code: B1081
Recommendation: **Replace in 2021**

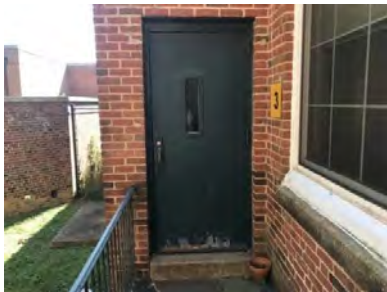
Exterior Door in Poor condition.

Wood, Solid-Core Decorative High-End w/
Glazing
George Mason Elementary School Campus
Building exterior

Doors are badly deteriorated. - AssetCALC ID: 3147159

Uniformat Code: B2051
Recommendation: **Replace in 2023**

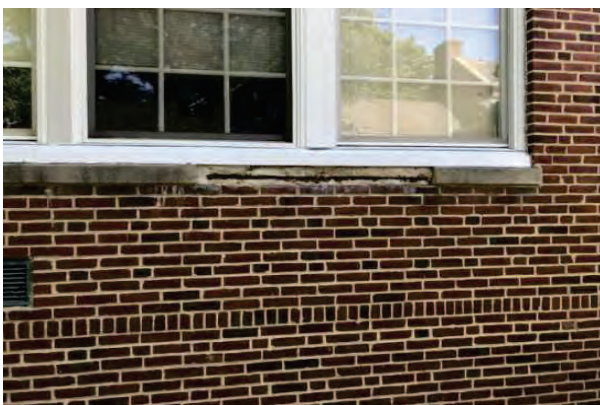
BROKEN CONCRETE WINDOW LINTEL

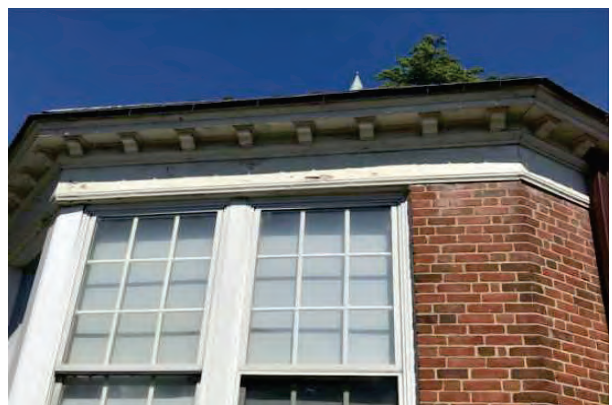
DETERIORATED WOOD TRIM
