FACILITY CONDITION ASSESSMENT

James K. Polk Elementary
5000 Polk Avenue
Alexandria, Virginia 22302

148303.21R000-009.354

December 17, 2021

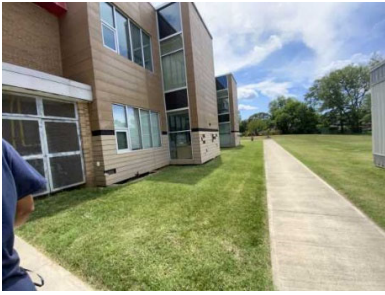
Exterior Walls in Failed condition.

Fiber Cement Siding, 1-2 Story Building
James K. Polk Elementary School Campus
Building exterior

Siding on rear and left elevation of the building is failing (broken) and exposing foundation to the elements. - AssetCALC ID: 3148332

Uniformat Code: B2011
Recommendation: **Replace in 2021**

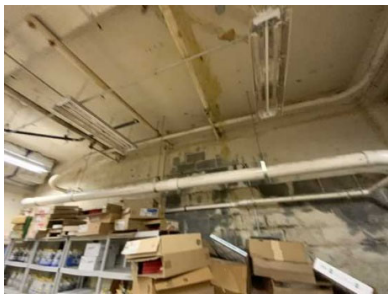
Fire Suppression System

Full System Install/Retrofit, Medium Density/Complexity
James K. Polk Elementary School Campus
Throughout building

Building does not have sprinkler system and installation is recommended. - AssetCALC ID: 3148325

Uniformat Code: D4011
Recommendation: **Install in 2025**
