# FACILITY CONDITION ASSESSMENT

Lyles-Crouch Traditional Academy  
530 South Saint Asaph Street  
Alexandria, Virginia 22302

December 14, 2021

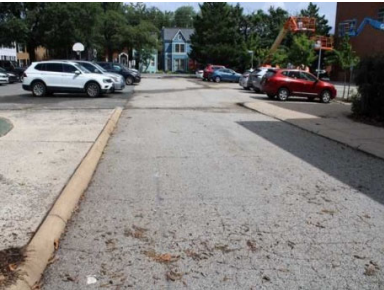
### Parking Lots in Poor condition.

Pavement, Asphalt  
Lyles-Crouch Traditional Academy (2021)  
Lyles-Crouch Traditional Academy School  
Campus Parking area

Parking lot has drainage issues as well as evident ponding and erosion. Regrading, milling and overlay is recommended. - AssetCALC ID: 3316216

Uniformat Code: G2021  
Recommendation: **Mill and Overlay in 2022**

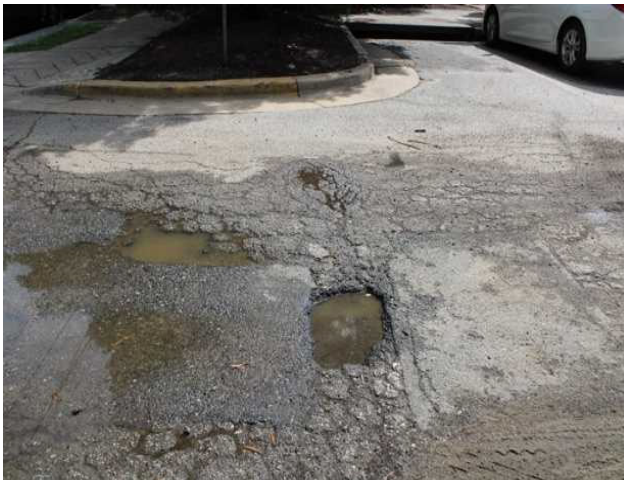
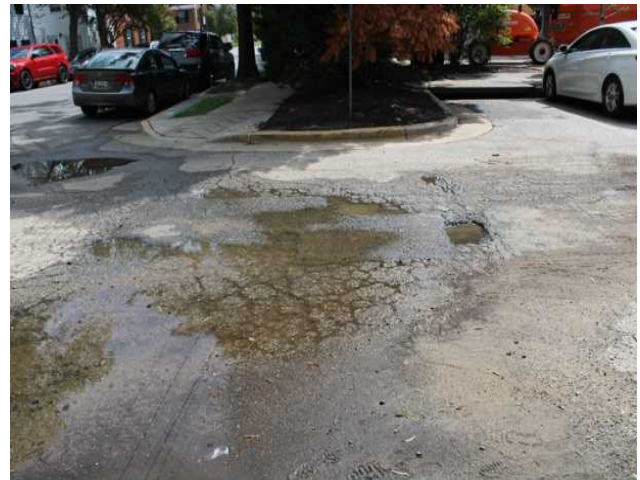
The parking lots and sidewalks have been periodically repaved and sectionally replaced as-needed over the years. The parking lot has drainage issues as well as evident ponding and erosion. Regrading, milling and overlay is recommended. Parking lot modifications are designed and submitted for permitting.

45 - PARKING LOTS

46 - PARKING LOTS
