FACILITY CONDITION ASSESSMENT

Mount Vernon Community School
2601 Commonwealth Avenue
Alexandria, Virginia 22302

148303.21R000-011.354

December 20, 2021

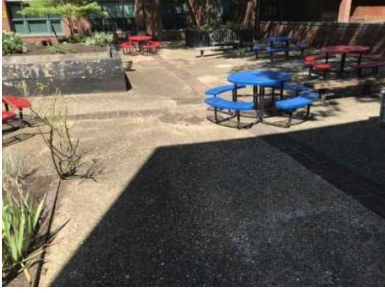
Sidewalk in Failed condition.

any pavement type, Sectional Repairs (per Man-Day)
Mount Vernon Community School Campus Courtyard

Grind trip hazard in courtyard. - AssetCALC ID: 3145910

Uniformat Code: G2031
Recommendation: **Repair in 2021**

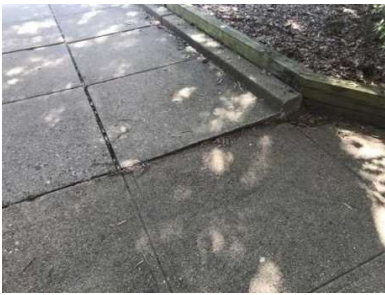
Sidewalk in Failed condition.

any pavement type, Sectional Repairs (per Man-Day)
Mount Vernon Community School Campus Site

Grind trip hazards. - AssetCALC ID: 3145861

Uniformat Code: G2031
Recommendation: **Repair in 2021**

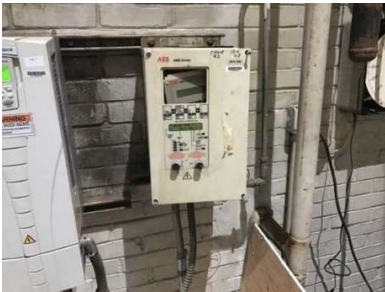
Variable Frequency Drive in Failed condition.

VFD, by HP of Motor
Mount Vernon Community School Campus Mechanical room

Serves Chilled water pump #3. Drive is in a state of disrepair. - AssetCALC ID: 3145926

Uniformat Code: D5039
Recommendation: **Replace/Install in 2021**

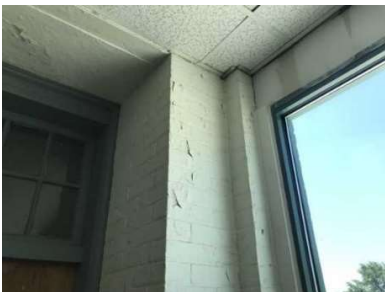
Wall Finishes in Failed condition.

any surface
Mount Vernon Community School Campus Throughout building

Damaged wall finishes exist on the north side of the building* due to prior roof leaks. - AssetCALC ID: 3145920

Uniformat Code: C2017
Recommendation: **Prep & Paint in 2021**

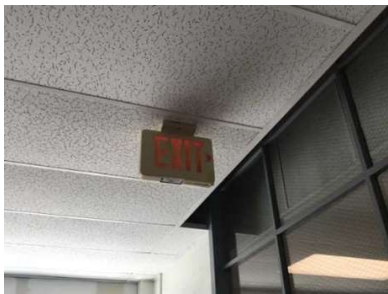
Emergency and Exit Lighting in Poor condition.

Exit Sign, LED
Mount Vernon Community School Campus
Throughout building

Unifomat Code: D5045
Recommendation: **Replace in 2023**

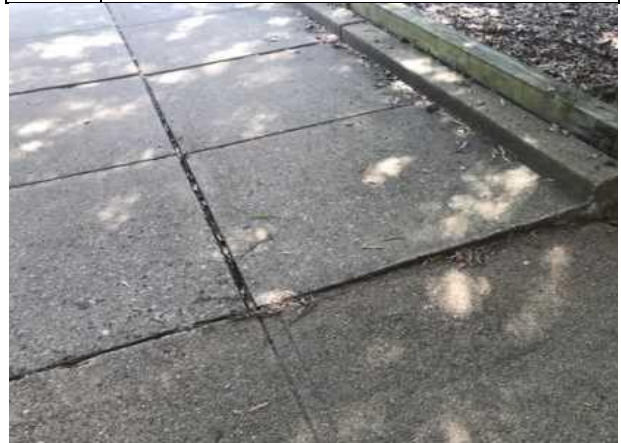
The site consists of a small parking area - which is shared with the library – and a large play area. The school is surrounded by a sidewalk on three sides. The sidewalk was observed to have trip hazards in isolated areas around the building.

#22: TRIP HAZARD ON SIDEWALK
