FACILITY CONDITION ASSESSMENT

Alexandria City Public Schools
2000 North Beauregard Street
Alexandria, Virginia 22311
John Finnigan

John Adams Elementary and Early Childhood
Center
5651 Rayburn Avenue
Alexandria, Virginia 22311

December 8, 2021

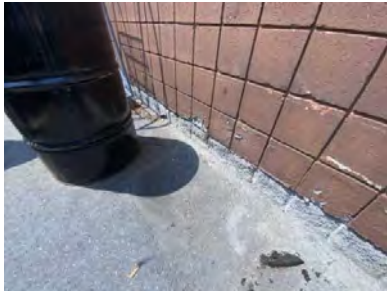
Exterior Walls in Failed condition.

Brick, 3+ Story Building
Transport Facility - System Wide Building exterior

The exterior brick wall on the elevation and back of the building was observed with damage, appeared to be caused by water/moisture intrusion. - AssetCALC ID: 3246881

Uniformat Code: B2011
Recommendation: **Repair in 2021**

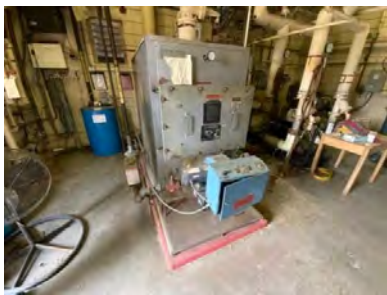
Boiler in Poor condition.

Gas, HVAC, 1260 MBH
Transport Facility - System Wide Boiler room

Boiler exhibit significant wear and tear as well as rust that may compromised internal components (electronics). - AssetCALC ID: 3229074

Uniformat Code: D3021
Recommendation: **Replace in 2022**

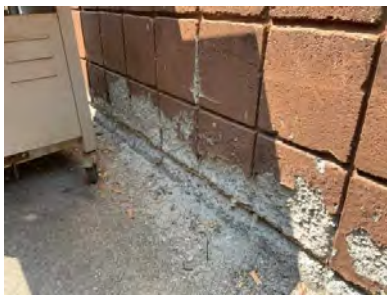
Recommended Follow-up Study: Civil, Site Drainage

Civil, Site Drainage
Transport Facility - System Wide Building exterior

Building personnel informed of water damage, water intrusion into the building coming from the front of the building and streaming on the left elevation due to the slope of the terrain. - AssetCALC ID: 3247061

Uniformat Code: P2032
Recommendation: **Evaluate/Report in 2021**
