# FACILITY CONDITION ASSESSMENT

Patrick Henry K-8  
4643 Taney Avenue  
Alexandria, Virginia 22302

148303.21R000-004.354

December 16, 2021

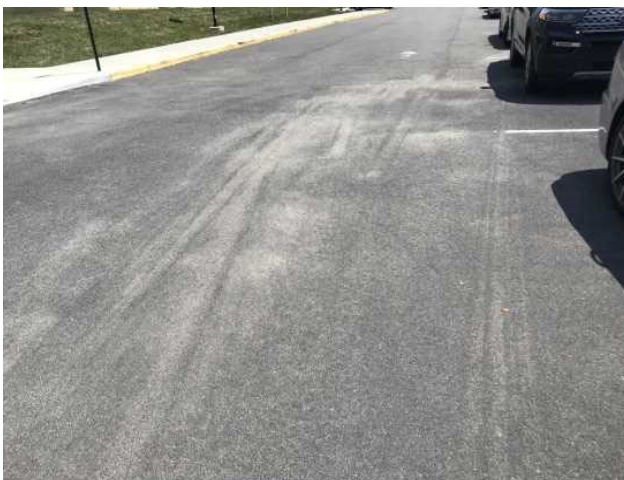
5 - PARKING LOTS, PAVEMENT, ASPHALT

G2020	Site	Fair	Parking Lots, Pavement, Asphalt, Seal & Stripe	45,000 SF	3	3196194
G2030	Site	Excellent	Sidewalk, Concrete, Large Areas	7,000 SF	48	3196184
Sitework						
G2060	Site	Excellent	Retaining Wall, Brick/Stone	5,000 SF	38	3196223
G2060	Building exterior	Good	Signage, Property, Monument, Replace/Install	1	18	3196212
G2060	Site	Excellent	Dumpster Enclosure, Masonry (CMU) Walls, 8' High (per LF), Replace/Install	125 LF	38	3196259
G2060	Site	Good	Flagpole, Metal	1	28	3196196
G4050	Site	Good	Pole Light Fixture w/ Lamps, any type 20' High, w/ LED Replacement, Replace/Install	10	18	3196199
G4050	Site	Good	Pole Light Fixture w/ Lamps, any type 20' High, w/ LED Replacement, Replace/Install	4	18	3196284

G2020	Site	3196194	Parking Lots, Pavement, Asphalt, Seal & Stripe		5	2	3	45000	SF	\$0.45	\$20,250				\$20,250					\$20,250					\$20,250					\$20,250			\$81,000
G2060	Building exterior	3196212	Signage, Property, Monument, Replace/Install		20	2	18	1	EA	\$3,000.00	\$3,000																		\$3,000			\$3,000	
G4050	Site	3196199	Pole Light Fixture w/ Lamps, any type 20' High, w/ LED Replacement, Replace/Install		20	2	18	10	EA	\$4,200.00	\$42,000																		\$42,000			\$42,000	
G4050	Site	3196284	Pole Light Fixture w/ Lamps, any type 20' High, w/ LED Replacement, Replace/Install		20	2	18	4	EA	\$4,000.00	\$16,000																		\$16,000			\$16,000	
Totals, Unescalated												\$0	\$0	\$0	\$20,250	\$0	\$0	\$0	\$400,000	\$423,570	\$160,000	\$0	\$0	\$0	\$2,022,094	\$0	\$0	\$0	\$400,000	\$4,541,668	\$160,000	\$0	\$8,127,582
Totals, Escalated (3.0% inflation, compounded annually)												\$0	\$0	\$0	\$22,128	\$0	\$0	\$0	\$491,950	\$536,566	\$208,764	\$0	\$0	\$0	\$2,969,513	\$0	\$0	\$0	\$661,139
