FACILITY CONDITION ASSESSMENT

Naomi L. Brooks Elementary
600 Russell Road Alexandria,
Virginia 22302

148303.21R000-008.354

December 21, 2021

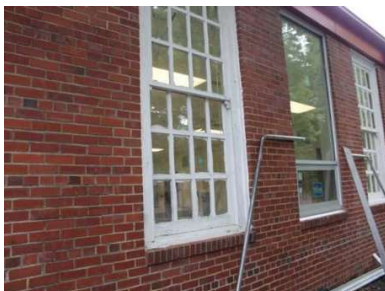
Window in Poor condition.

Wood, 16-25 SF
Naomi Brooks Elementary Matthew Maury
Elementary School Campus Exterior

Windows are showing signs of aging due to deterioration of woodwork. - AssetCALC ID: 3288093

Uniformat Code: B2021
Recommendation: **Replace in 2023**
