# FACILITY CONDITION ASSESSMENT

**Alexandria City Public Schools**  
2000 North Beauregard Street  
Alexandria, Virginia 22311  
John Finnigan

Transportation Facility  
3540 Wheeler Avenue  
Alexandria, Virginia 22302

*December 21, 2021*

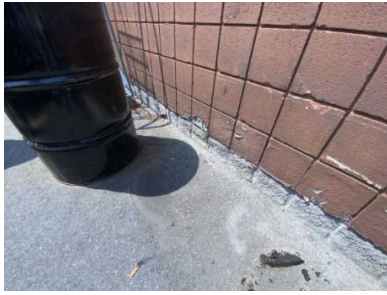
### Exterior Walls in Failed condition.

Brick, 3+ Story Building  
Transport Facility - System Wide Building exterior

The exterior brick wall on the elevation and back of the building was observed with damage, appeared to be caused by water/moisture intrusion. - AssetCALC ID: 3246881

Uniformat Code: B2011  
Recommendation: **Repair in 2021**

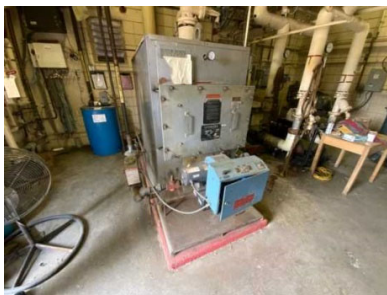
### Boiler in Poor condition.

Gas, HVAC, 1260 MBH  
Transport Facility - System Wide Boiler room

Boiler exhibit significant wear and tear as well as rust that may compromised internal components (electronics). - AssetCALC ID: 3229074

Uniformat Code: D3021  
Recommendation: **Replace in 2022**

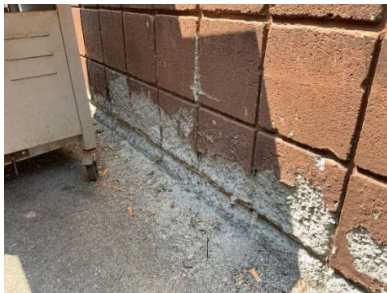
### Recommended Follow-up Study: Civil, Site Drainage

Civil, Site Drainage  
Transport Facility - System Wide Building exterior

Building personnel informed of water damage, water intrusion into the building coming from the front of the building and streaming on the left elevation due to the slope of the terrain. - AssetCALC ID: 3247061

Uniformat Code: P2032  
Recommendation: **Evaluate/Report in 2021**

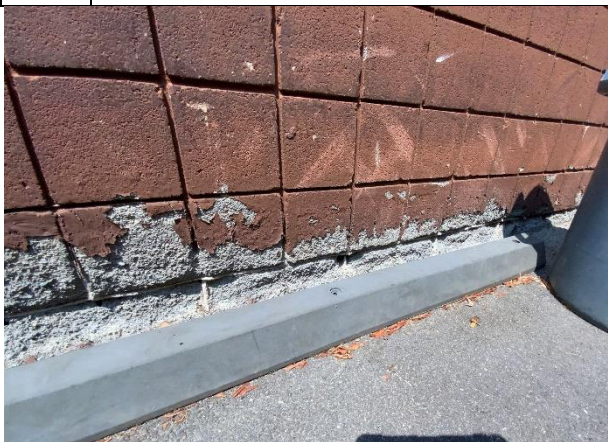
#29: EXTERIOR WALL WATER DAMAGE

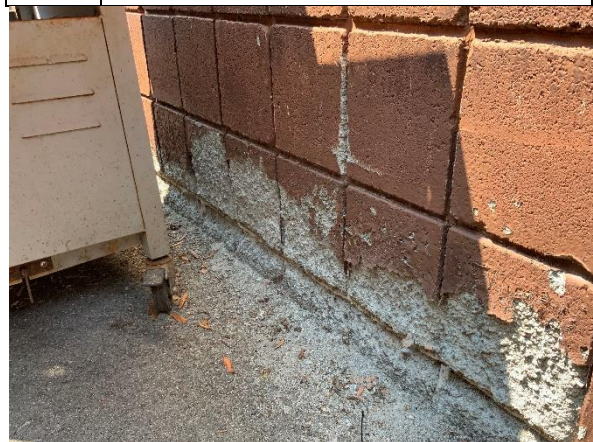
#30: EXTERIOR WALL DAMAGE
