FACILITY CONDITION ASSESSMENT

Samuel W. Tucker Elementary
435 Ferdinand Day Drive
Alexandria, Virginia 22302

148303.21R000-012.354

December 20, 2021

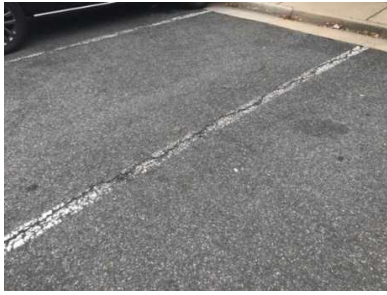
Parking Lots in Failed condition.

Pavement, Asphalt
Samuel W. Tucker Elementary School
Campus Site

Uniformat Code: G2021
Recommendation: **Seal and Stripe in 2021**

Restriping budgeted and scheduled - AssetCALC ID: 3391083

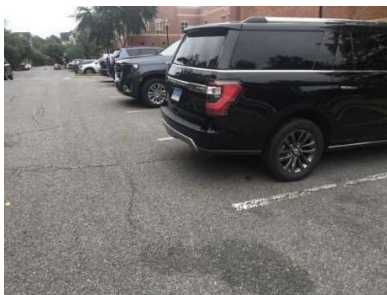
Parking Lots in Failed condition.

Pavement, Asphalt
Samuel W. Tucker Elementary School
Campus Site

Uniformat Code: G2021
Recommendation: **Mill and Overlay in 2021**

Pavement work budgeted and scheduled - AssetCALC ID: 3390983

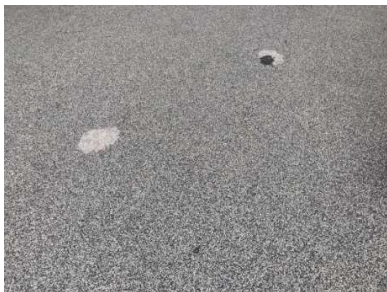
Playfield Surfaces in Poor condition.

Rubber, Small Areas
Samuel W. Tucker Elementary School
Campus Site

Uniformat Code: G2055
Recommendation: **Replace in 2021**

Needs replacement - AssetCALC ID: 3391041

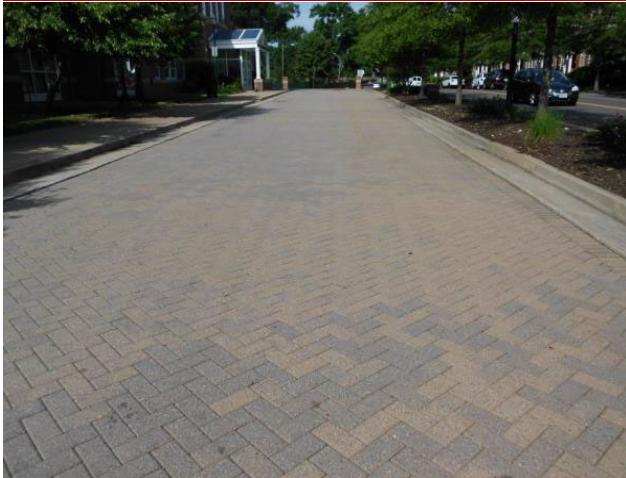
7 - OVERVIEW OF PAVER DRIVEWAY

QUESTION		RESPONSE				COMMENTS
		Yes	No	Unk	NA	
7	Are there any problems with foundations or structures, like excessive settlement?	X				Drive loop pavers have sunk, the area needs to be investigated to determine if there is a settlement / compaction problem.
8	Are there any wall, window, basement or roof leaks?		X			
9	Has any part of the facility ever contained visible suspect mold growth, or have there been any indoor air quality or mold related complaints from occupants?		X			
10	Are your elevators unreliable, with frequent service calls?		X			
11	Are there any plumbing leaks, water pressure, or clogging/back-up problems?		X			
12	Have there been any leaks or pressure problems with natural gas, HVAC supply/return lines, or steam service?		X			
13	Are any areas of the facility inadequately heated, cooled or ventilated? Any poorly insulated areas?		X			
14	Is the electrical service outdated, undersized, or otherwise problematic?		X

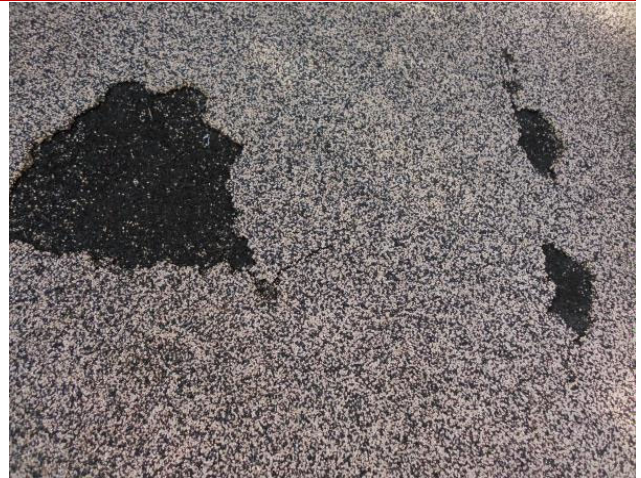
8 - CLOSEUP OF DAMAGED GROUND SURFACE
AT PLAYGROUND
