# FACILITY CONDITION ASSESSMENT

## BOYLSTON ELEMENTARY SCHOOL

200 Sewall Street, Boylston, MA 01505

FINAL REPORT: August 14, 2023  
H&A JN 2102.03

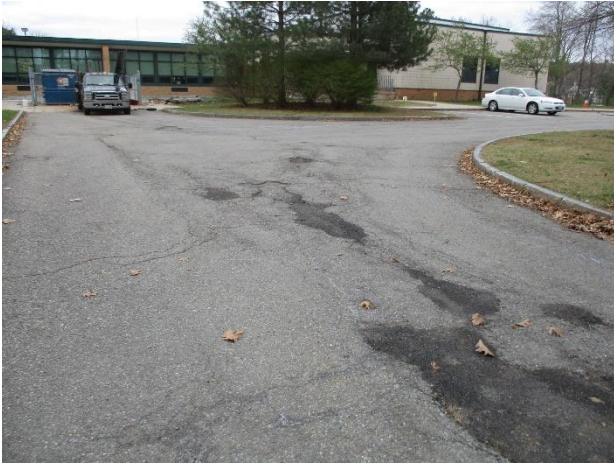
1.1 Slight bituminous deterioration at driveway.

Work Item Description	Qty	Unit	Unit Cost	Total	<sup>1</sup> Total w/ Soft Costs	Priority 1	Priority 2	Priority 3	Totals
<b>1. SITE</b>					<b>BOYLSTON ELEMENTARY SCHOOL</b>				
<b>1.1 Drives and Parking Lots:</b> Bituminous paving shows some minimal cracking and aging. Patch and sealcoat bituminous paving.	100	SY	40.00	4,000	5,200		5,200		5,200
<b>1.2 Bituminous Curbing:</b> Bituminous curbing is damaged/missing in some areas. Replace bituminous curbing at drives and parking lot.	330	LF	20.00	6,600	8,580	8,580			8,580
<b>1.3 Granite Curbing:</b> Some granite curbs at the parking lot at the corners are heavily damaged. Replace with new granite curbs.	40	LF	30.00	1,200	1,560	1,560			1,560
<b>1.4 Concrete Ramp and Sidewalks:</b> Concrete sidewalks have small areas of deterioration. Patch and repair to match existing.	5	SY	50.00	250	325	325			325
<b>1.5 Storm Drainage:</b> Some storm drains show signs of settling. Reset existing storm drains.	2	EA	10,000.00	20,000	26,000		26,000		26,000

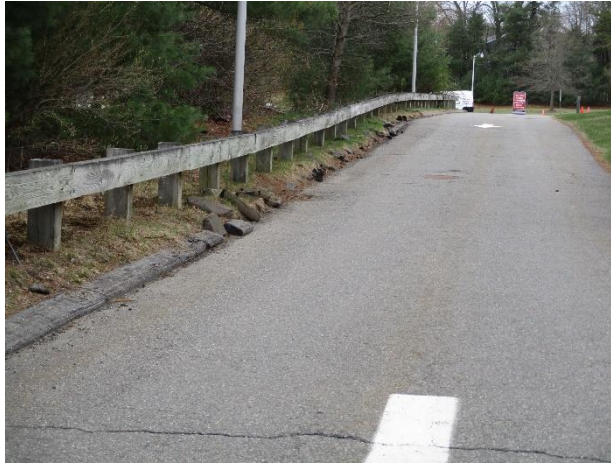
1.2 Damaged bituminous curbs.

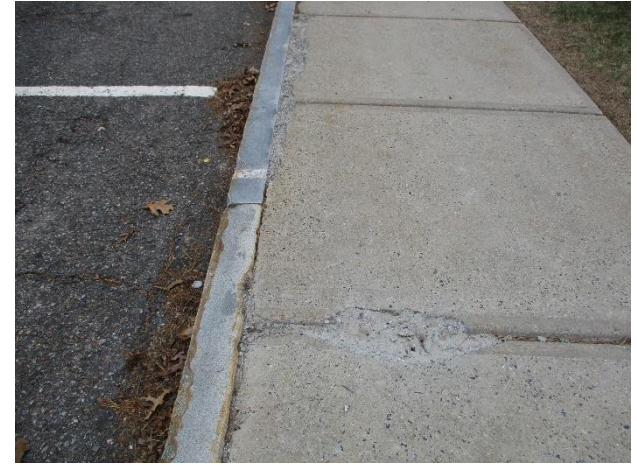
1.4 Small area of deterioration at the concrete sidewalk.

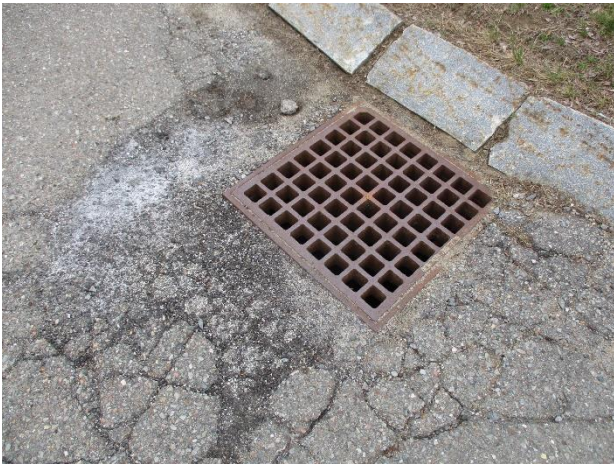
1.5 Settling storm drain and deterioration of bituminous pavement.

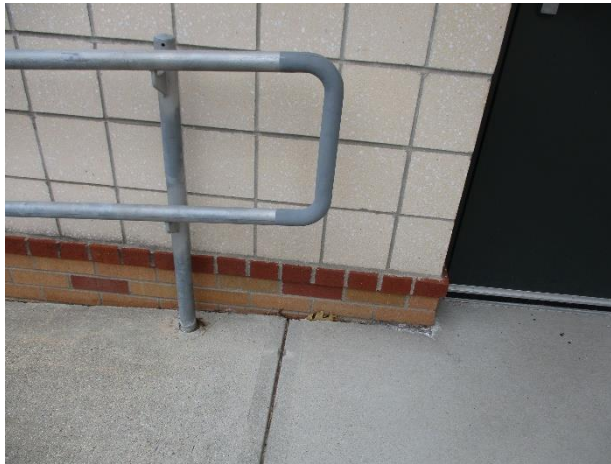
1.6 Handrail extension does not meet ADA requirement.

<b>1.6 Exterior Handrails:</b> Exterior handrail extension does not meet the ADA code. Extend the handrail extension 12" beyond top of slope.	1	LS	1,000.00	1,000	1,300			1,300	1,300
<b>1.7 Timber Guardrail:</b> Two sections on the timber guardrail were damaged. Replace these two sections with new.	1	LS	1,000.00	1,000	1,300	1,300			1,300
<b>1.8 Effluent Pump Station:</b> Pumps are approaching end of useful service life. Replace pumps with new equipment.	2	EA	10,000.00	20,000	26,000		26,000		26,000
<b>Total</b>						11,765	57,200	1,300	70,265
<b>Total Inflated @ 6% for Priority 1, 4% for Priorities 2-3 and Compounded Annually</b>						13,219	69,593	1,924	84,736

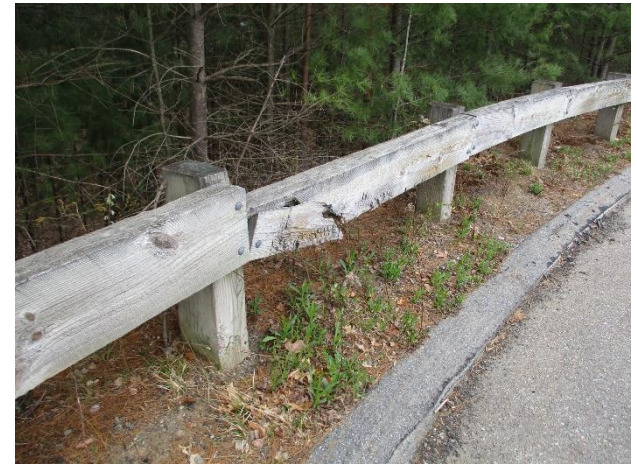
1.7 Damaged timber guardrail.

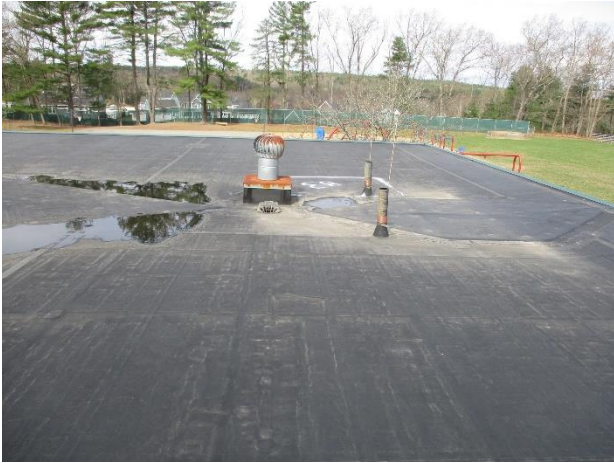
2.1 Ponding near roof drain.

Work Item Description	Qty	Unit	Unit Cost	Total	<sup>1</sup> Total w/ Soft Costs	Priority 1	Priority 2	Priority 3	Totals
<b>2. BUILDING ENVELOPE</b>					<b>BOYLSTON ELEMENTARY SCHOOL</b>				
<b>2.1 EPDM Roofs:</b> The existing EPDM roofing membrane has been leaking and is at the end of its life expectancy. Replace with new PVC roofing system.	56,000	SF	75.00	4,200,000	5,460,000	5,460,000			5,460,000
<b>2.2 Roof Drains:</b> Some roof drains will need to be replaced along with the new roof system.	5	EA	2,500.00	12,500	16,250	16,250			16,250
<b>2.3 Metal Roof System:</b> Existing metal standing seam roofing and painted finish is failing and rusting in many areas. Replace with new roofing system.	4,200	SF	90.00	378,000	491,400	491,400			491,400
<b>2.4 Roof Snow Guards:</b> Replace the snow guard along with the new roof system.	130	LF	25.00	3,250	4,225	4,225			4,225
<b>2.5 Downspout and splash block:</b> Splash blocks are missing at the downspout. Install new splash blocks.	7	EA	50.00	350	455	455			455

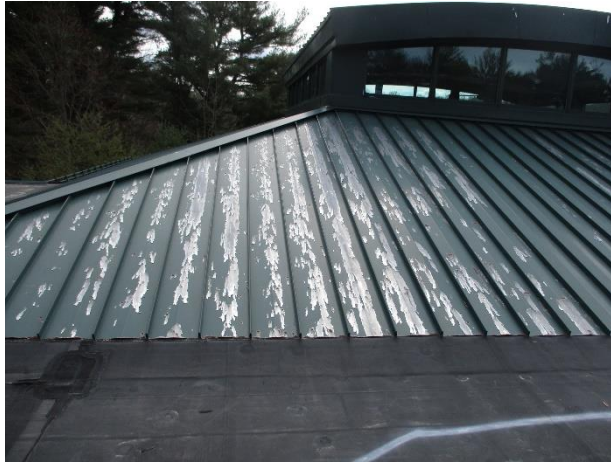
2.3 Deteriorating standing seam metal roof system.

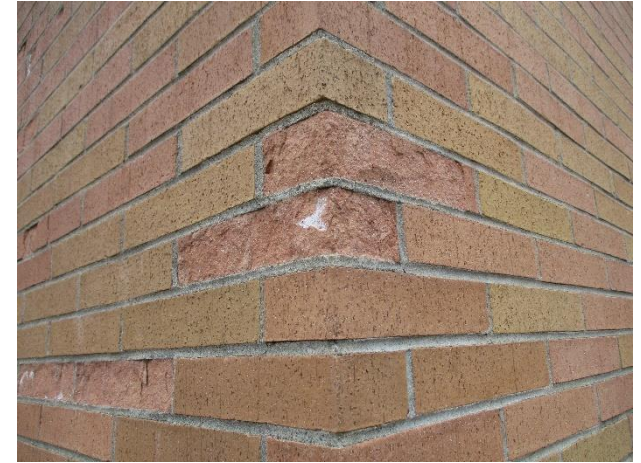
2.6 Cracked and spalling bricks.

<b>2.6 Damaged Masonry Walls:</b> Replace cracked and spalling bricks.	30	SF	630.00	18,900	24,570	24,570			24,570
<b>2.7 Repoint brick masonry mortar joints:</b> Repoint brick masonry walls at the ramp and various parts of the building.	144	SF	45.00	6,480	8,424	8,424			8,424
<b>2.8 Staining and Efflorescence:</b> Power wash and clean at various locations of ground face block and brick veneer masonry walls.	12,000	SF	7.00	84,000	109,200	109,200			109,200
<b>2.9 Exterior Wood Doors:</b> Replace old exterior wood doors at the kitchen with new FRP door and frame.	1	EA	1,000.00	1,000	1,300	1,300			1,300
<b>2.10 Exterior Wall Sealant Joints:</b> Remove dry and cracked sealant at masonry control joints and replace with new backer rod and sealant.	1,500	LF	15.00	22,500	29,250	29,250			29,250

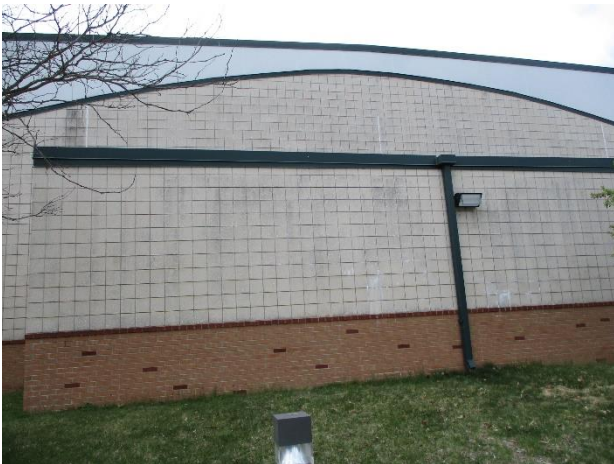
2.8 Staining and efflorescence at ground face blocks.

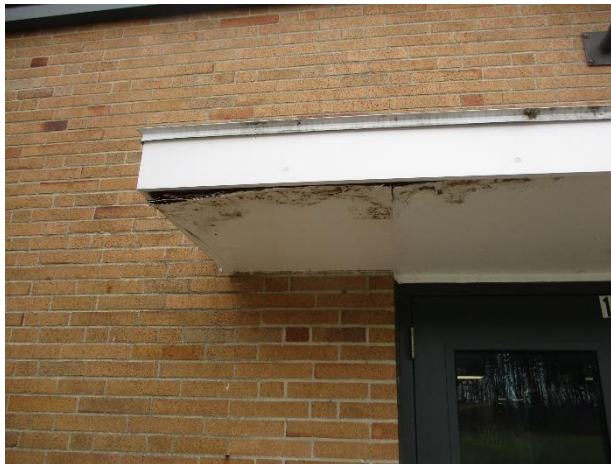
2.11 Deteriorated soffit by Door #10.

Work Item Description	Qty	Unit	Unit Cost	Total	<sup>1</sup> Total w/ Soft Costs	Priority 1	Priority 2	Priority 3	Totals
<b>2. BUILDING ENVELOPE</b>					<b>BOYLSTON ELEMENTARY SCHOOL</b>				
<b>2.11 Roof Canopy Soffit:</b> Roof Canopy Soffit by Exterior Door 10 is rotting and falling apart. Replace with new plywood soffit, painted.	1	LS	500.00	600	780	780			780
<b>2.12 Window Screen:</b> Replace broken window screens at double hung windows.	5	EA	100.00	500	650	650			650
<b>2.13 Bird Nest Removal:</b> Remove and clean bird nests at various at building connectors.	1	LS	500.00	500	650	650			650
<b>2.14 Active Water Infiltration on Ground Face Block at the Gym:</b> Further investigation will be required to determine the source of water infiltration. Investigate and prepare recommendations.	1	LS	10,000.00	10,000	13,000	13,000			13,000
<b>2.15 Roof Hatch Guardrail:</b> Add safety guardrail at roof hatch.	1	LS	2,500.00	2,500	3,250	3,250			3,250

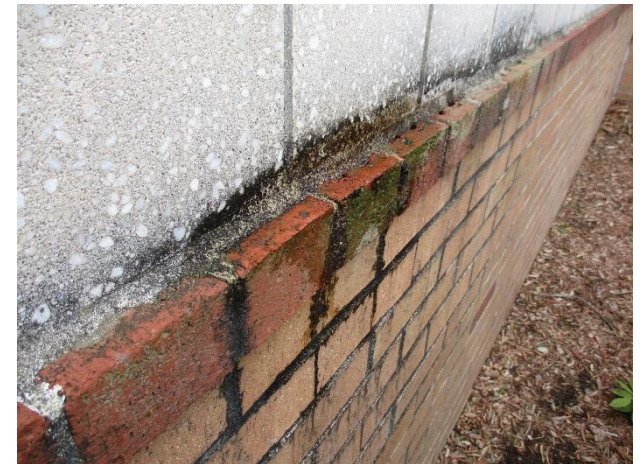
2.14 Water infiltration at ground face block by the gym.

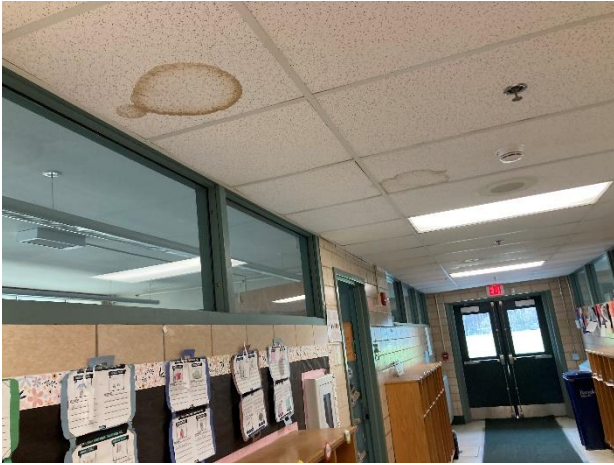
3.2 Stained ACT tiles in corridor.

Work Item Description	Qty	Unit	Unit Cost	Total	<sup>1</sup> Total w/ Soft Costs	Priority 1	Priority 2	Priority 3	Totals
<b>3. BUILDING INTERIORS</b>					<b>BOYLSTON ELEMENTARY SCHOOL</b>				
<b>3.1 Ceiling Finishes:</b> Library - GWB Ceiling in Library is damaged and peeling from water damage. Patch, repair and repaint damaged ceiling areas.	40	SF	30.00	1,200	1,560		1,560		1,560
<b>3.2 Ceiling Finishes:</b> Remove and replace damaged/ stained ACT ceiling tiles in various locations throughout building.	400	SF	10.00	4,000	5,200		5,200		5,200
<b>3.3 Wall Finishes:</b> Grout is failing or missing in areas of tiled restrooms Boys 1072 and Girls 1073. Re-grout tile in failing areas.	30	LF	20.00	600	780		780		780
<b>3.4 Floor Finishes:</b> Water is infiltrating through the floor and has deteriorated the VCT flooring in the corridor outside of Boys Restroom 1072. It is recommended to perform further investigation through the corridor wall in order to locate the water source and thereby provide a solution to future infiltration.	1	LS	10,000.00	10,000	13,000	13,000			13,000

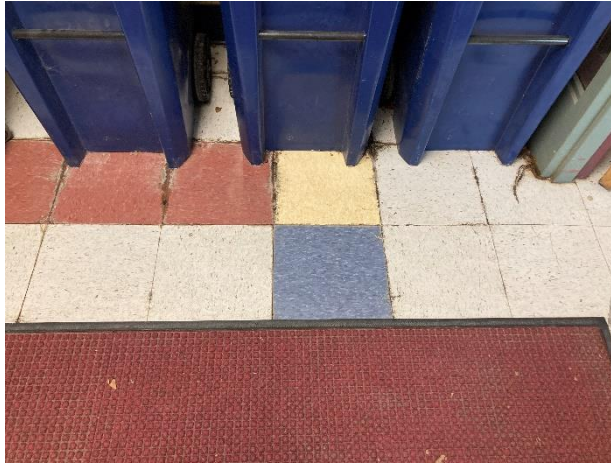
3.4 Water infiltrating and deteriorating VCT flooring in corridor.

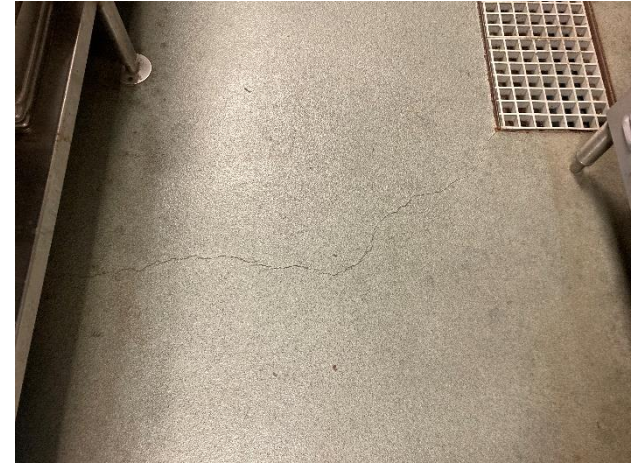
3.7 Cracks in epoxy flooring in kitchen.

<b>3.5 Floor Finishes:</b> Carpet - Carpet is stained, damaged and past its expected useful life. Replace existing carpet with new in all locations throughout building.	5,560	SF	15.00	83,400	108,420		108,420		108,420
<b>3.6 Floor Finishes:</b> Replace damaged or cracking VCT tiles in various areas throughout building.	3,500	SF	12.00	42,000	54,600		54,600		54,600
<b>3.7 Floor Finishes:</b> Kitchen - Existing epoxy kitchen flooring is cracked and stained. Replace the epoxy floor with new.	1,250	SF	16.00	20,000	26,000		26,000		26,000
<b>3.8 Floor Finishes:</b> Entry Vestibule - Recessed walk-off mats in entry vestibules are damaged and torn. Replace existing recessed walk-off mats with new.	160	SF	15.00	2,400	3,120		3,120		3,120

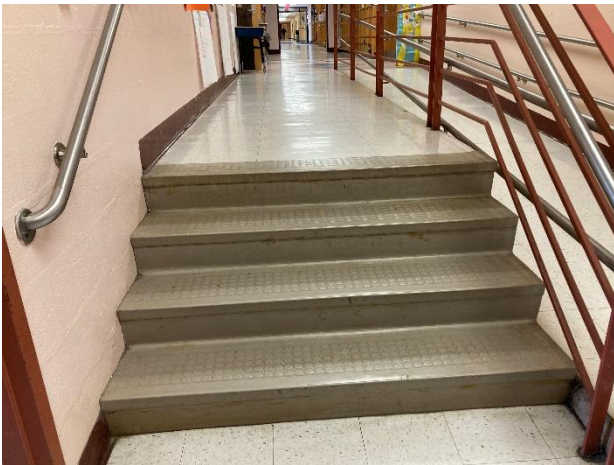
3.9 Deteriorated rubber stairs and non-compliant guard and hand rails.

Work Item Description	Qty	Unit	Unit Cost	Total	<sup>1</sup> Total w/ Soft Costs	Priority 1	Priority 2	Priority 3	Totals
<b>3. BUILDING INTERIORS</b>					<b>BOYLSTON ELEMENTARY SCHOOL</b>				
<b>3.9 Stairs:</b> Rubber stair treads and risers are stained and worn. Remove and replace all existing rubber stair treads and risers.	40	SF	50.00	2,000	2,600		2,600		2,600
<b>3.10 Stairs:</b> Guardrails - Existing guardrails at interior ramp and stairs have excessive spacing between guard elements. Replace guardrails to provide proper spacing and comply with accessibility standards.	25	LF	250.00	6,250	8,125			8,125	8,125
<b>3.11 Stairs:</b> Handrails - Existing handrails at interior ramp and stairs do not have adequate extension at landings. Revise handrails to extend min. 12" parallel beyond top and bottom stairs and ramps to comply with accessibility standards.	6	EA	250.00	1,500	1,950			1,950	1,950
<b>3.12 Doors:</b> Interior hollow metal doors and frames are corroded and peeling. Repaint hollow metal doors and frames in various locations throughout building.	1,250	SF	15.00	18,750	24,375		24,375		24,375

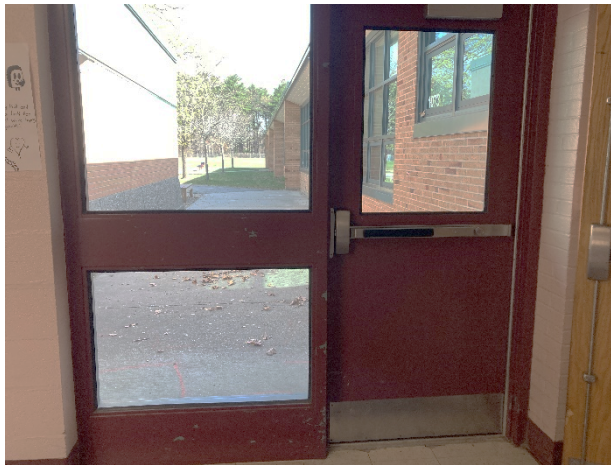
3.12 Corroded and peeling hollow metal door and frame.

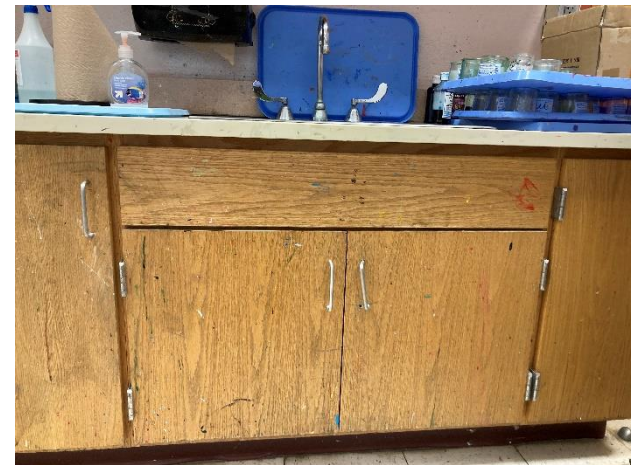
3.13 Damaged classroom casework and hardware.

<b>3.13 Casework:</b> Classrooms - classroom casework and associated hardware is damaged, worn, and in a state of disrepair. Replace all existing classroom casework and associated hardware with new.	580	LF	500.00	290,000	377,000		377,000		377,000
<b>3.14 Casework:</b> Cubbies - Open wood cubbies in corridor are worn and showing signs of age. Replace with new units.	120	LF	200.00	24,000	31,200		31,200		31,200
<b>3.15 Casework:</b> Library - Wood veneer Library circulation desk is peeling, dented and deteriorated. Remove and replace existing circulation desk with new.	1	LS	10,000.00	10,000	13,000		13,000		13,000

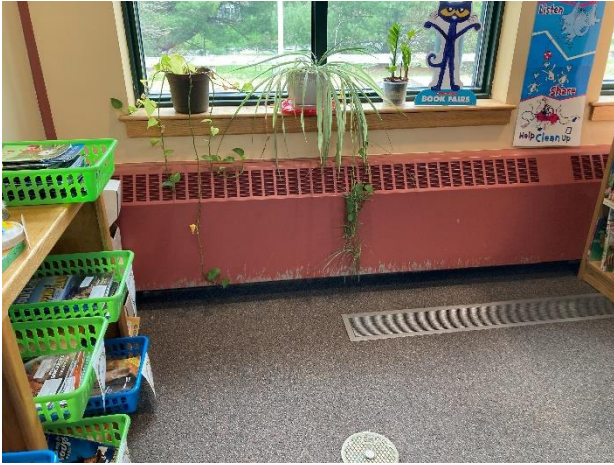
4.5 Outdated classroom unit ventilators.

Work Item Description	Qty	Unit	Unit Cost	Total	<sup>1</sup> Total w/ Soft Costs	Priority 1	Priority 2	Priority 3	Totals
<b>4. MECHANICAL</b>					<b>BOYLSTON ELEMENTARY SCHOOL</b>				
<b>4.1 Turbine Ventilators:</b> Rooftop turbine ventilators are corroded. Replace with new units.	4	EA	250.00	1,000	1,300	1,300			1,300
<b>4.2 Circulation Pump Valves:</b> Hot water circulation pump valves are leaking and require replacement.	3	EA	400.00	1,200	1,560	1,560			1,560
<b>4.3 Pipe Insulation:</b> Insulation is damaged at boilers. Replace with new.	10	LF	4.00	40	52	52			52
<b>4.4 Pipe Insulation:</b> Domestic hot water piping is missing insulation at boiler room. Add to existing piping as required.	10	LF	4.00	40	52	52			52
<b>4.5 Classroom Unit Ventilators:</b> Units are approaching the end of useful life expectancy. Replace with new units.	41	EA	8,375.00	343,375	446,388		446,388		446,388
<b>4.6 RTU-1:</b> Packaged 2390 CFM rooftop air handling unit at Administration is beyond expected service life. Replace with new unit.	1	EA	9,675.00	9,675	12,578		12,578		12,578

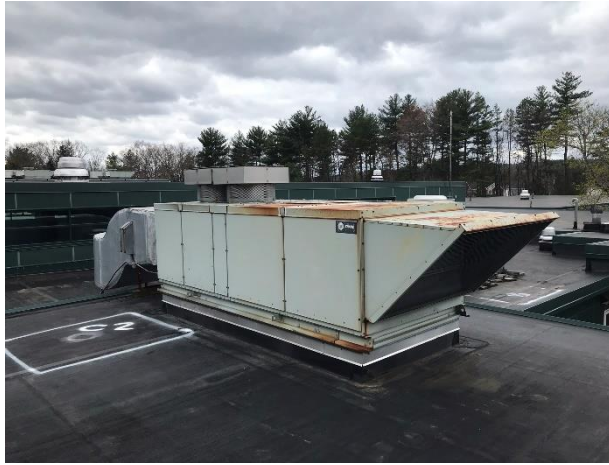
4.7 Outdated rooftop air handling unit.

<b>4.7 RTU-2:</b> Packaged 5000 CFM rooftop air handling unit at Media Center is beyond expected service life. Replace with new unit.	1	EA	22,800.00	22,800	29,640		29,640		29,640
<b>4.8 RTU-3:</b> Packaged 2000 CFM rooftop air handling unit at Computer Lab is beyond expected service life. Replace with new unit.	1	EA	11,175.00	11,175	14,528		14,528		14,528
<b>4.9 Kitchen Hood Exhaust EF-15:</b> Rooftop kitchen hood 6000 CFM exhaust fan is beyond expected useful service life. Exposed ductwork is corroded. Replace with new equipment.	1	LS	10,000.00	10,000	13,000		13,000		13,000

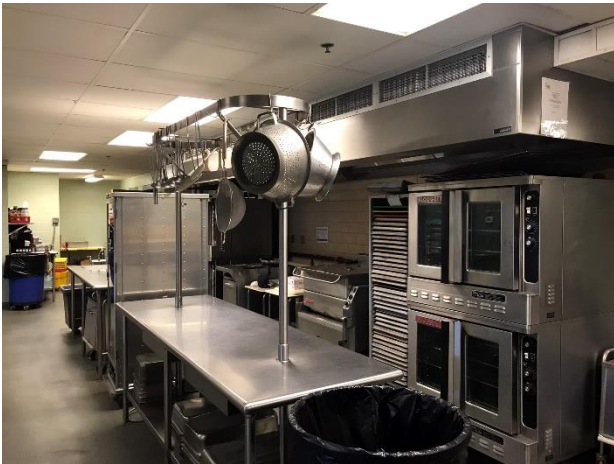
4.19 Outdated kitchen equipment.

Work Item Description	Qty	Unit	Unit Cost	Total	<sup>1</sup> Total w/ Soft Costs	Priority 1	Priority 2	Priority 3	Totals
<b>4. MECHANICAL</b>					<b>BOYLSTON ELEMENTARY SCHOOL</b>				
<b>4.20 Maintenance Garage:</b> Garage does not include floor drain or gas/oil separator. Provide drain, separator and associated piping.	1	LS	15,000.00	15,000	19,500			19,500	19,500
<b>4.21 Gas Piping:</b> Paint exterior gas piping.	1	LS	500.00	500	650	650			650
<b>Total</b>						8,294	2,336,134	838,929	3,183,357
<b>Total Inflated @ 6% for Priority 1, 4% for Priorities 2-3 and Compounded Annually</b>						9,319	2,842,264	1,241,820	4,093,403

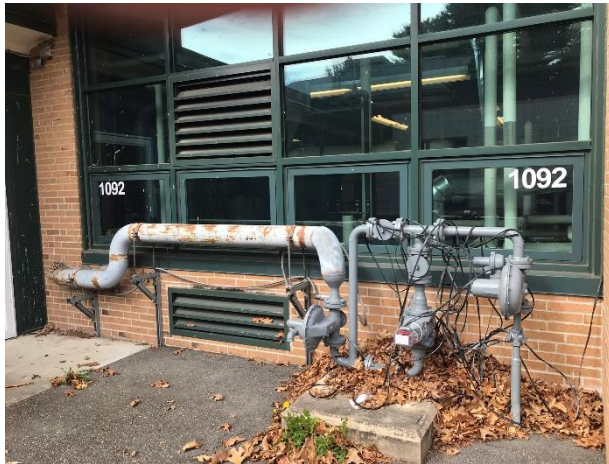
4.21 Corroded exterior gas piping.

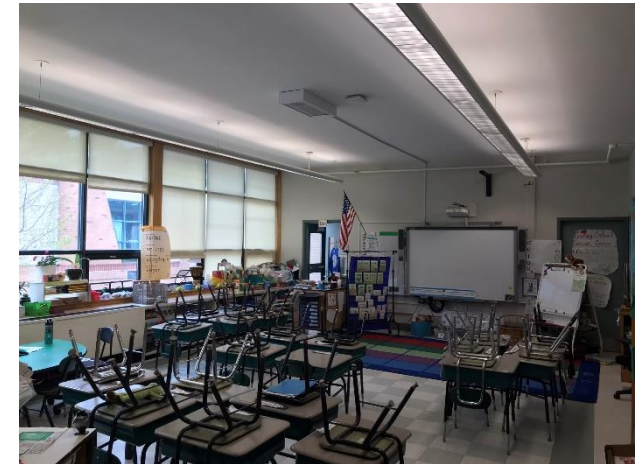
5.1 Suspended fluorescent light fixtures in classroom.

Work Item Description	Qty	Unit	Unit Cost	Total	<sup>1</sup> Total w/ Soft Costs	Priority 1	Priority 2	Priority 3	Totals
<b>5. ELECTRICAL, DATA, SECURITY, COMMUNICATION, AV SYSTEMS</b>					<b>BOYLSTON ELEMENTARY SCHOOL</b>				
<b>5.1 Lighting Systems:</b> Replace fluorescent lighting with LED fixtures throughout.	61,413	SF	15.00	921,195	1,197,554		1,197,554		1,197,554
<b>5.2 Effluent Pump Station:</b> Extend standby power to pump station.	300	LF	50.00	15,000	19,500		19,500		19,500
<b>5.3 Alarm Monitoring:</b> Add Alarm Monitoring to Stand-By Generator.	1	LS	2,500.00	2,500	3,250		3,250		3,250
<b>5.4 Alarm Monitoring:</b> Add Alarm Monitoring to Septic Tank Float Alarm System.	1	LS	2,500.00	2,500	3,250		3,250		3,250
<b>5.5 Server:</b> Install new Dell PowerEdge R520.	1	EA	14,000.00	14,000	18,200	18,200			18,200
<b>5.6 Wireless Access Points:</b> Install new AeroHive AP250 Devices.	28	EA	800.00	22,400	29,120		29,120		29,120
