2021 School District of Onalaska Long Range Planning Study

PART 1 - Facilities Condition Assessment

2021 SCHOOL DISTRICT OF ONALASKA: LONG RANGE PLANNING STUDY FACILITIES CONDITION ASSESSMENT

School District of Onalaska

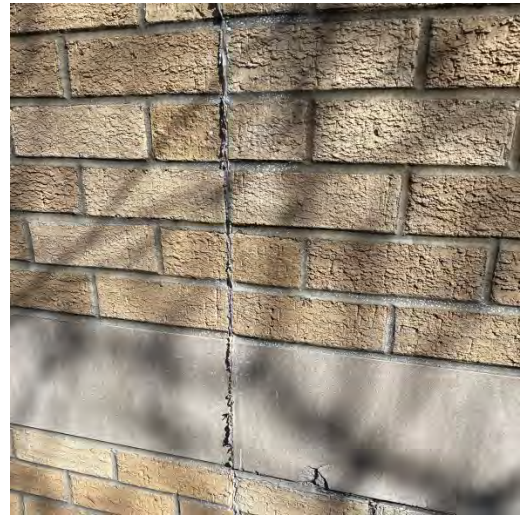
Control joint displays brick expansion

1. Various control joints should be cut out and re-caulked. Control joints that display brick expansion should be monitored on an annual basis to ensure they maintain a waterproof joint.
2. The District may want to consider re-coating the acrylic stucco with a new flexible elastomeric coating that will reinforce the weather-tightness of these wall areas.
3. Flashing above arches or sealant in head stones need to be considered at South entrance 'P' in order to minimize ongoing water damage.

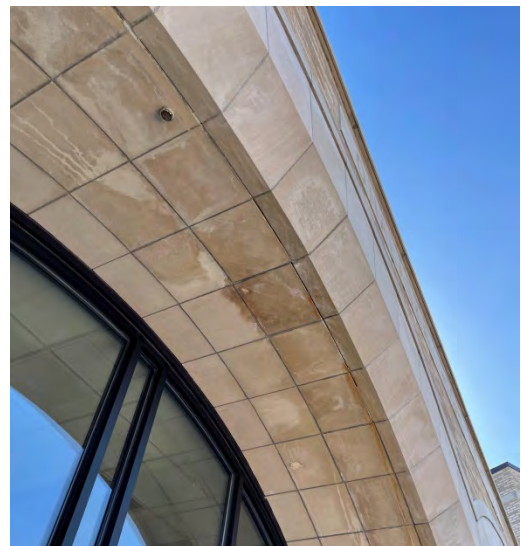
4. Metal roof edge fascia, flashings and wall caps also appear to be in relatively good condition and do not warrant any immediate action.
5. Limited wall areas of the 1988 addition were clad with an exterior acrylic stucco surface. The surface appears to be functioning as a weather barrier but shows some signs of aging, to be expected. A couple of hairline cracks were observed that may be a result of seasonal expansion and shrinkage cycles.
6. South entrance 'P' displays ongoing moisture leaks from open joints in stone and lack of flashing. Interior water damage has occurred in adjacent classroom ceilings.

Moisture leakage at South entry 'P'

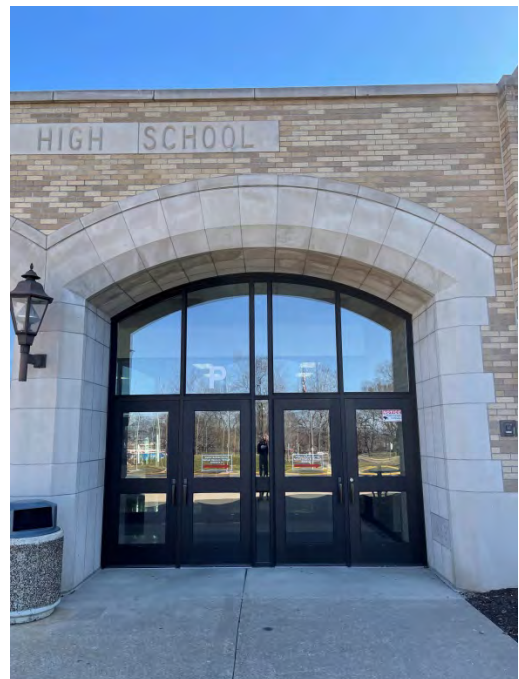
Updated aluminum entrance doors

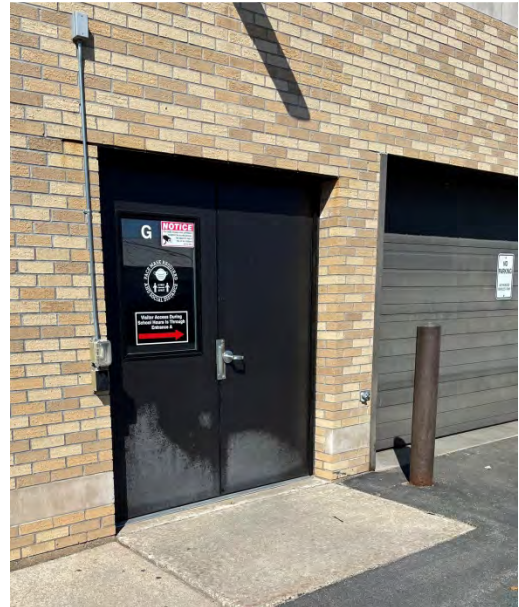
1. Aluminum entrances remain in good condition.
2. Fiberglass doors 'I' & 'G' show wear on lower portion of doors.

Fiberglass doors 'I' & 'G' show wear

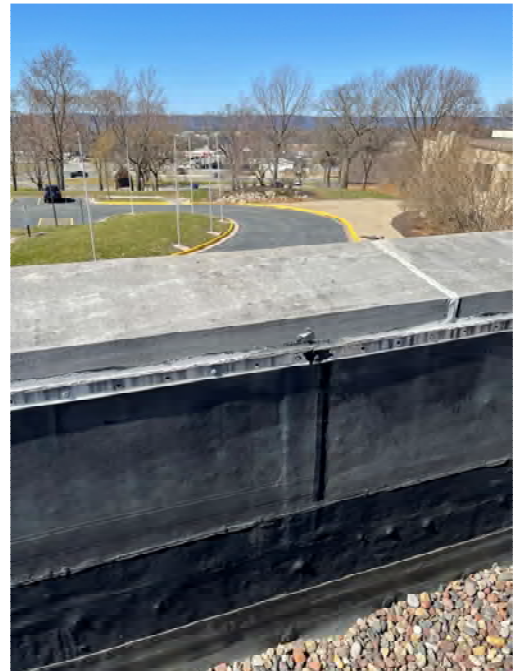
1. Based on discussions with the District's roofing consultant, Bechtel LLC, it was noted that in general, the existing rubber roofing is in satisfactory condition with an indefinite remaining life-span.
2. The typical shrinkage of the single-ply membrane roofing was noted to be expected for a roof approaching 27 years of age. The shrinkage primarily shows up where the rubber membrane is pulling away ('tenting') from the vertically flashed face of the wall.

Perimeter membrane

1. The primary areas of focus should be directed at the ballasted roof membrane seams and perimeter roof edge conditions. It was recommended that the perimeter membrane be cut and re-flashed with a reinforced perimeter strip.
2. Roof curbs for mechanical equipment and skylights should also be re-flashed.
3. Properly maintained, the lifespan of the existing roofs could be extended indefinitely or at least added to the list of deferred maintenance projects. The decision to re-roof areas of the high school may be evaluated on a cost basis that compares the cost to repair the perimeter flashings and seams versus tear-off and replacement of the entire rubber membrane.

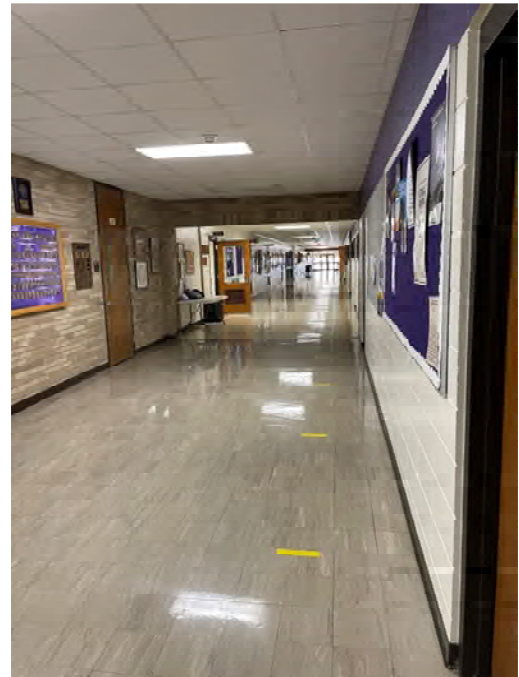
1. In general, the various floorings are well maintained, including the remaining vinyl asbestos tile from the original construction.
2. The vinyl composition tile shows typical minor signs of cracking or telegraphing of imperfections in the concrete slab substrate.
3. The fritztile tile appears to be well maintained and maintenance staff is satisfied with the performance of the tile in these high traffic areas.
4. Overall, carpet is in good condition. The PAC has multiple areas showing wear and detachment that requires replacement.
5. The maple gymnasium flooring was fully sanded, painted and sealed in 2020.

VCT and VAT in hallway

1. At vinyl composition tile, various floor expansion joints need to be inspected for potential trip hazards.
2. PAC carpet should be replaced entirely.

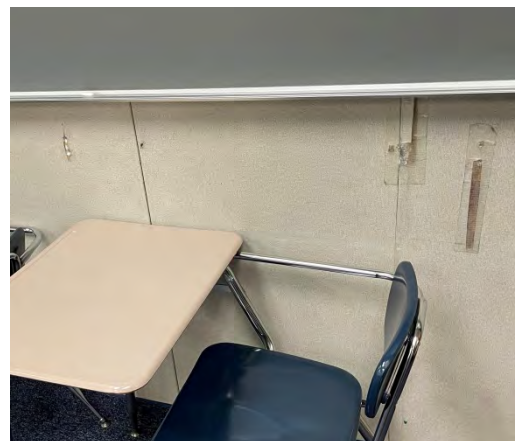
1. Overall, concrete block walls are in satisfactory condition.
2. Fabric on demountable walls shows wear and tears in multiple areas.
3. Demountable partitions do not provide adequate sound control between rooms.

Demountable partitions are aged and worn

1. Demountable walls are recommended to be replaced with standard wall construction and sound insulation to minimize noise bleeds between classrooms and hallways.

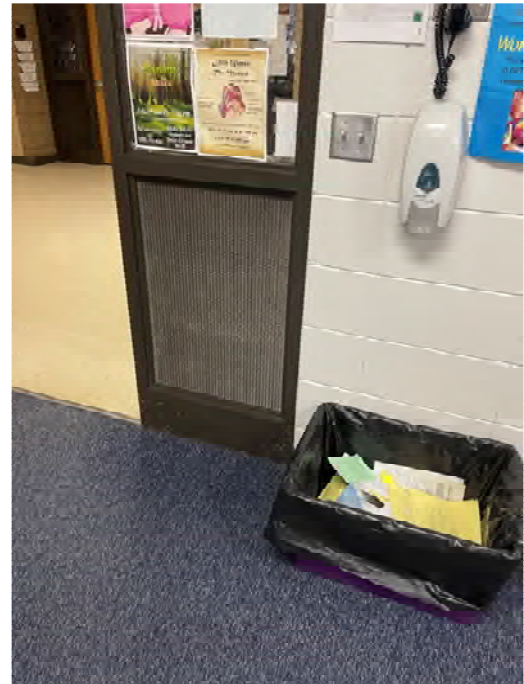
1. Wood doors exhibit normal deterioration from the years of service.
2. Latch sets have been changed out to ADA compliant lever handles.

Hollow metal door frames show wear

1. Wood doors can generally continue to be used and replaced on a case by case basis; however, a select number of wood doors are damaged to the point of requiring replacement.
2. Hollow metal door frames should be repaired and repainted as needed.
3. Wire glass should be removed and replaced with new fire-rated safety glass.

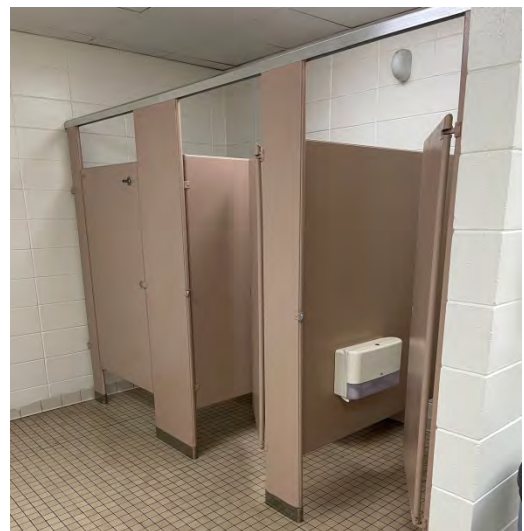
1. Metal toilet stall partitions show typical age and wear.
2. Solid plastic toilet partitions are in good condition.

Metal toilet partitions

1. Remaining metal partitions can continue to be used but can be changed out to solid plastic as part of any toilet room remodeling project.

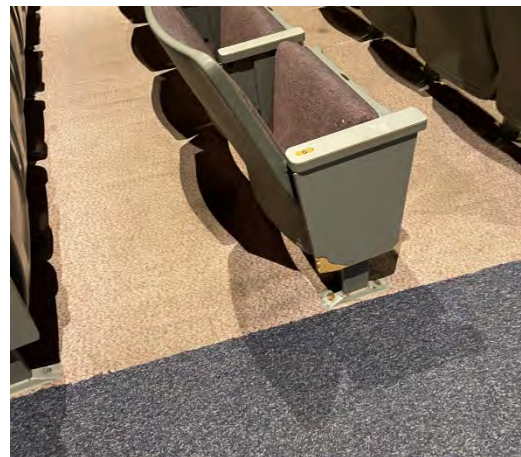
1. Overall, finishes in the PAC are aged and worn. Floor carpet is pulling up and detached in areas. Wall carpet displays moisture damage.
2. Mezzanine is accessed by stairs. Space is used for storage of props and scenery. Movability of materials appears difficult due to size of items and access to space.
3. ADA access to the stage is limited to the rear hallway and non-existent to the orchestra pit. Sound booth is not ADA accessible.
4. Stage does not have sufficient wing space or fly space for theater performances.
5. Full band of 130 students does not fit on the stage.

Seats show damage and wear

1. All finishes need updating. Carpet needs full replacement. Acoustical wall carpet should be replaced with proper acoustical panels.
2. Shortcomings of this area will be reviewed with the overall design study for the high school.

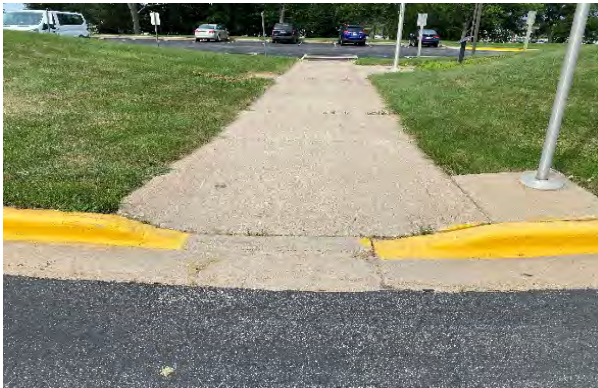
No detectable warning fields – map grid E4 and E5

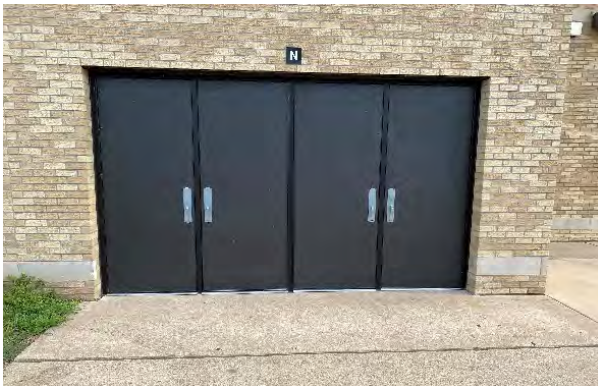
Joint seals needed – map grid D5, C6-7

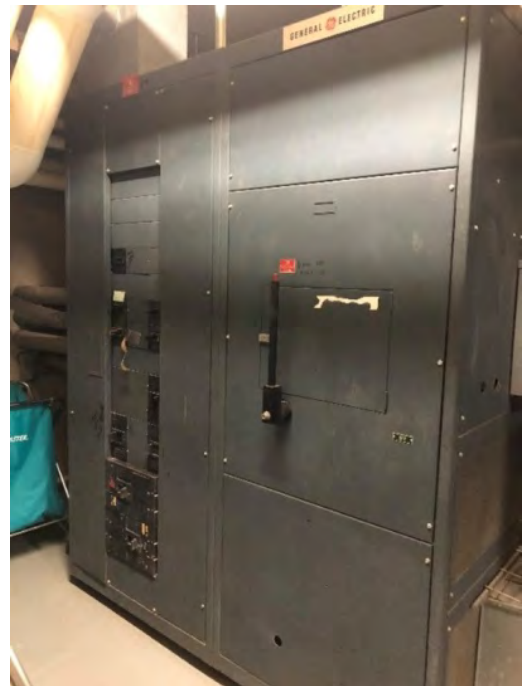
1. The main Switch Board is in good working condition with no issues reported by Maintenance Staff.
2. The main service switchboard does not have a surge protection device.
3. The existing 1960 Switchboard located in what is referred to as the 'Laundry Room #211C should be removed and replaced with new. This switchboard feeds an existing air handling unit, woods and Metals Shop Panelboards, Panel LCF-2 and unlabeled Panels. Switchboard is fed from the 1988 Switchboard.

Old switchboard

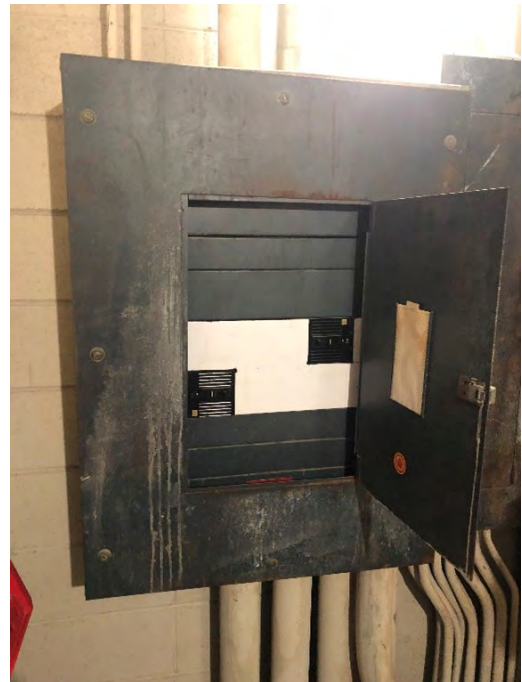
1. All existing panelboards are generally full and do not have space for additional circuit breakers.
2. The panelboards that were installed in 1968 are at the end of their useful life due to the operating lifespan of circuit breakers.
3. The panelboards that were installed in 1988 are in good working order. However as noted above are full and have minimal space for additional circuit breakers.
4. In the Kitchen by the Service Line, the panelboard is full and should be replaced with a new larger panelboard. It is also the opinion of this writer; the existing panelboard should be relocated to a better location. \$4,000.

Panelboard

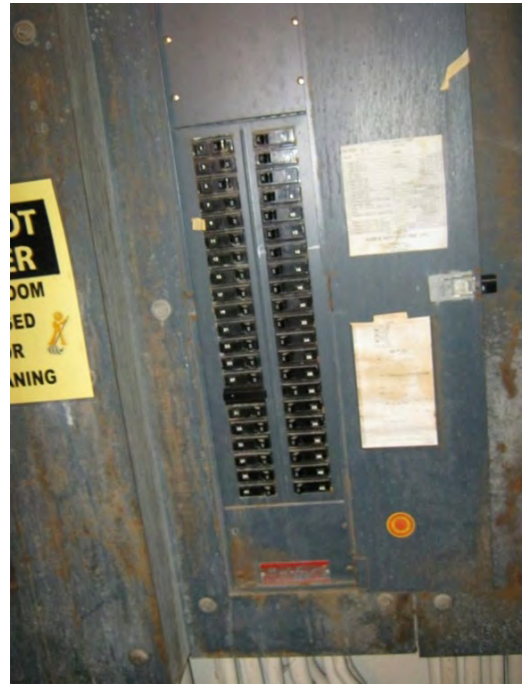
1. The expected remaining lifespan of the 1968 panelboards is about 0 - 5 more years and should be replaced as soon as possible.
2. The expected remaining lifespan of the 1988 panelboards is about 15-20 more years.

Panelboard

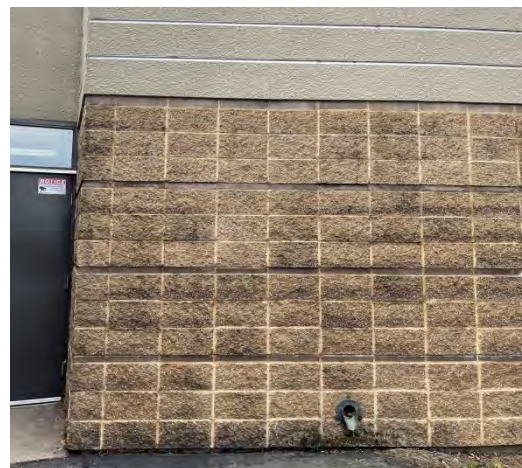
1. The exterior stucco wall cladding was cleaned and recoated in 2017.
2. Exterior control joints were re-sealed in 2017.
3. Walls are poorly insulated.
4. Various areas at stucco walls are cracked or damaged.
5. Ground face CMU at commons display moisture damage. Hairline cracks are visible due to lack of expansion joints.
6. Drip flashing at base of walls has deteriorated, rusted or broken off in multiple areas.
7. Ribbed metal panels are in good condition overall but have few areas where panels are detached or coming loose.

Ground face CMU requires maintenance

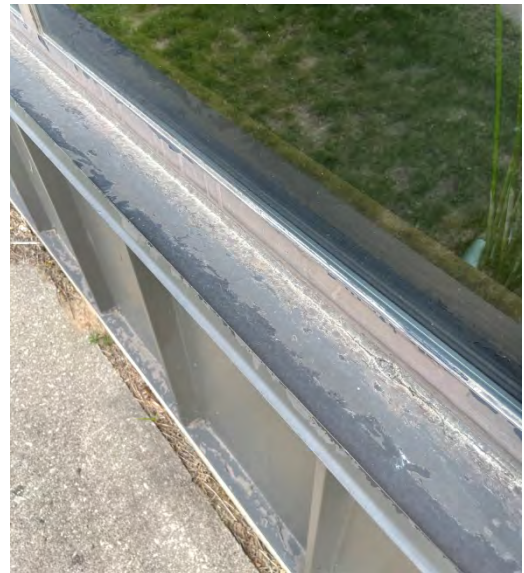
1. The original windows from the 1978 construction project are still in place and consist of a shallow depth thermally broken aluminum frame with 1 inch insulated glass.
2. The existing aluminum windows are framed within the metal stud exterior walls. The wall area below the windows is clad with ribbed metal fascia panels.
3. Newer thermal pane windows can be found at the commons area, north of the transformer.

Original aluminum windows aged

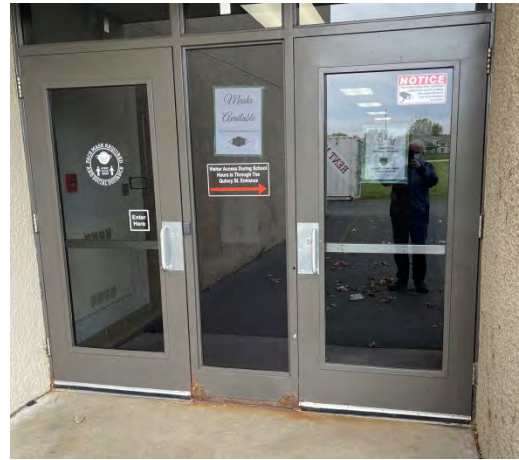
Hollow metal doors display rust

1. Aluminum entrances can likely remain for the present but should be included on the list for future replacement.
2. In general, hollow metal steel doors and frames can also continue to be used and repaired as necessary. Replacement with new insulated galvanized steel doors and frames should be considered for inclusion on any list for future building upgrades.

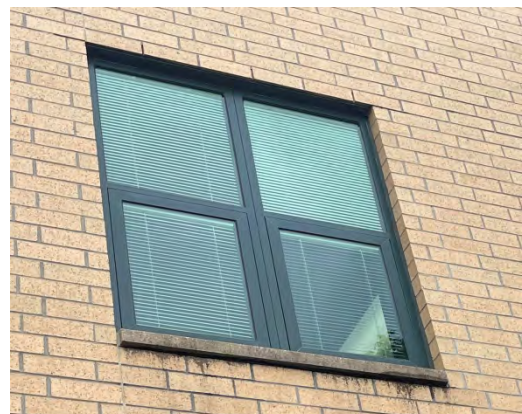
Precast concrete sills to be monitored

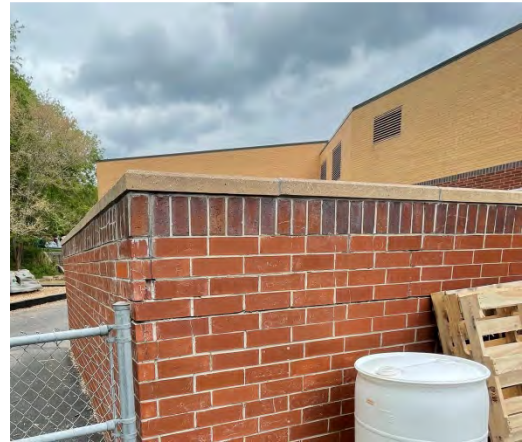
Dumpster enclosure requires repair or replacement at all walls

2. Brick partial high walls should be considered for future replacement. Soft joints shall be provided at stone caps. Ongoing repairs may be considered as part of a district maintenance project in lieu of replacement.
3. The colored precast concrete sills shall be monitored for maintenance and could be cleaned from stains. Sills may be re-sealed with prefinished metal flashing as part of a district maintenance project. Priority is not high at this time.
4. Door lintels may be repainted and monitored for maintenance.

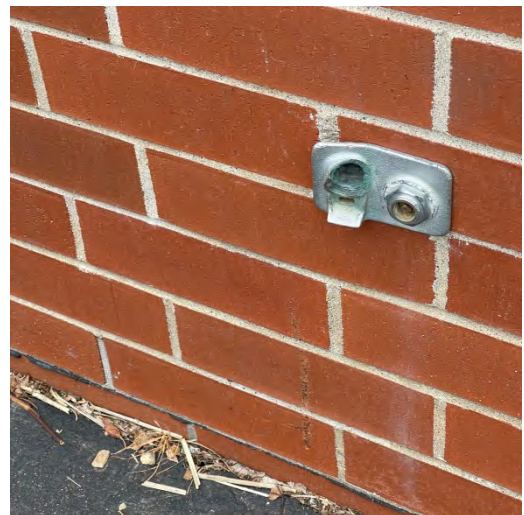
Damaged hose bib and membrane flashing deteriorated at base of wall

1. Hose bibs require monitoring to prevent continuing damage.
2. Dumpster gates may be assessed in regards to daily operation. No work is recommended at this time.

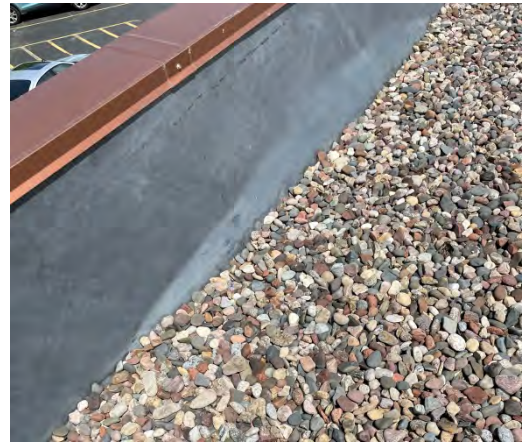
1. In general, the ballasted roof areas appear to be in satisfactory condition. Perimeter of the rubber membrane roofs will likely continue pulling away from any parapet or raised roof curbs from ongoing shrinkage.
2. The foam roofs above the 1966 classroom/gymnasium wing will continue to require frequent inspections for holes thru the foam that will contribute to leakage into the interior. The foamed roof surface is irregular and allows water to pond before finding its way to the roof drains and scuppers. Damage from birds is often the source of creating holes in the foam which can expand over time. This roof was recoated in 2013.
3. Sheet metal fascia appears in satisfactory condition. The original fascia at the 1966 south end addition appears worn and deteriorating.

Roof membrane pulling away from parapet

1. For purposes of extending the lifespan of the ballasted single ply rubber membrane roof, it is recommended that the perimeters be cut out and re-flashed with reinforced perimeter strip as needed. Membrane seams should also be reviewed/stripped on a scheduled annual basis. The maintenance work should extend the life of the ballasted roofing indefinitely.
2. The urethane foam roofs can continue to be re-coated and repaired indefinitely with the understanding that frequent inspections and repairs will likely be necessary. Total tear-off and replacement with a single-ply membrane (EPDM or PVC) remains an option when conditions justify the cost of maintaining versus total replacement.

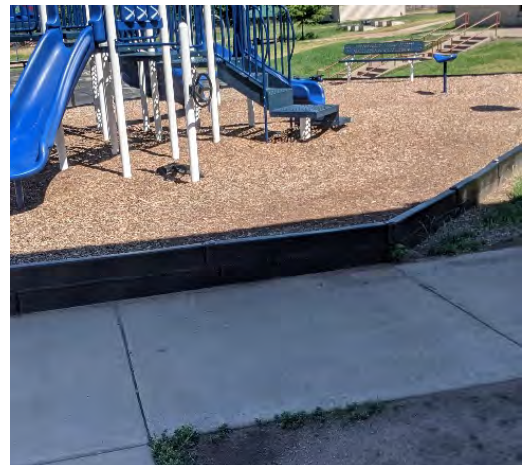
No ADA access – map grid E3

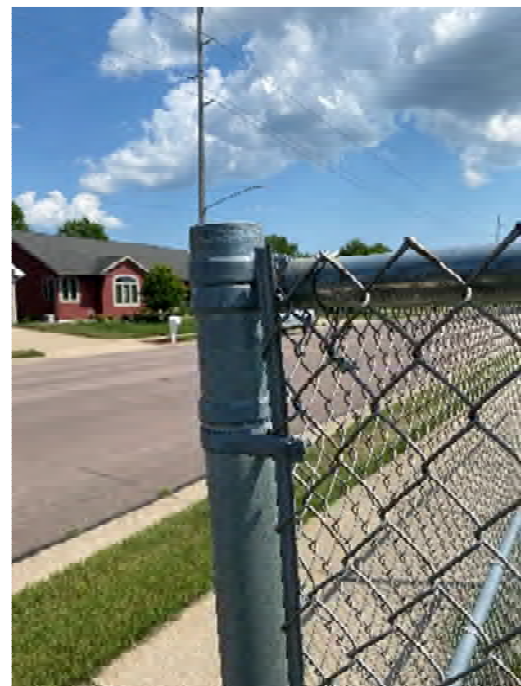
Missing end cap

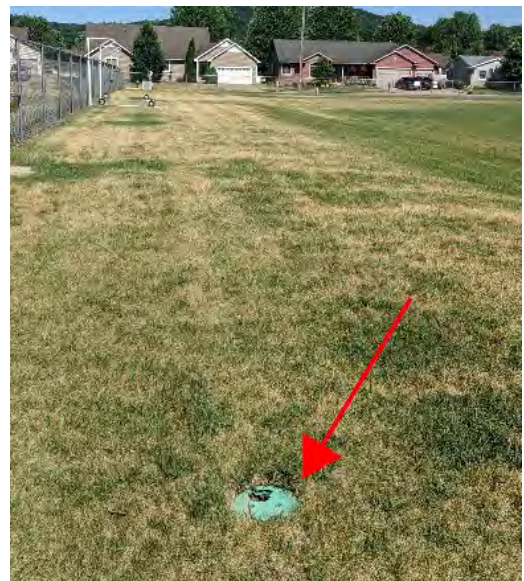
Broken valve box cover

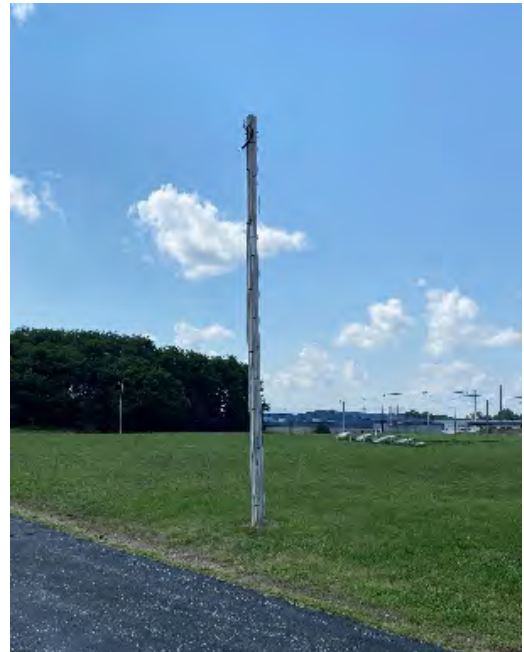
Missing light fixture – map grid H6
