TUTT - Tuttle: Vacant Building Report

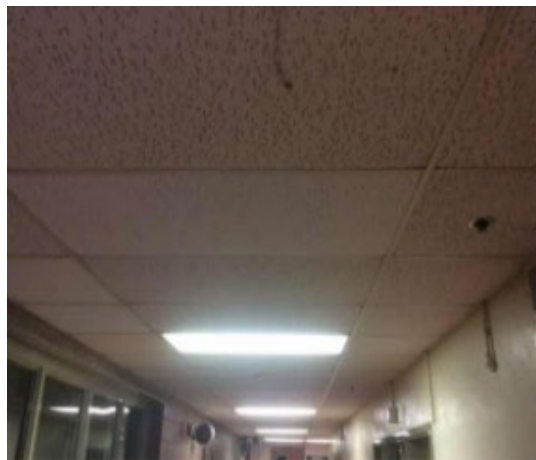
C3032 Suspended Ceilings:- View of Acoustic Ceiling System - Standard

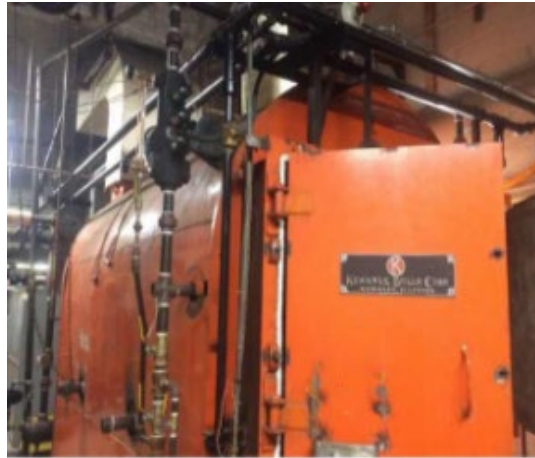
D3021 Boilers:- View of HW Boiler - Oil/Gas - 1010 to 4505
MBH (30 to 134 BHP)
