Bridges Academy

1702 McLaughlin Avenue, San Jose, CA

Bridges Academy - Master Planning Evaluation

Evaluation Summary

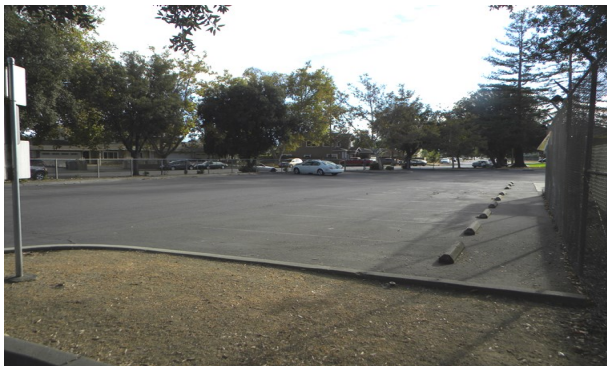
Some flatwork and walkways were upgraded in 2011 and 2012 to eliminate cracks and tripping hazards. The expansion to the existing parking lot replaced many cracks and tripping hazards at the front of the school. There is one remaining drinking fountain that needs to be upgraded.

A bottle filler station should be installed in the cafeteria to meet ADA compliance.

It is recommended that the DA parking spaces be restriped and signage added.

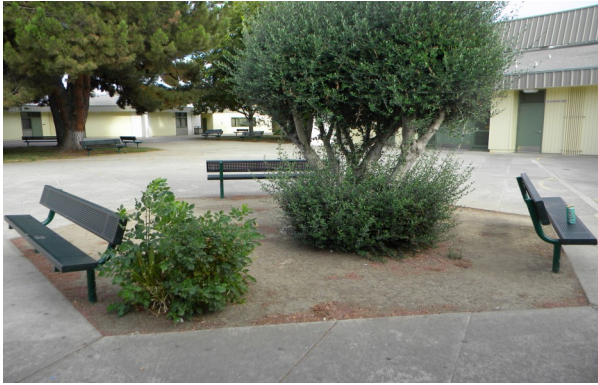
Planting has been upgraded throughout the last few years at the front and interior of the campus. At the rear parking lot, many trees were thinned out to increase the ability for security and ease of maintenance.

It is recommended that drainage be added at the perimeter of the larger lawn areas as this area is typically wet.

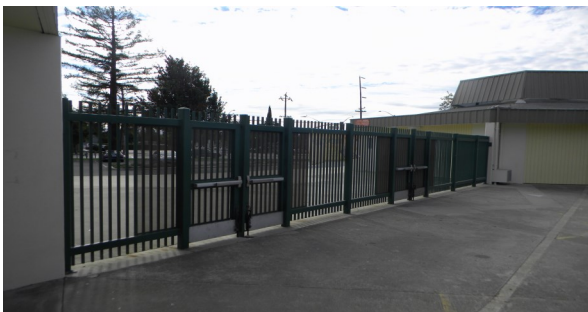
New decorative fencing was added at the perimeter of the entire campus. The large concrete block wall at the rear of the campus was demolished and new chain link fencing was added for improved security. Recommend decorative fencing to be added. New security cameras were added in 2013. Technology for closed circuit security camera systems has drastically improved and has become more affordable to install and operate. There are areas at the existing gymnasium whereas exiting out has been locked from the outside.

It is recommended that because there are still existing exit gates that are locked from the outside which can create an exiting issue, a new

way of existing out from the Gym needs to be added.

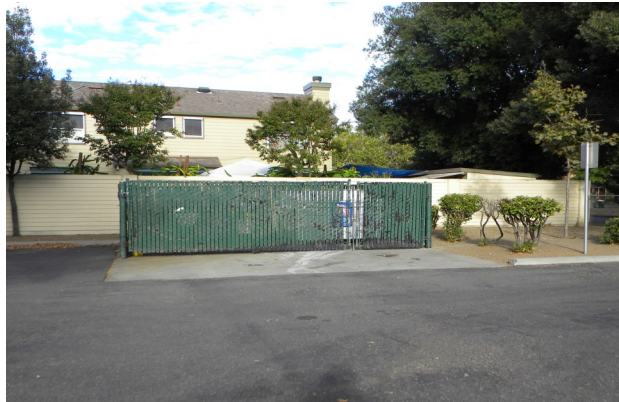
The existing trash enclosure is showing wear. The fencing needs to be replaced with new slats.

It is recommended that a new block wall enclosure with a roof and a hose bib be added for the existing garbage enclosure.

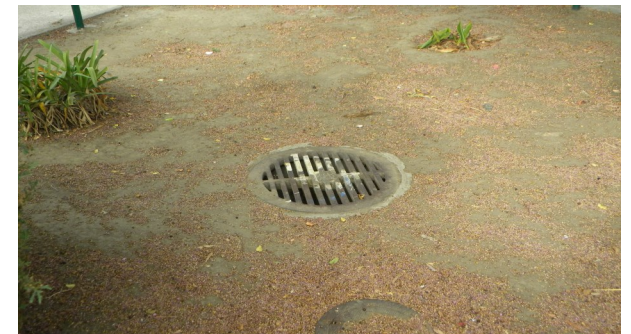
Several rain water leaders are not properly specified for vandal resistance and do not have the District Standard clean-outs. Drainage at this site has not been a problem since the front parking lot upgrades.

It is recommended that the existing rain water

leaders be altered at their bases with new District Standard clean-outs.

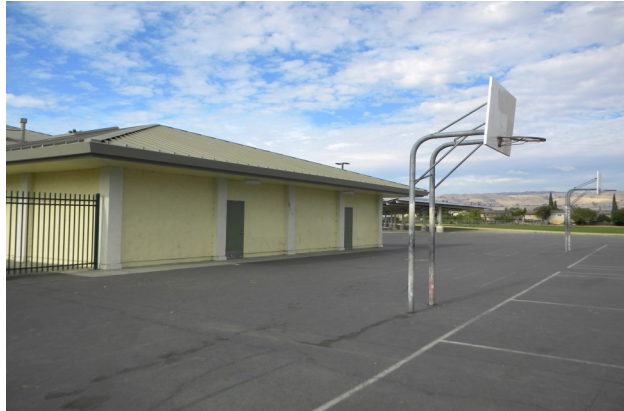
The existing basketball backstops, rims and chains are missing or are inadequate. There are currently no ball walls available at this site.

It is recommended that all basketball backstops be replaced with new rims and chains.

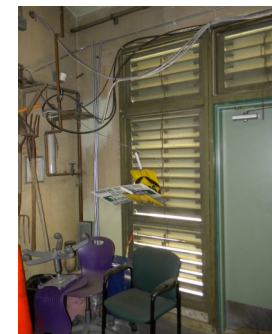
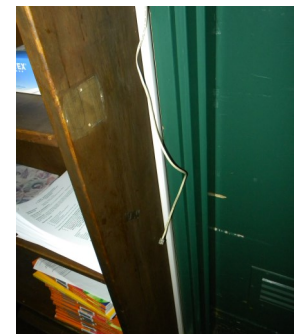
There are not currently enough electrical outlets in the classrooms or other student service areas. There are several locations where loose wiring is hanging from the roof and walkways.

It is recommended that some additional electrical outlets be provided at select areas of this campus. All loose wiring should be removed.

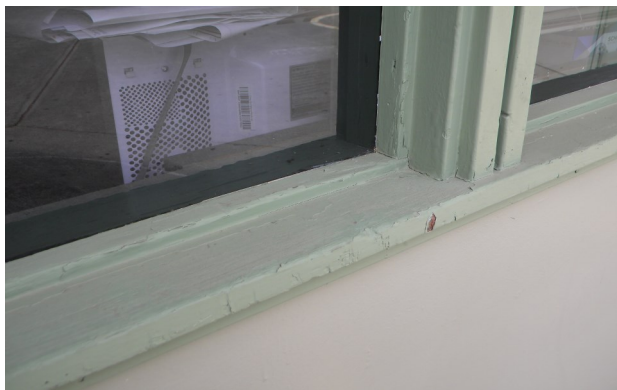
The original campus buildings were constructed in an era when natural resources such as natural gas and electricity were inexpensive. Windows are single glazed throughout and insulation does not currently meet new construction standards. The skylights in the Gymnasium

have exceeded their intended life. The existing thickened lamination system is discolored and decaying. It is recommended that insulation be added to all exterior walls and added to all ceiling cavities. Windows should be replaced with double glazed window systems. It is recommended that the skylight system in the Gymnasium be replaced.

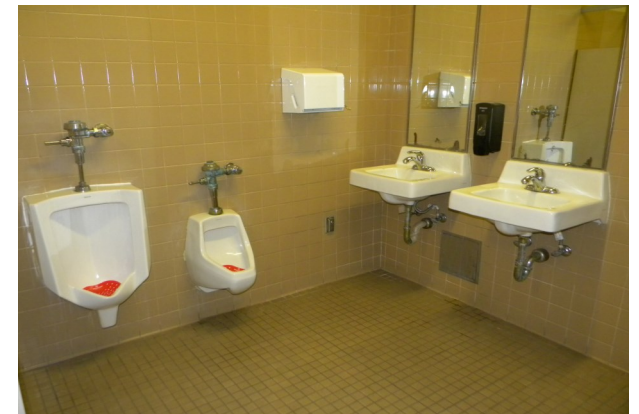
The existing toilet rooms finishes were modernized in 2004.

It is recommended that all toilet partitions be replaced within the next 5 years.

It is recommended that select toilet partitions and mirrors be replaced in the next five years

as they are approaching their useful lifecycle. It is recommended that the floor grout be acid washed or steamed to remove cumulative coatings.

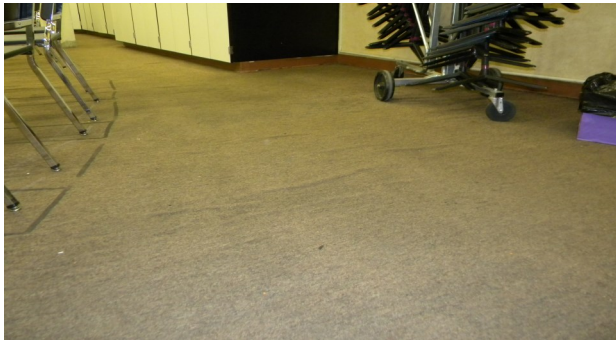
Most of the flooring is getting older. Floor carpeting can last for about 15 years. All carpeting at this site is approaching its useful lifecycle.

The VCT flooring in the music room is original to the school and should be replaced. The VCT in storage rooms is cracking and should be replaced.

It is recommended that all floor carpeting and associated VCT be replaced in the next three years in all storage rooms and the music room.

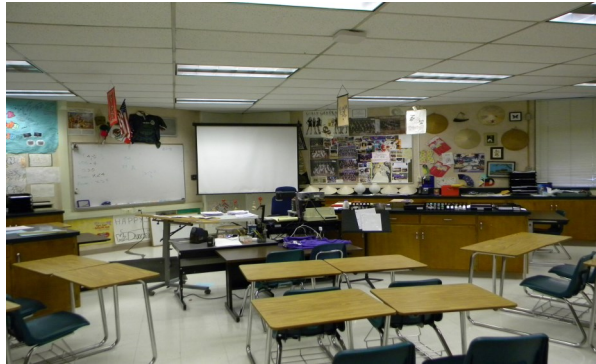
All suspended ceilings are in need of new ceiling tiles at several locations. There are areas of ceilings where interior modifications or roof leaks have occurred. Hard lid ceilings are discolored from moisture or modest vandalism.

It is recommended that all ceiling tiles be replaced and the grid be painted. It is recommended that all hard lid ceilings be painted.

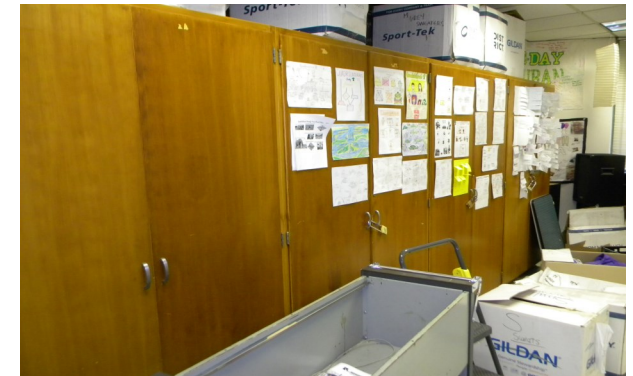
Although the cabinetry was upgraded in 2004, there are signs of abuse, vandalism and heavy wear and tear at some various locations. Most of the casework has newer tops whereas the base cabinets were left alone during the past renovation. There are no teaching units.

It is recommended that all cabinetry be re-

placed entirely throughout the campus to meet the District standards including teaching walls.
