Dahl Elementary School

3200 Water Street, San Jose, CA 95111

Captain Jason M. Dahl Elementary - Master Planning Evaluation

Evaluation Summary

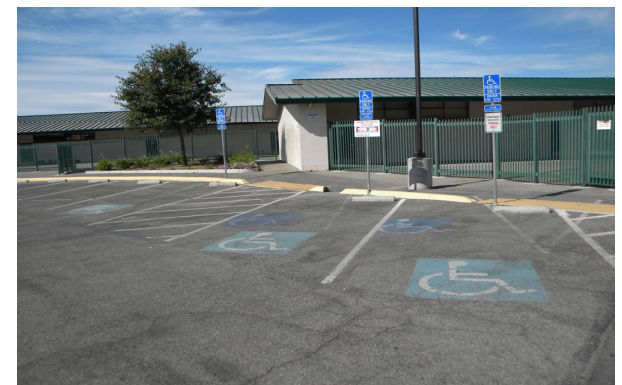
best suited for this site. The existing pavement is beginning to show signs of moisture damage. The drop off area in front of the kindergarten needs delineator between the drop off area and the drive through area. It is recommended that the parking lot get slurry sealed to hide existing striping and then get re-striped. It is recommended that additional striping be added to better define the drop off lane and the drive through lane.

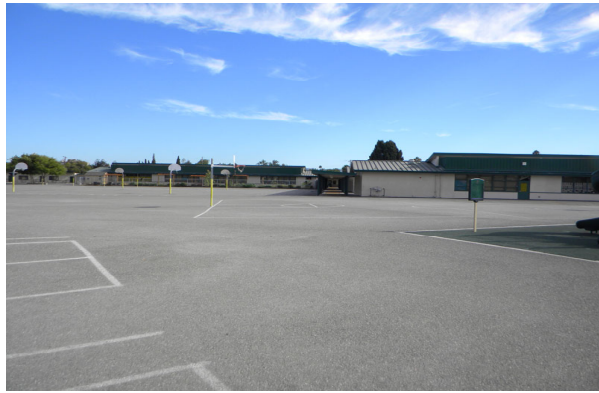
Captain Dahl School's existing paved play area is in fair condition. However, the existing AC paving was paved new around the existing steel ramps of the portables which created a tripping hazard. There are several cracks in the existing pavement.

It is recommended that crack fill and slurry be installed at the paved area in the next five years and the ramps be lifted to be paved underneath them.

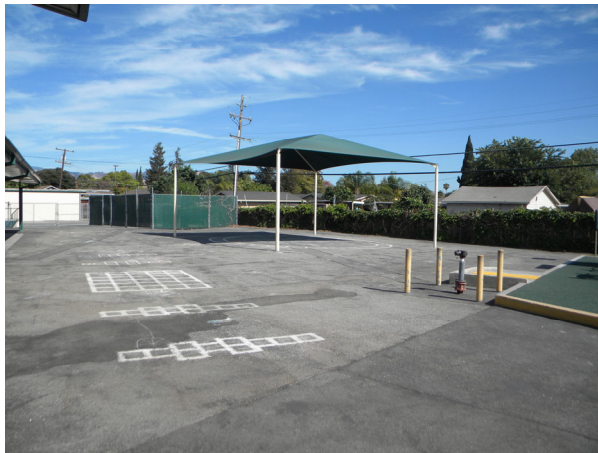
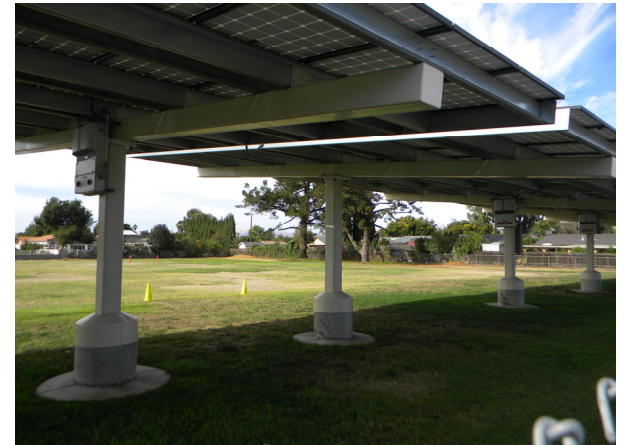
The existing lawn is in poor condition. The area under the large photovoltaic arrays is not getting sunshine. The site desires a walking track.

It is recommended that the area under the photovoltaic arrays be changed to a pavement or decomposed granite material. The grass field should be removed and replaced. It would be desirable to install a new DG walking track at the grass field area.

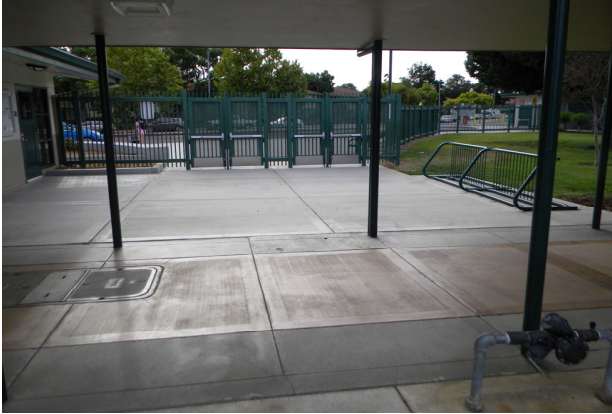
New decorative fencing was added at the perimeter of the entire campus during the renovation several years ago. There is an older fence along site the existing neighbors fence line that should be replaced whereas there are still small areas at the perimeter of the campus where students and neighbors can still pass through.

It is recommended that new fencing should replace the old fence along the existing shared neighbor property line and all perimeter gaps should be filled in with new fencing.

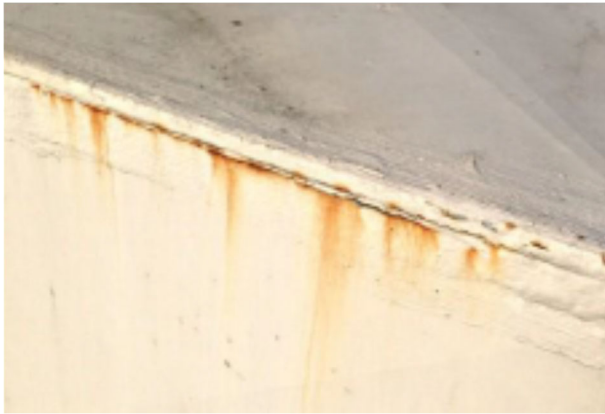
Based on the roofing report, the existing campus was re-roofed in 2010. The report shows that there is concern over the equipment as well as maintenance issues at the covered walkways and some edge flashing conditions.

It is recommended to coat all interior equipment wells with a roof waterproofing material as specified in the roofing report. Preventative maintenance on the built-up roof and gutters is also recommended.

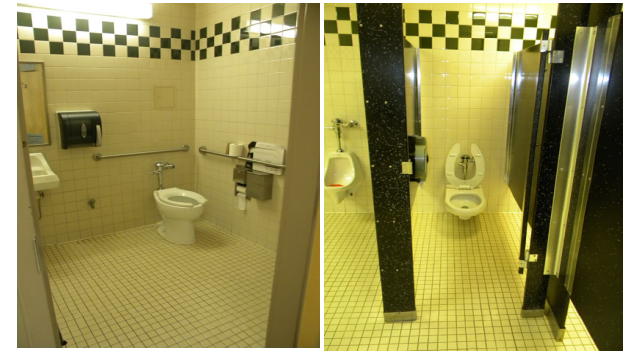
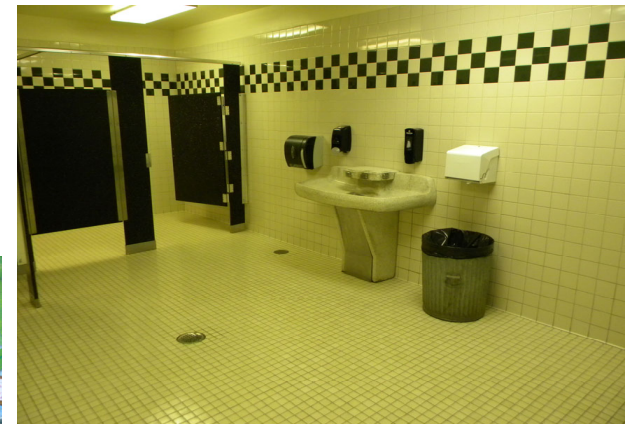
The existing toilet rooms finishes were modernized in 2009/2010. It was observed that the existing bathrooms signage does not

meet current code requirements.

It is recommended that signage be upgraded.

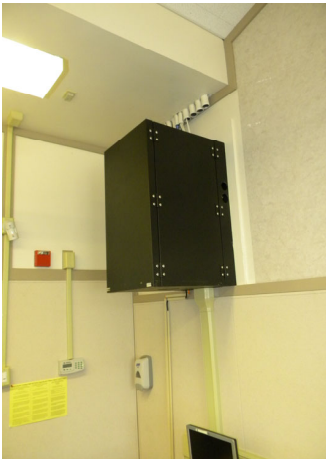
The observations and reports to us indicate that the IDF units in the G wing is too high off the ground for easy maintenance, and that the cafeteria has only one WAP but is in need of two WAP. It is also reported that each classroom should have one central WAP.

It is recommended the existing IDF in Wing G be relocated with the coordination of the District IT personnel. A new WAP should be added to the cafeteria building and one at each classroom.

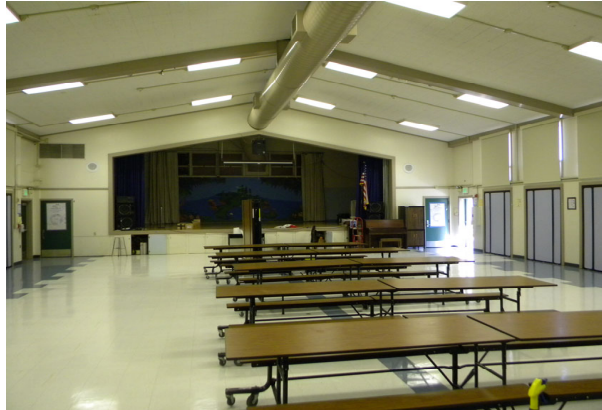
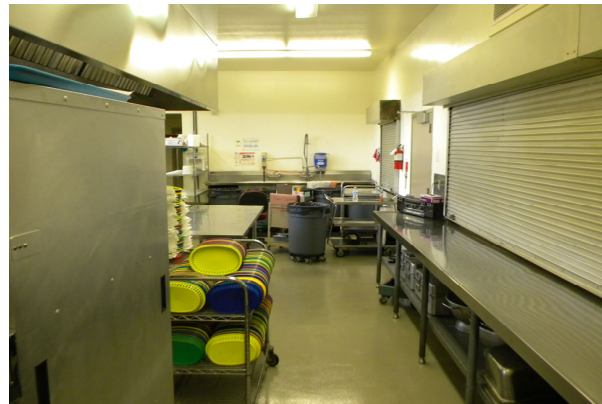
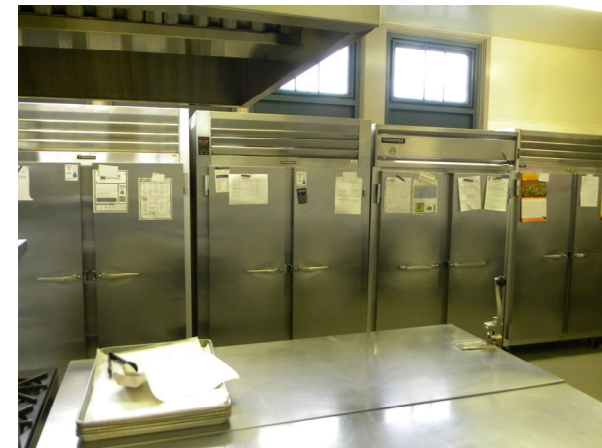
The existing Kitchen and cafeteria is in satisfactory condition. The kitchen is in need of a new refrigeration and freezer unit.

It is recommended that the refrigerator and freezer units be replaced.
