# Lairon College Preparatory

3975 Mira Loma Way, San Jose, CA

## Lairon College Preparatory Academy - Master Planning Evaluation

### Evaluation Summary

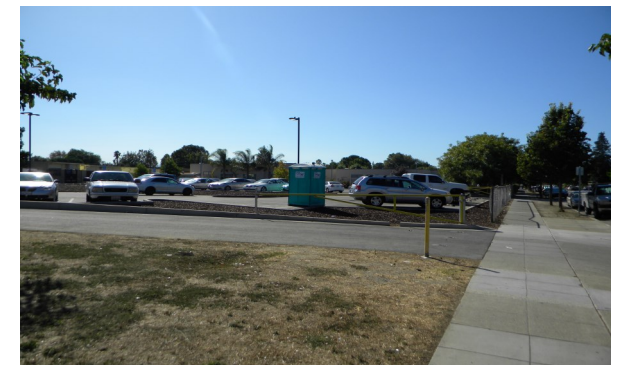
There are two parking lots on site. The main parking lot also includes a small drop off area that was expanded in 2010 to its maximum possible size. The secondary parking lot was altered when the two story classroom building was added to this site. There is a third parking lot that should be mentioned that is used by Santa Clara County Office of Education Special

During 2019 the main parking lot received a refresh with new wheel stops, signage, entry gates and a new parking stalls to drop off lane divider.

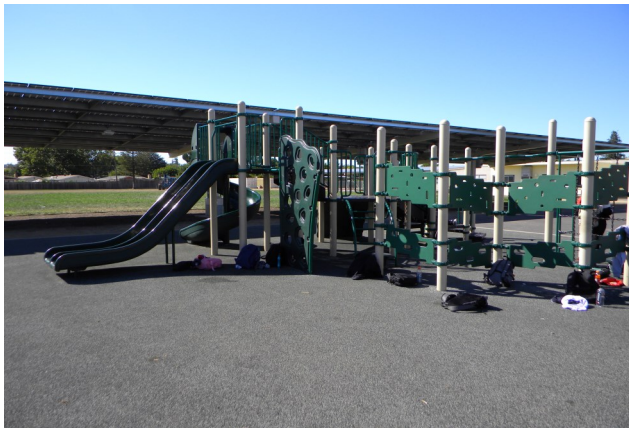
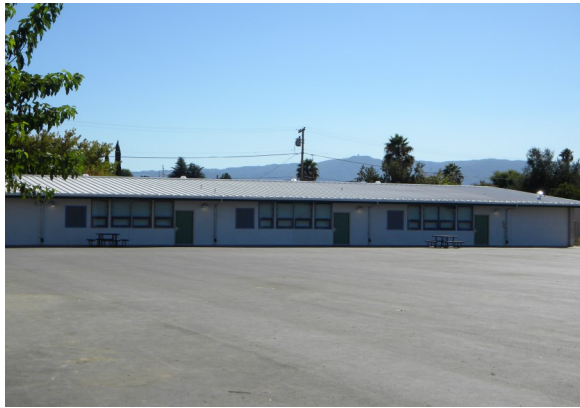
The site had new play structure installed in 2014 with district standard rubberized fall protection material.

There is no need for any changes at this time.

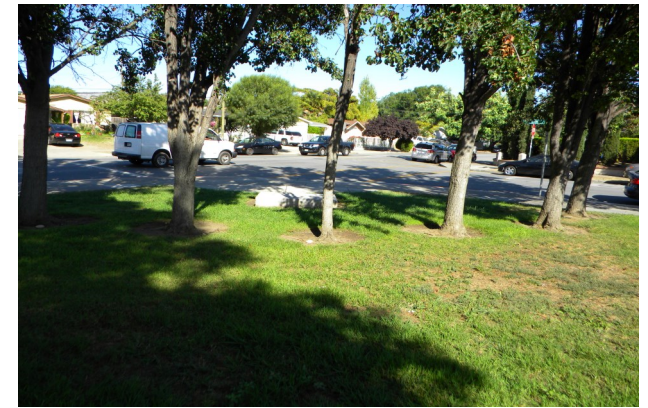
All of the interior landscape areas are artificial turf installed in 2019. All exterior landscape areas and the rear play field are sod with irrigation. In general all existing sod areas are in good shade but are on domestic water. Recycled water is not available in this area.

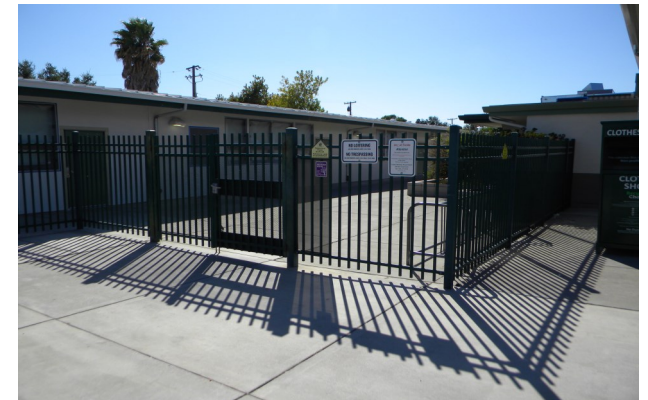
The entire campus is enclosed with decorative fencing on the frontage side and chain link fencing on the rear perimeter. Gates and lock sets were replaced during the 2019 modernization.

No additional fencing is needed at this time.

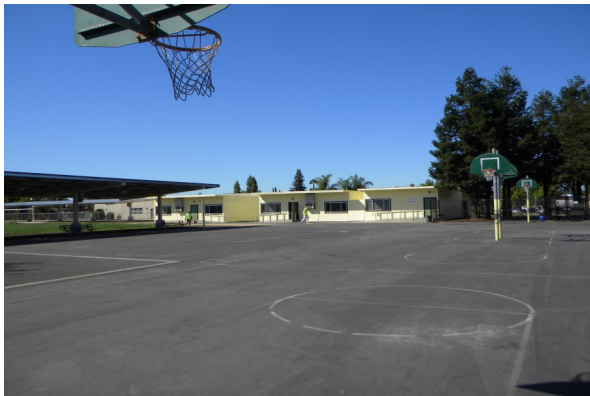
The existing basketball backstops, rims and chains are missing or are inadequate. There are currently no ball walls available at this site.

It is recommended that all basketball backstops be replaced with new rims and chains.

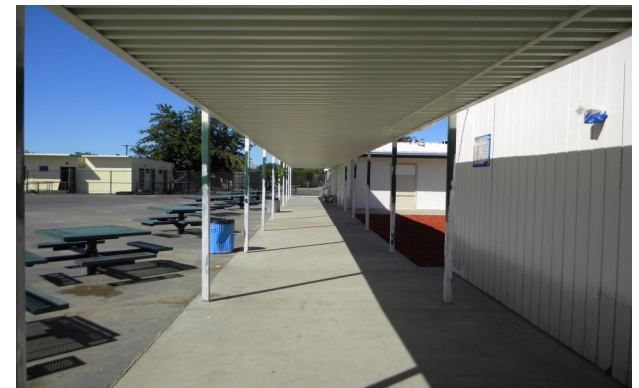
The campus currently has an adequate covered walkway system.

There is no need to modernize the covered walkway system at this site.

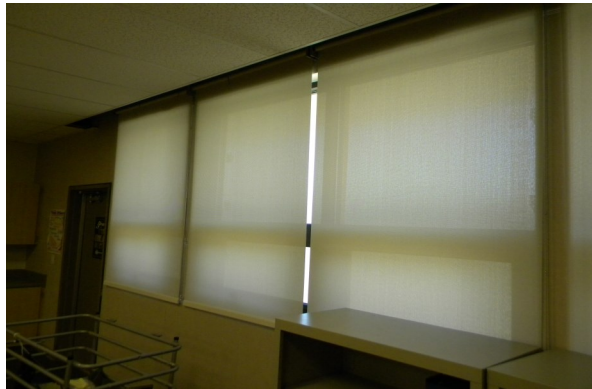
During the 2019 modernization the building insulation and exterior window systems were replaced for all classroom wings. The administration / cafeteria building were omitted.

It is recommended that the administration / cafeteria building be renovated with new building insulation and windows.

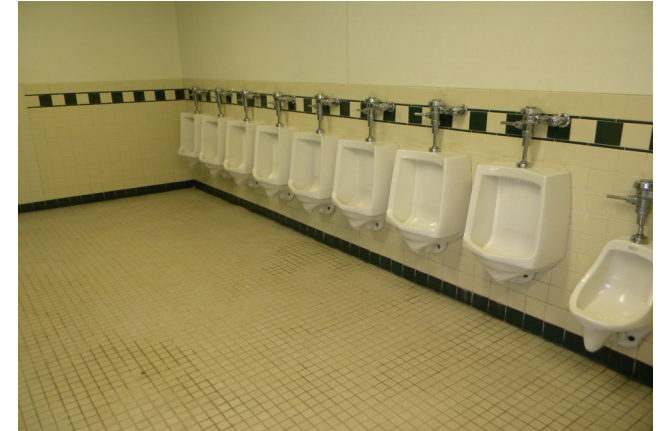
The restrooms in the administration / cafeteria

building were renovated in 2000 and are still in need of a complete refurbishment.

It is recommended that the administration and cafeteria bathrooms be renovated completely.

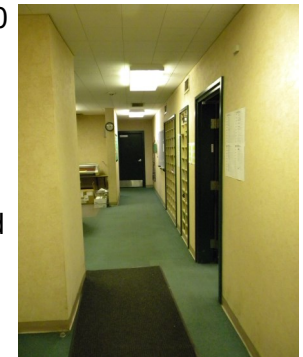
The administration has little to no tackable wall

surfaces. Most walls are covered with vinyl wall coverings. The cafeteria has as impact resistant paintable surfaces.

It is recommended that the administration area and associated offices be retrofitted with tackable wall panels throughout.

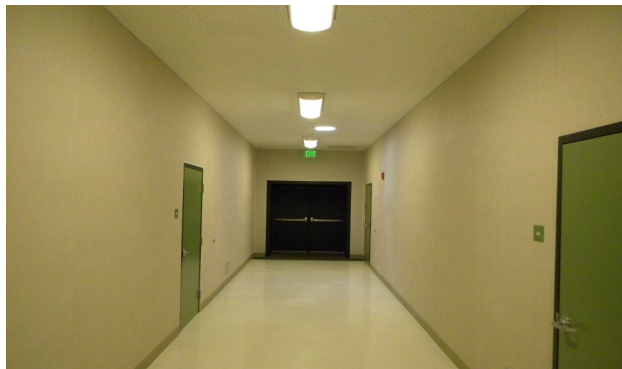
The classroom wing interior wall finishes were upgraded in the 2019 moderation.

Other than the recommendation of vinyl walls above, the cafeteria walls should be replaced with new high impact panels.

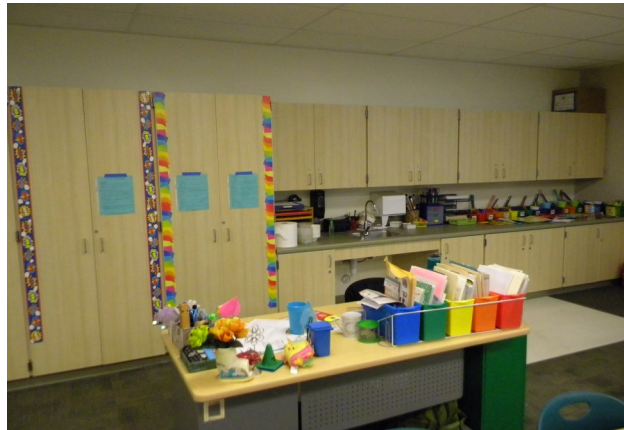
All suspended ceilings in the classroom wings are new. The administration and cafeteria ceilings are either hard lid or glue up ceiling tiles that are in need of replacement.

It is recommended that all ceilings in the administration and cafeteria spaces be replaced with new ceiling systems. It is recommended that all hard lid ceilings be painted.

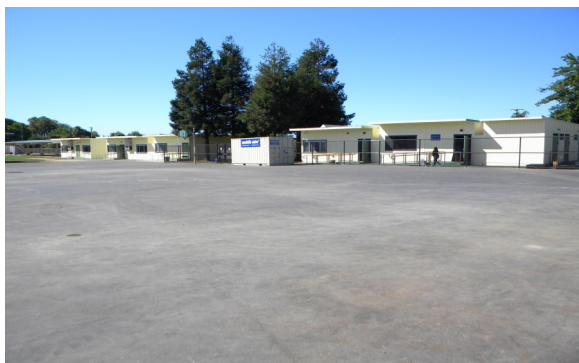
Two 24x40 units and one 12x40 restroom unit were renovated in 2018 for use as the Franklin McKinley Children's Initiative facility.

One 24x40 classroom was renovated in 2018 and is currently being used as the Wellness Center for the Community by the District .

The remaining three units are from the 1997 class size reduction mandate from the state and are not currently being used for classroom instruction.

It is recommended that any of the Portable units not being used be removed to avoid any future ongoing maintenance issues.

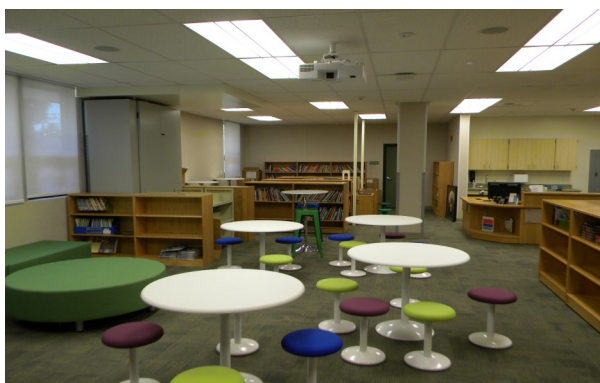
The library space was completely renovated during the 2019 modernization and included a new student media center.
